Project Name		CASp Survey #	Date
Heller Park		532004	5/12/2014 5/14/2014
Address		Weather	Temperature
257 16 th Street Costa Mesa, CA		Sunny	79° F 95° F
CASp Inspector	Owner	Start Time	Finish Time
Steve Miller #532	City of Costa Mesa	9:00 am 8:00 am	11:30 am 1:30 pm

Introduction

Findings

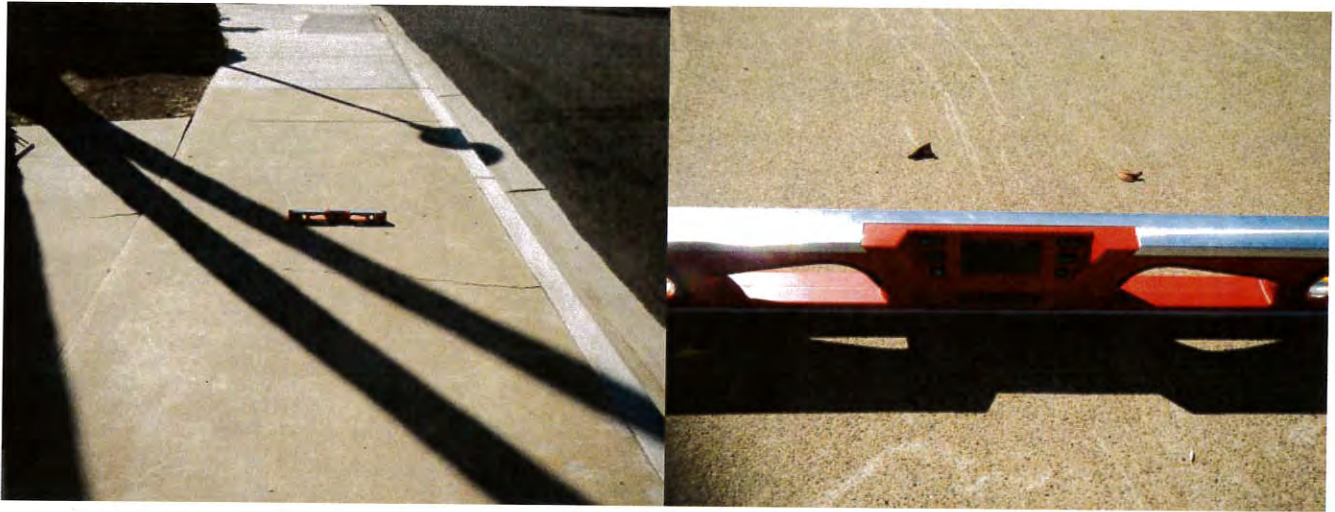
- 1) 3.7% cross slope in excess of 1:48 at west end of sidewalk on Knox Place. (2013 CBC 11B403.3)

Provide walkways with 1:20 maximum slope in the direction of travel and 1:48 cross slope.

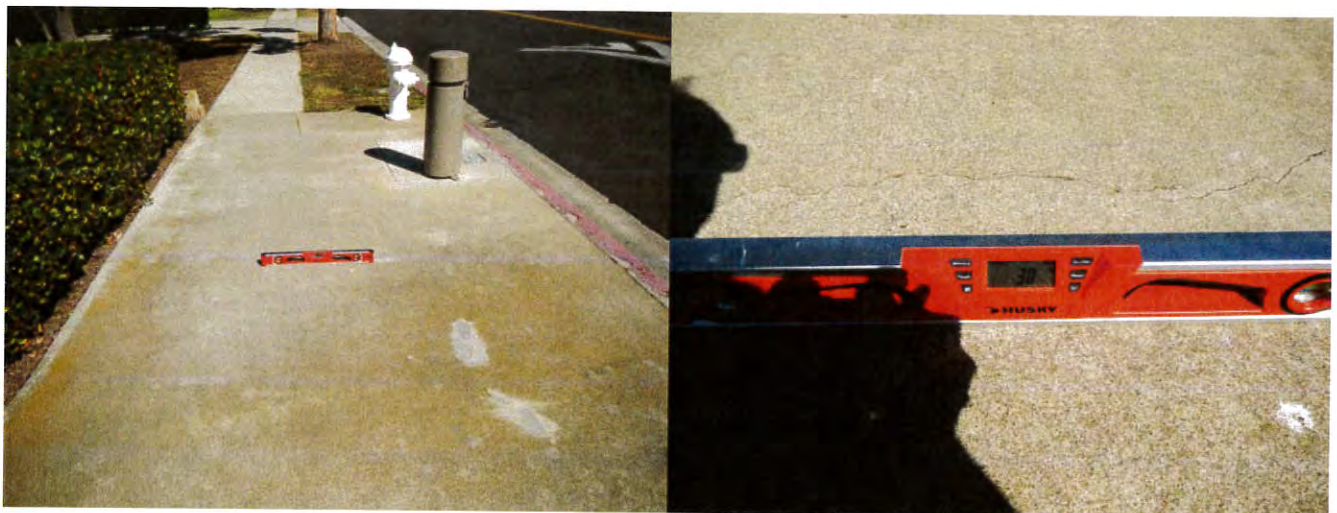
- 2) 3.0% cross slope in excess of 1:48 at west end of sidewalk on 16th Street. (2013 CBC 11B403.3)

Provide walkways with 1:20 maximum slope in the direction of travel and 1:48 cross slope.

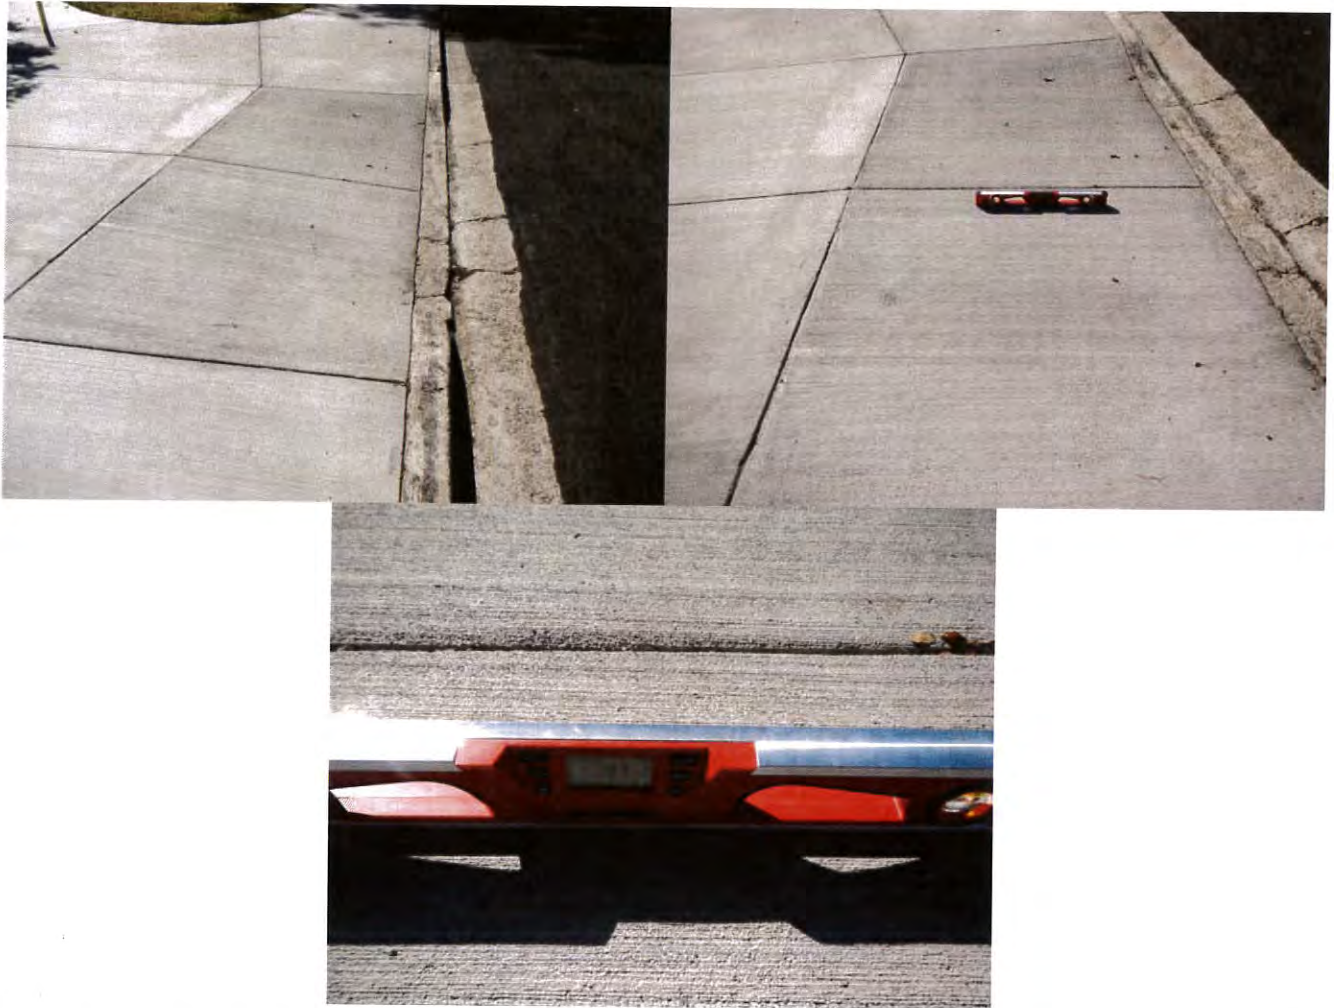
- 3) Curb ramp at west end of sidewalk on Knox Place is in excess of 1:12 on the ramp run. The flared sides are in excess of 1:10. Counter slope in street in excess of 1:20. The transition from gutter to curb cut is not level. There is no 12" wide grooved border at the top of the ramp. There are no detectable warnings. (2013 CBC 11B406.2)

Provide 48" minimum wide curb ramp with running slope not steeper than 1:12 and flared sides not steeper than 1:10. Ramp cross slope shall not exceed 1:48. Curb ramp shall have level (not greater than 1:48 slope) landing at top of ramp that extends the entire width of the ramp and 48" deep. Provide counter slope that does not exceed 1:20 in gutter and street. Provide a transition to gutter that is not the same level. Provide a 12" wide grooved border at the top of the ramp including the flared sides. The grooved border shall consist of a series of grooves 1/4" wide by 1/4" deep at 3/4" on center. Provide 36" deep detectable warnings (truncated domes per 2013 CBC 11B705.1) the entire width of the curb ramp excluding the flared sides and the curb depth.

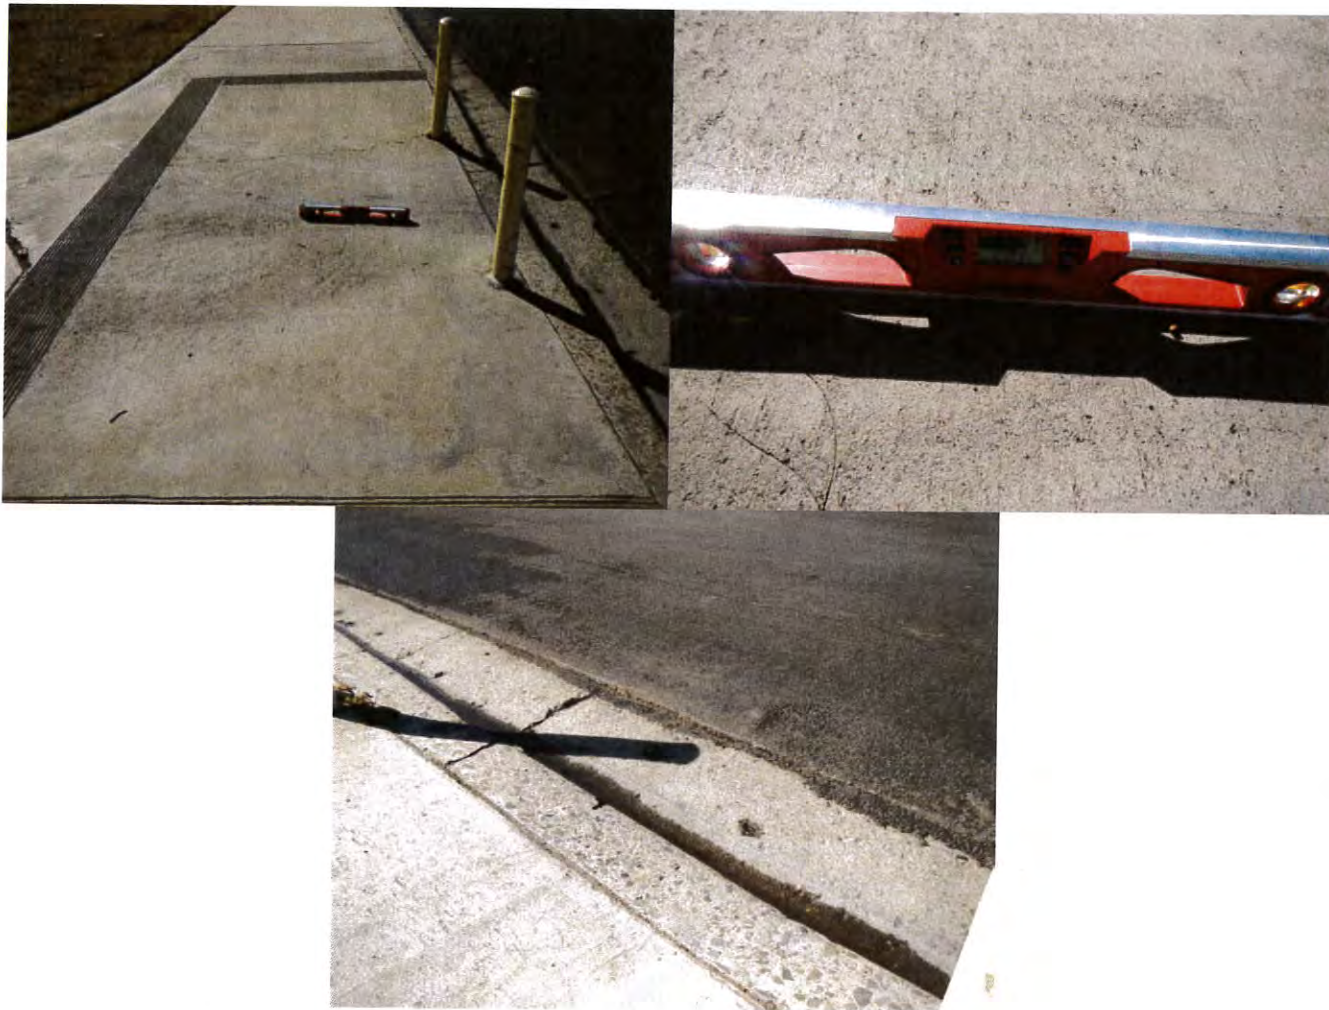
- 4) Curb ramp at east end of sidewalk on Knox Place is in excess of 1:12 on the ramp run. Counter slope in street in excess of 1:20. The transition from gutter to curb cut is not level. There is not a 12" wide grooved border at the top of the west flared side. There are no detectable warnings. (2013 CBC 11B406.2)

Provide 48" minimum wide curb ramp with running slope not steeper than 1:12 and flared sides not steeper than 1:10. Ramp cross slope shall not exceed 1:48. Curb ramp shall have level (not greater than 1:48 slope) landing at top of ramp that extends the entire width of the ramp and 48" deep. Provide counter slope that does not exceed 1:20 in gutter and street. Provide a transition to gutter that is not the same level. Provide a 12" wide grooved border at the top of the ramp including the flared sides. The grooved border shall consist of a series of grooves 1/4" wide by 1/4" deep at 3/4" on center. Provide 36" deep detectable warnings (truncated domes per 2013 CBC 11B705.1) the entire width of the curb ramp excluding the flared sides and the curb depth.

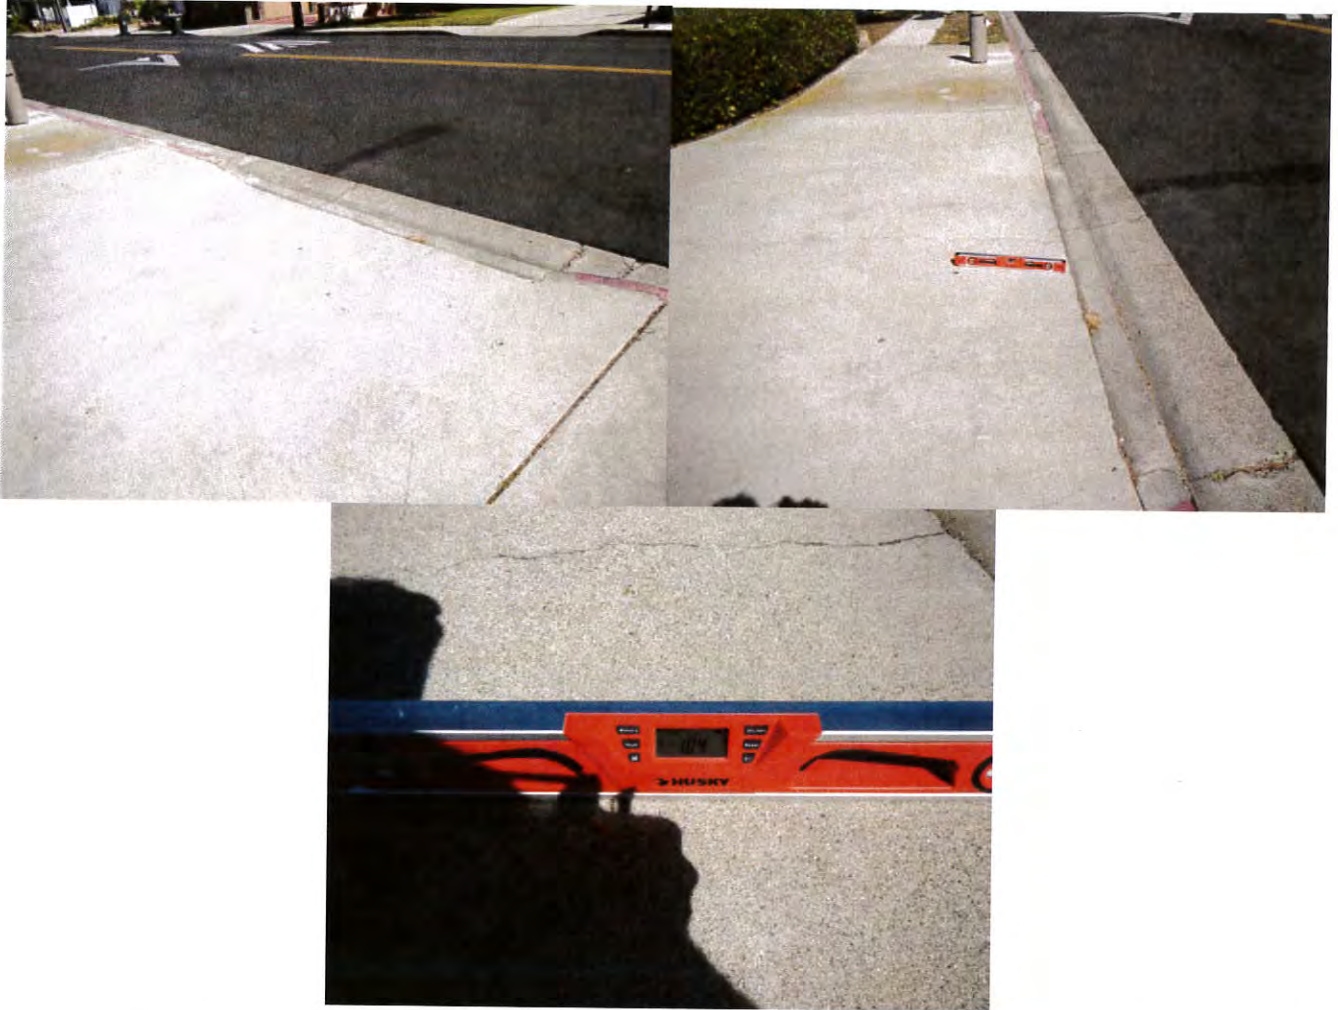
- 5) Curb ramp at west end of sidewalk on 16th Street is in excess of 1:12 on the ramp run. Counter slope in street in excess of 1:20. The transition from gutter to curb cut is not level. There is no 12" wide grooved border at the top of the ramp. There are no detectable warnings. (2013 CBC 11B406.2)

Provide 48" minimum wide curb ramp with running slope not steeper than 1:12 and flared sides not steeper than 1:10. Ramp cross slope shall not exceed 1:48. Curb ramp shall have level (not greater than 1:48 slope) landing at top of ramp that extends the entire width of the ramp and 48" deep. Provide counter slope that does not exceed 1:20 in gutter and street. Provide a transition to gutter that is not the same level. Provide a 12" wide grooved border at the top of the ramp including the flared sides. The grooved border shall consist of a series of grooves 1/4" wide by 1/4" deep at 3/4" on center. Provide 36" deep detectable warnings (truncated domes per 2013 CBC 11B705.1) the entire width of the curb ramp excluding the flared sides and the curb depth.

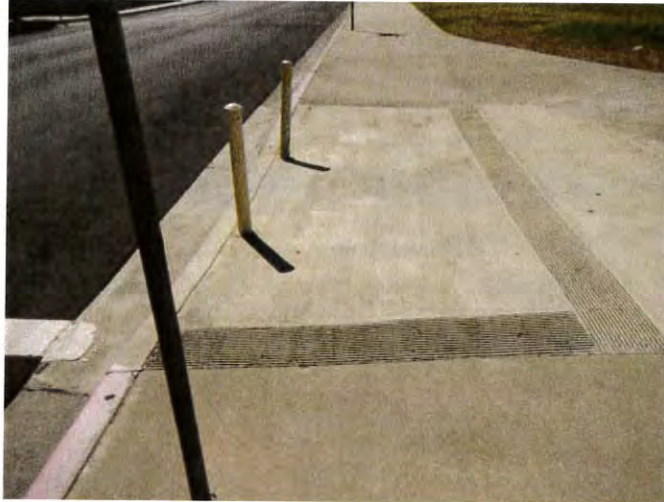
- 6) There are no detectable warnings for the curb ramp at east end of sidewalk on 16th Street. (2013 CBC 11B705.1)

Provide 36" deep detectable warnings (truncated domes per 2013 CBC 11B705.1) the entire width of the curb ramp excluding the flared sides and the curb depth.

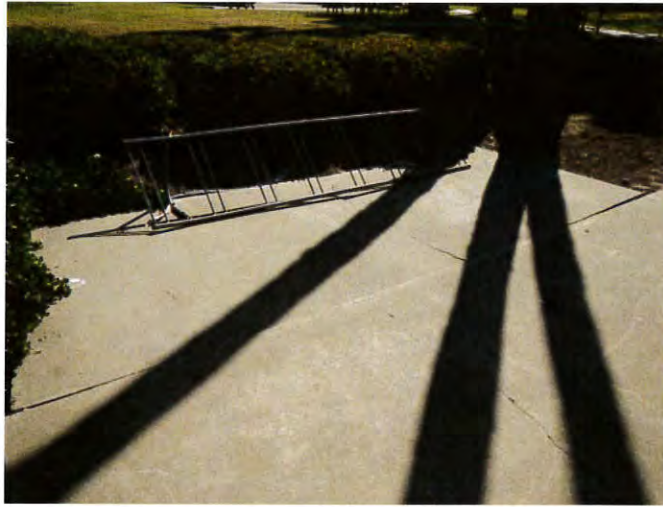
- 7) 1-1/4" level change in excess of 1/2" without edge treatment at bike stand on west corner of park. (2013 CBC 11B-303.2)

Reduce level change to 1/4" high maximum or 1/2" with a 1:2 bevel starting at 1/4" high.

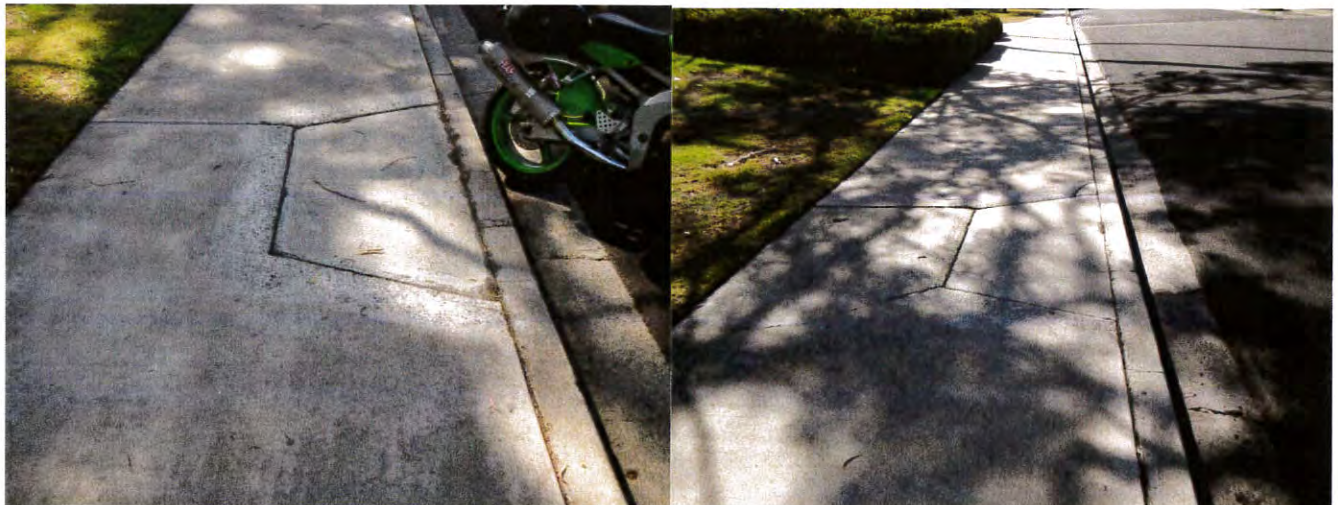
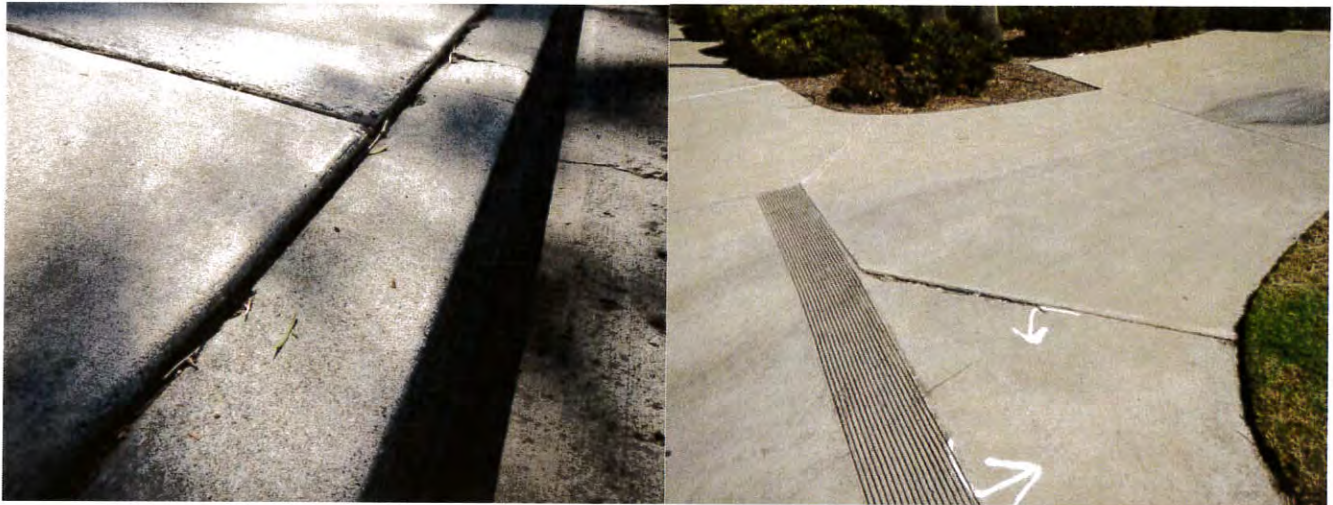
- 8) Multiple level changes in excess of 1/2" without edge treatment along Knox place sidewalk. (2013 CBC 11B-303.2)

Reduce level change to 1/4" high maximum (or 1/2" with a 1:2 bevel starting at 1/4" high.)

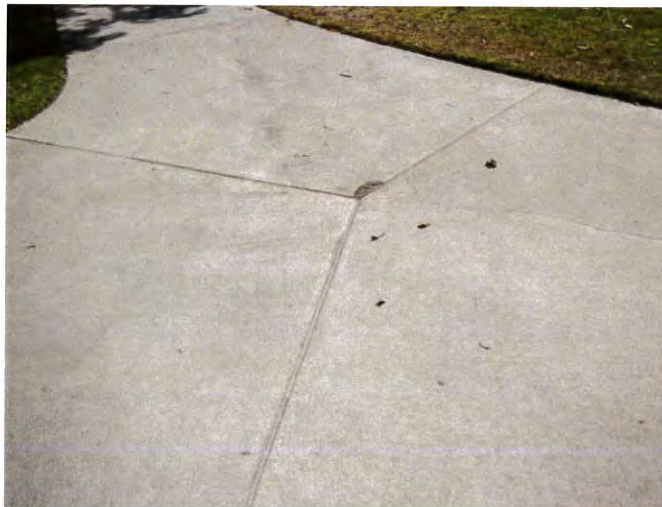
9) Level change in excess of 1/2" without edge treatment at south end of south sidewalk. (2013 CBC 11B-303.2)

Reduce level change to 1/4" high maximum (Fill in hole.)

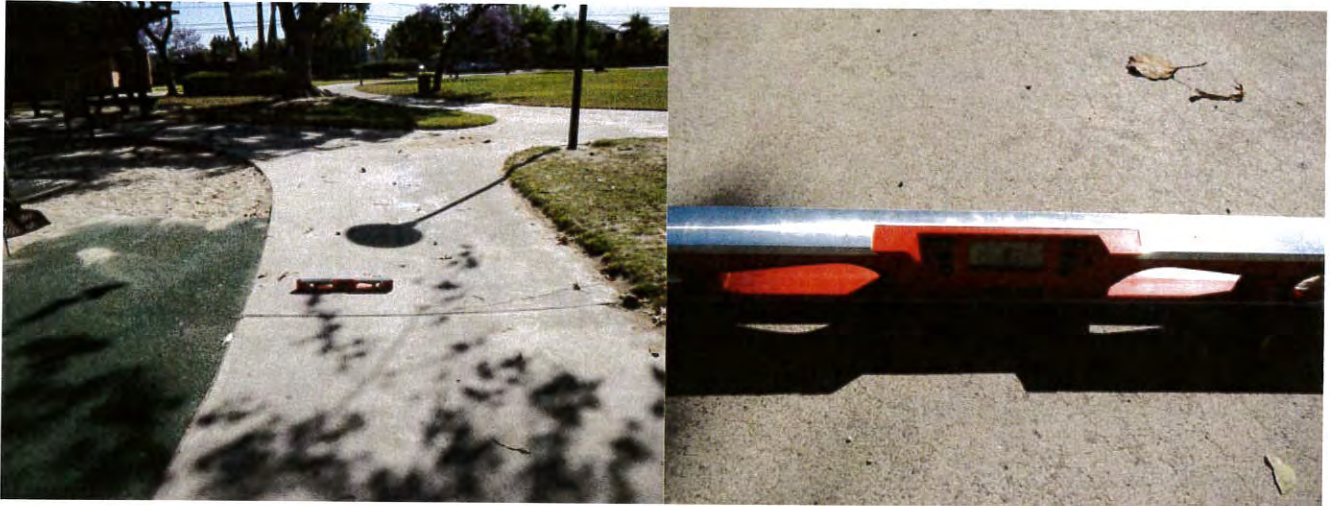
10) 3.3% cross slope in excess of 1:48 at sidewalk south of playground equipment. (2013 CBC 11B403.3)

Provide walkways with 1:20 maximum slope in the direction of travel and 1:48 cross slope.

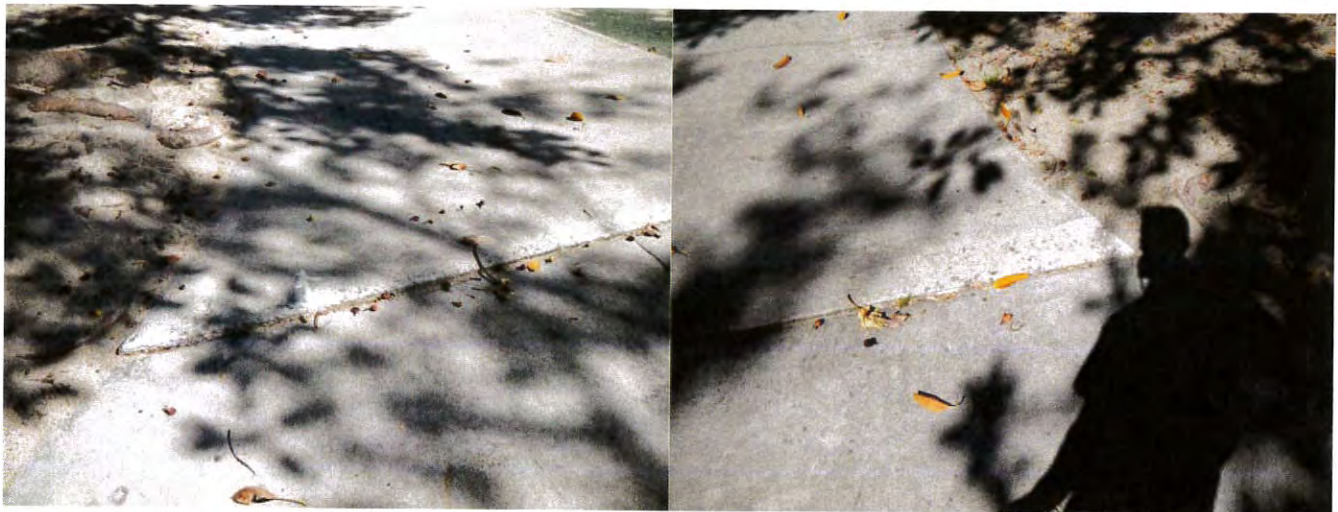
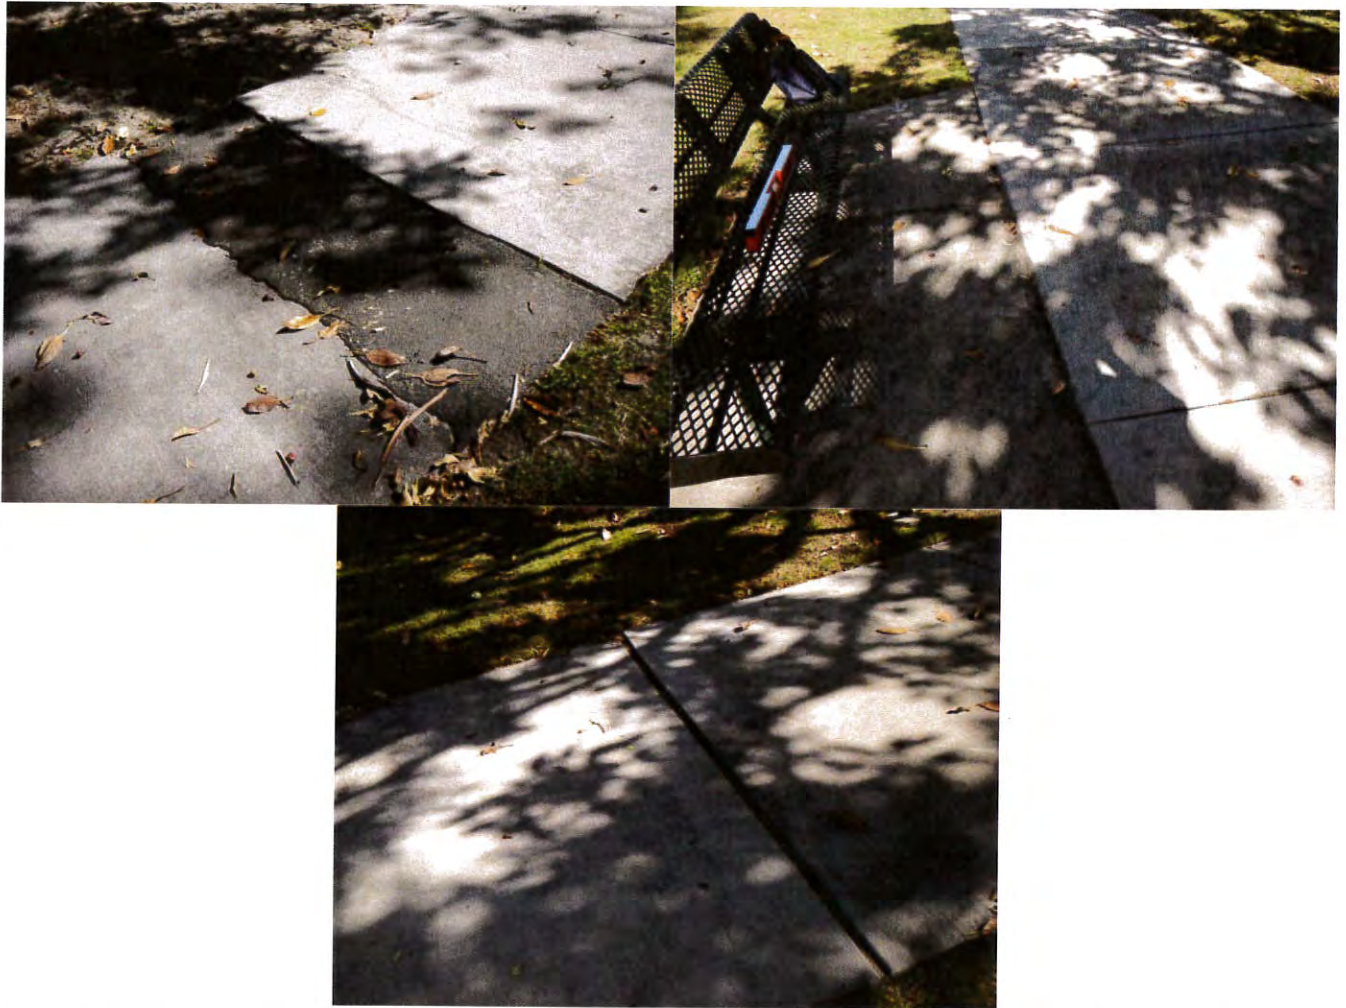
11) Multiple level changes in excess of 1/2" without edge treatment along West sidewalk in park. (2013 CBC 11B-303.2)

Reduce level change to 1/4" high maximum. (or 1/2" with a 1:2 bevel starting at 1/4" high.)(Or provide 1:20 slope maximum in direction of travel.)

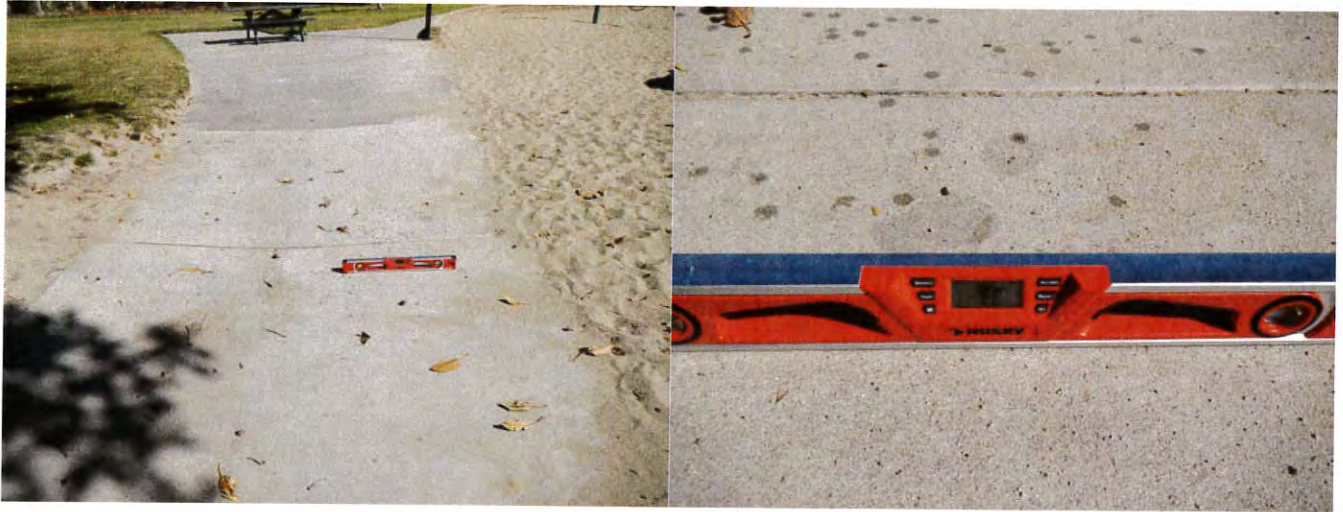
12) 6.8% cross slope in excess of 1:48 at sidewalk west of playground equipment. (2013 CBC 11B403.3)

Provide walkways with 1:20 maximum slope in the direction of travel and 1:48 cross slope.

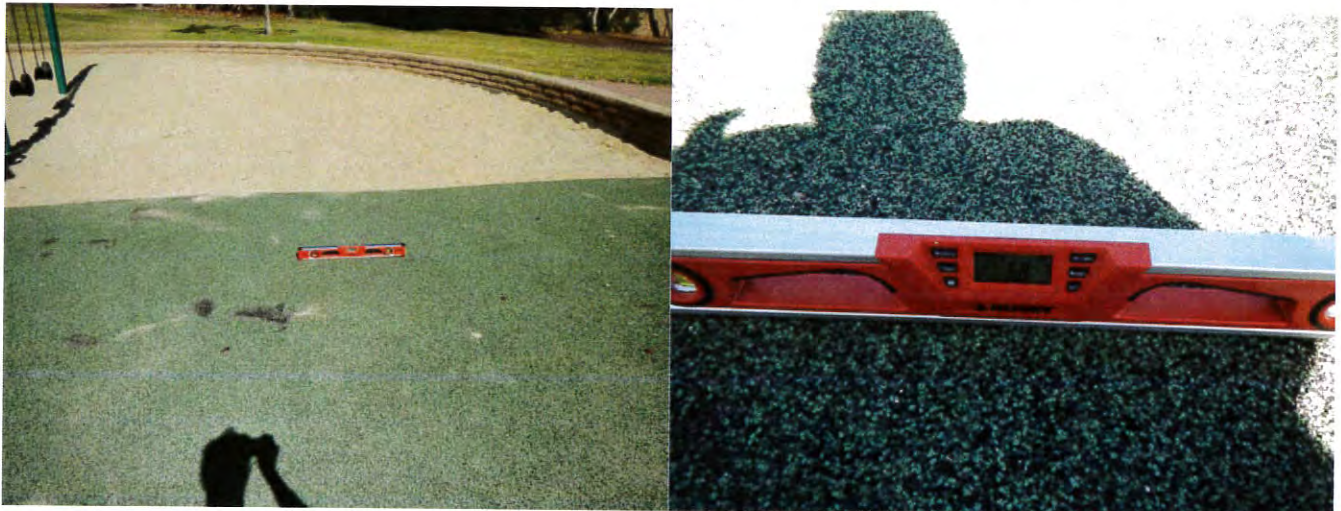
13) 6.8% slope in excess of 1:20 at rubber walkway north of swing equipment. (2013 CBC 11B403.3)

Provide walkways with 1:20 maximum slope in the direction of travel and 1:48 cross slope.

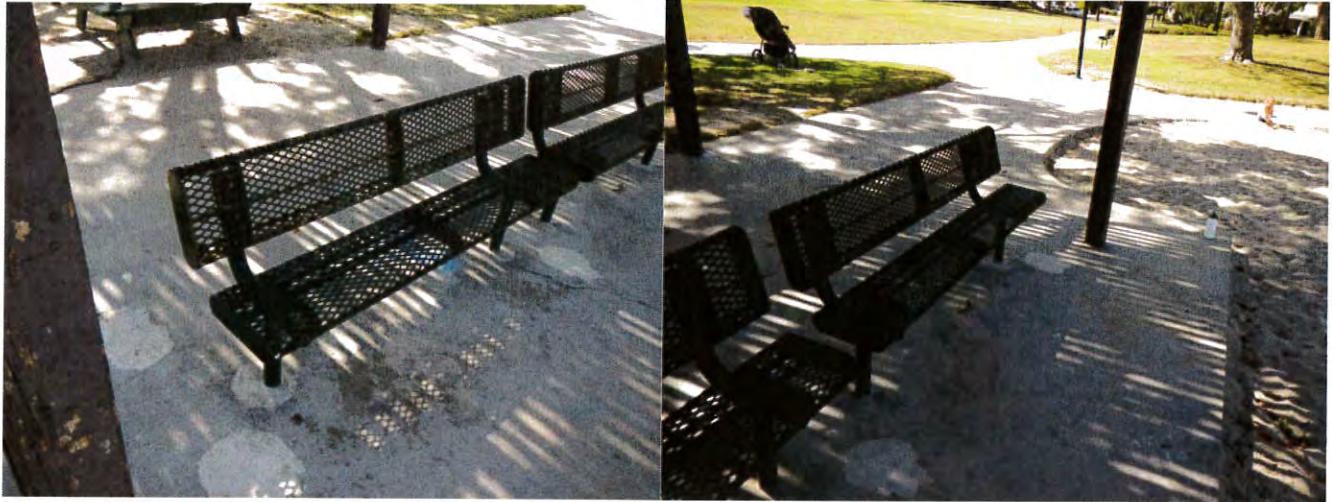
14) No 36" wide accessible route to benches east of play equipment (2013 CBC 11B-403.5.1)

Provide minimum 36" wide route to component.

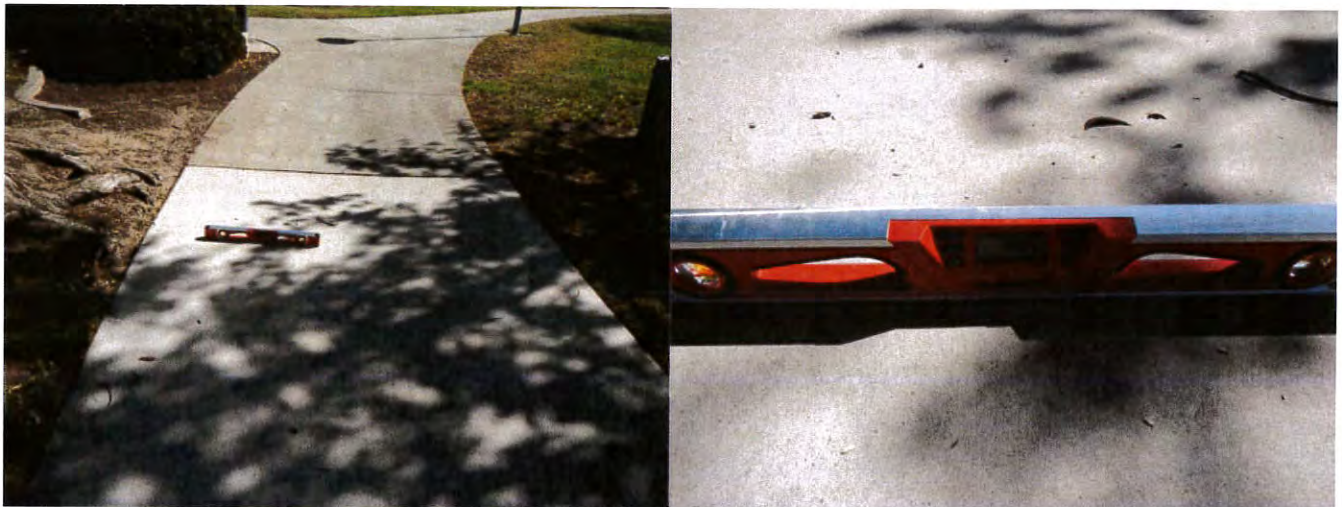
15) 5.1% cross slope in excess of 1:48 at sidewalk east of trellis. (2013 CBC 11B403.3)

Provide walkways with 1:20 maximum slope in the direction of travel and 1:48 cross slope.

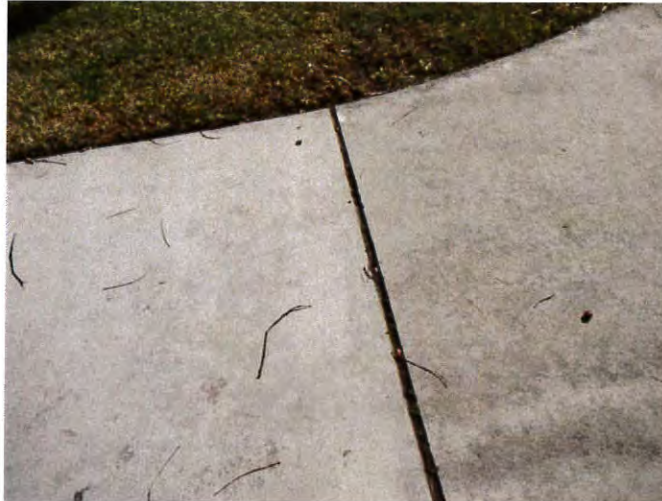
- 16)** Level change in excess of $\frac{1}{2}$ " without edge treatment along sidewalk south of toilet rooms. (2013 CBC 11B-303.2)

Reduce level change to 1/4" high maximum (or 1/2" with a 1:2 bevel starting at 1/4" high.)

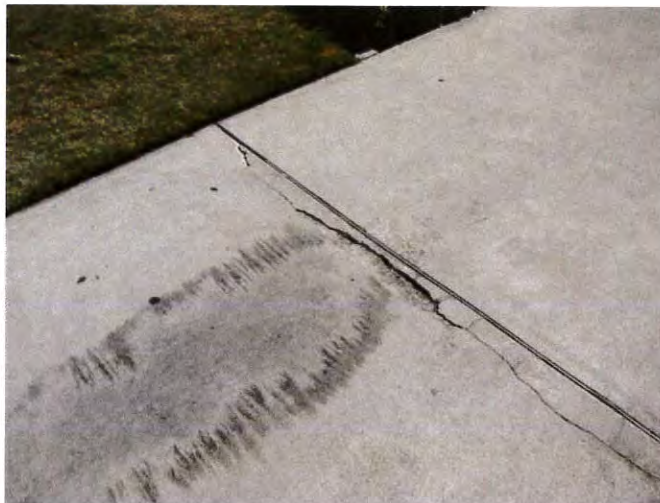
- 17)** 3/4" level change in excess of $\frac{1}{2}$ " without edge treatment along sidewalk south of bike rack near 16th street. (2013 CBC 11B-303.2)

Reduce level change to 1/4" high maximum (or 1/2" with a 1:2 bevel starting at 1/4" high.)

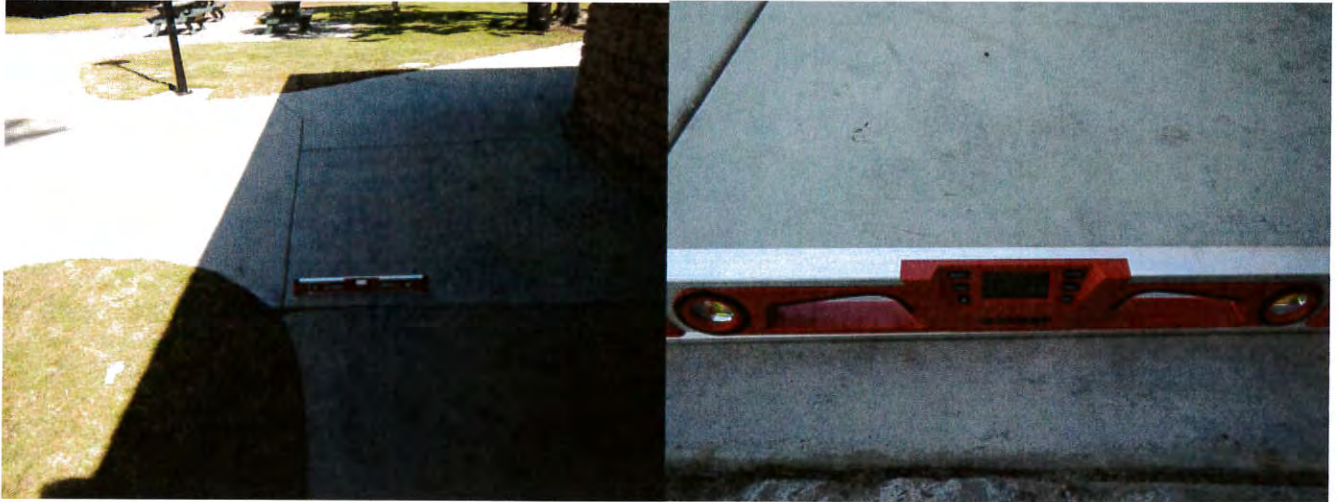
18) 3.3% cross slope in excess of 1:48 at sidewalk west of toilet rooms. (2013 CBC 11B403.3)

Provide walkways with 1:20 maximum slope in the direction of travel and 1:48 cross slope.

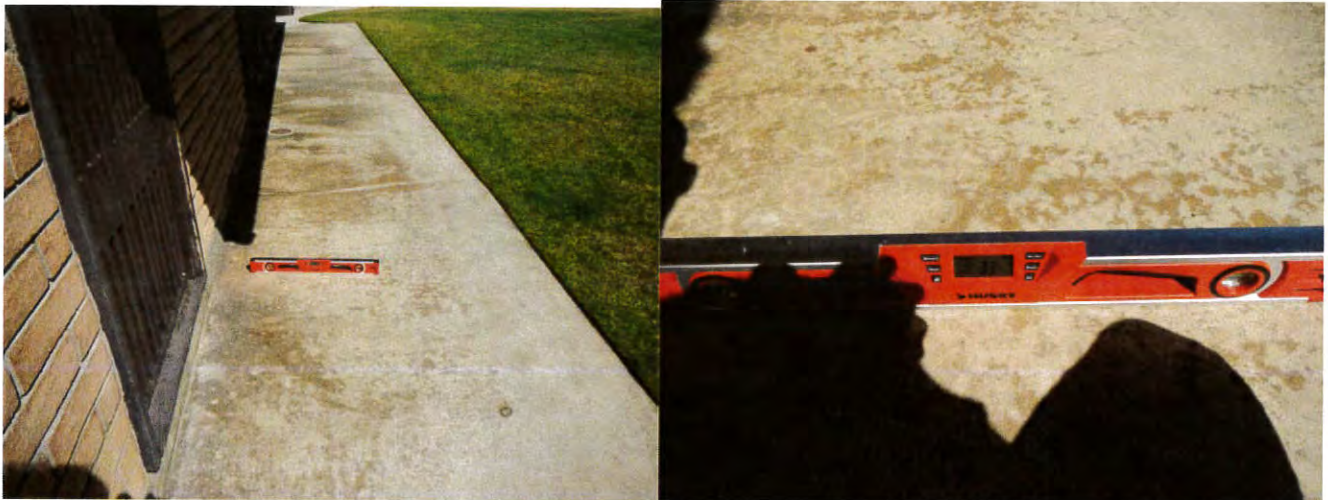
19) 3.3% cross slope in excess of 1:48 at sidewalk east of toilet rooms. (2013 CBC 11B403.3)

Provide walkways with 1:20 maximum slope in the direction of travel and 1:48 cross slope.

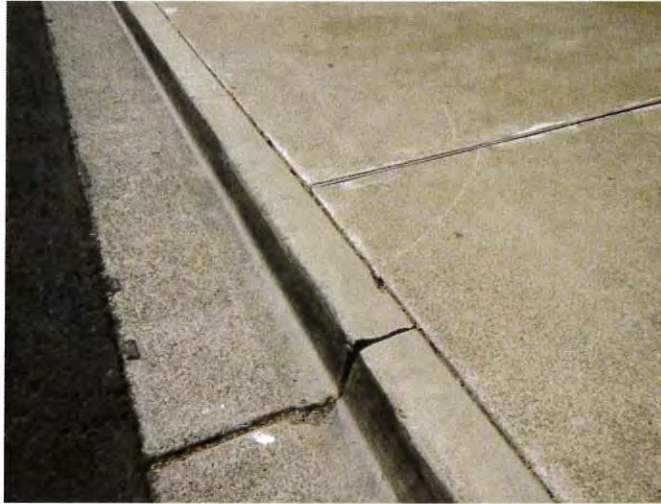
20) 1" level change in excess of 1/2" without edge treatment along 16th street sidewalk. (2013 CBC 11B-303.2)

Reduce level change to 1/4" high maximum (or 1/2" with a 1:2 bevel starting at 1/4" high.)

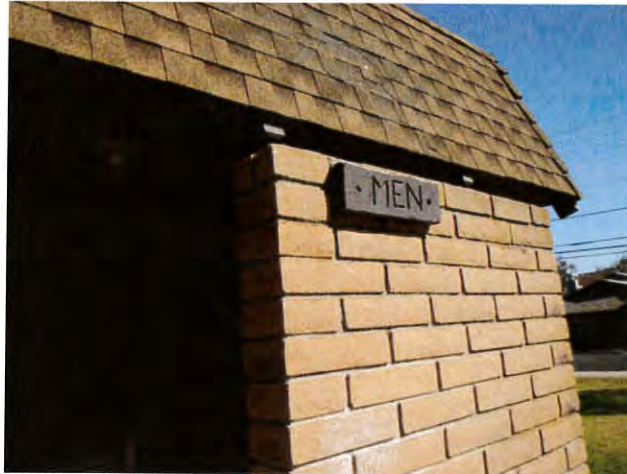
- 1) No accessible signage at entrance to men's toilet room (2013 CBC 11B-216.8)

Provide accessible signs at entrance to accessible toilet room to include geometric symbol per 11B-703.7.2.6, ISA per 11B-216.8, Room Designation per 11B-216.6, Raised Characters per 11B-703.2, Braille per 11B-703.3, Pictograms per 11B-703.6, and located per 11B-703.4.2.

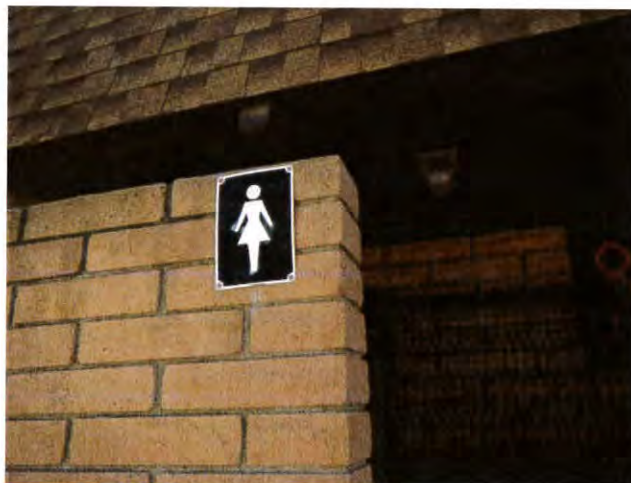
- 2) No accessible signage at entrance to women's toilet room (2013 CBC 11B-216.8)

Provide accessible signs at entrance to accessible toilet room to include geometric symbol per 11B-703.7.2.6, ISA per 11B-216.8, Room Designation per 11B-216.6, Raised Characters per 11B-703.2, Braille per 11B-703.3, Pictograms per 11B-703.6, and located per 11B-703.4.2.

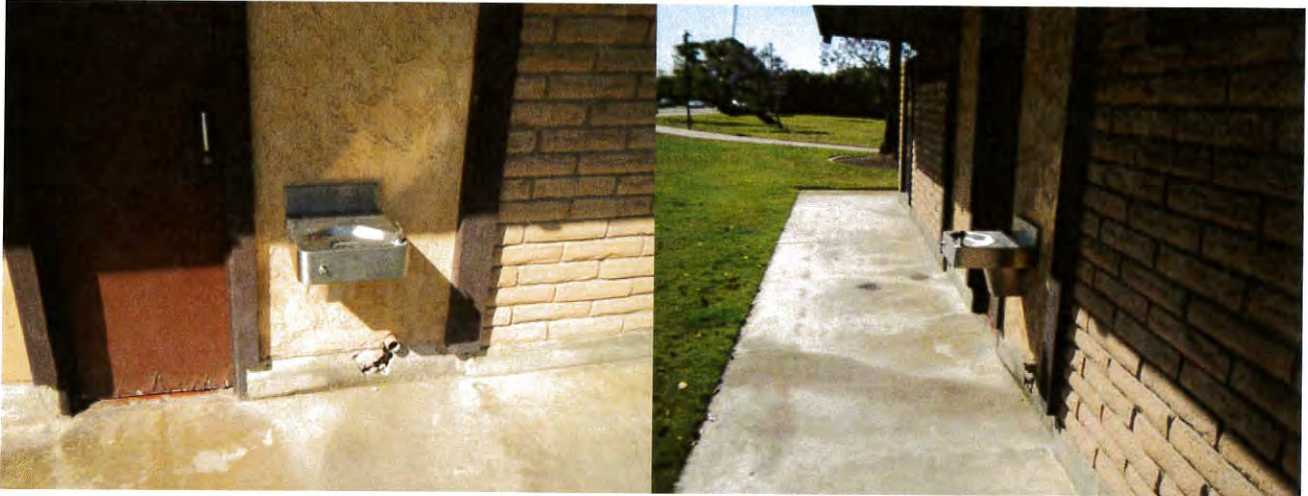
- 1) Drinking fountain protruding into path of travel. (2013 CBC 11B-307.2 and 11B-602.9) 2" high water flow from low drinking fountain is not 4". (2013 CBC 11B-602.6) No drinking fountain for standing persons. (2013 CBC 11B-602.7)

Provide pedestrian protection for drinking fountain per 11B-602.9. Provide water flow 4" high minimum. Provide additional drinking fountain with spout located 38"-43" above finish floor.

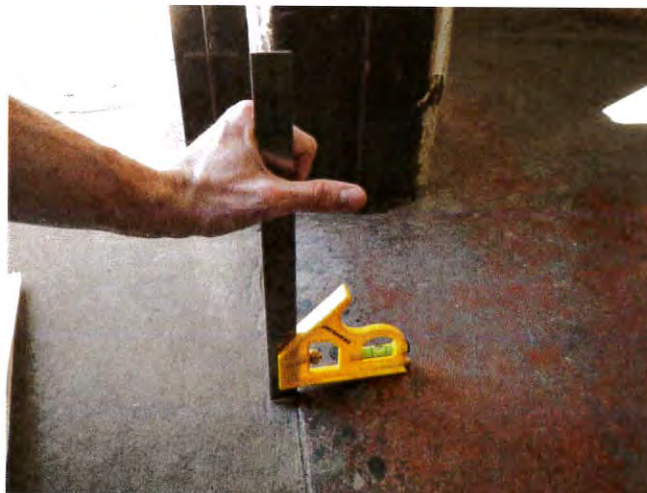
- 2) Door threshold into men's toilet room in excess of 1/2" high without edge treatment. (2013 CBC 11B-404.2.5)

Reduce level change to 1/4" high maximum (or 1/2" with a 1:2 bevel starting at 1/4" high.)

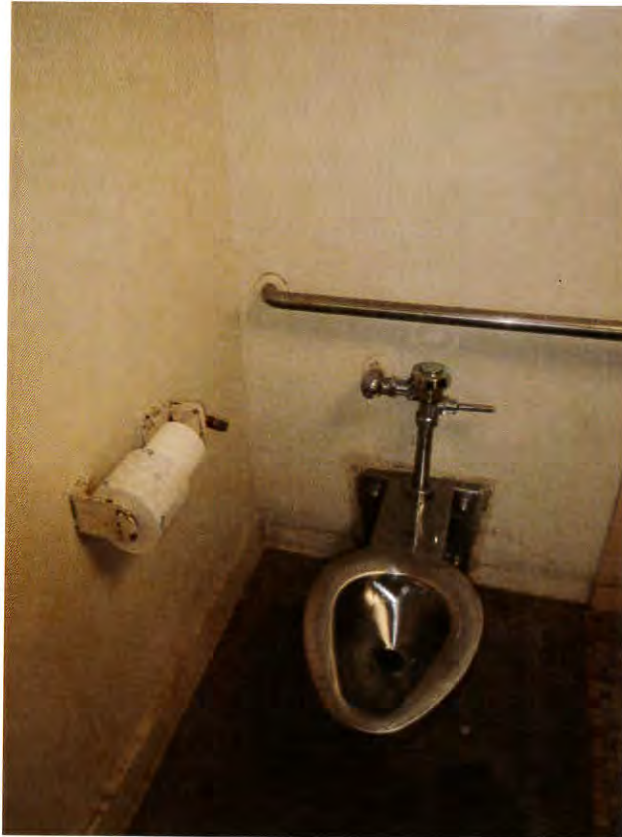
- 3) Water closet in men's toilet room is 19" from adjacent wall to center line of water closet. (2013 CBC 11B-604.2) The top of the seat is 14-1/2" from finish floor. (2013 CBC11B-604.4) There is no grab bar on the adjacent wall. (2013 CBC 11B-604.5) The rear wall grab bar is located with 10" on one side of the water closet centerline and 26" on the other. (2013 CBC 11B-604.5.2)

- 6) Toilet paper dispenser centerline is not 7" in front of the water closet in men's toilet room. Toilet paper dispenser limits continuous flow of paper. (2013 CBC 11B-604.7)

Provide water closet with 17-18" from adjacent wall to center line of water closet. Provide water closet with top of seat at 17-19" from finish floor. Seats shall be 2" high maximum. Provide side wall grab bar per 11B-604.5.1. Provide rear wall grab bar with 12" on one side of the water closet centerline and 24" on the other.

Relocate dispenser so the centerline is 7-9" in front of the toilet and 19" above finish floor to center line. Provide toilet paper holder which will not limit paper flow.

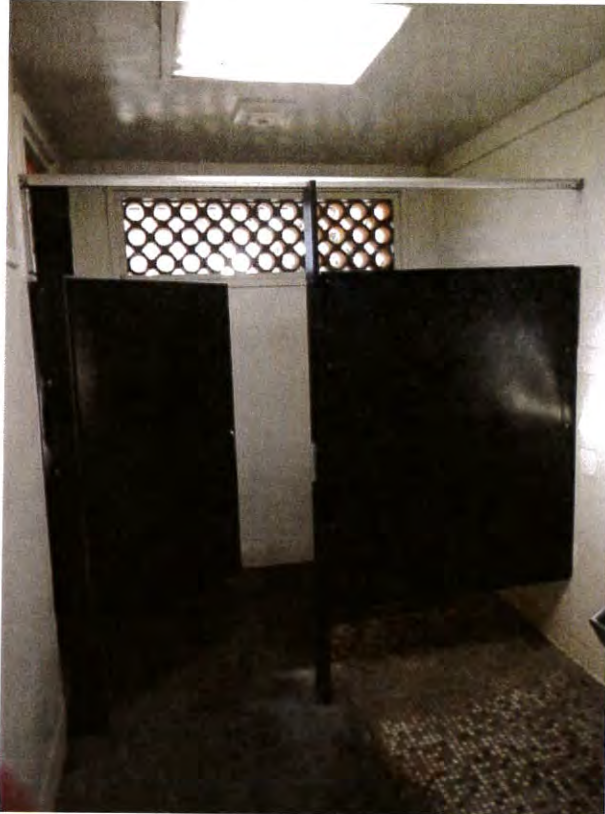
- 4) Door into men's water closet compartment conflicts with the water closet clear area. (2013 CBC 11B-604.8.1.2)
Door does not close automatically. (2013 CBC 11B-604.8.1.2)

Swing door out and provide self closing hinges.

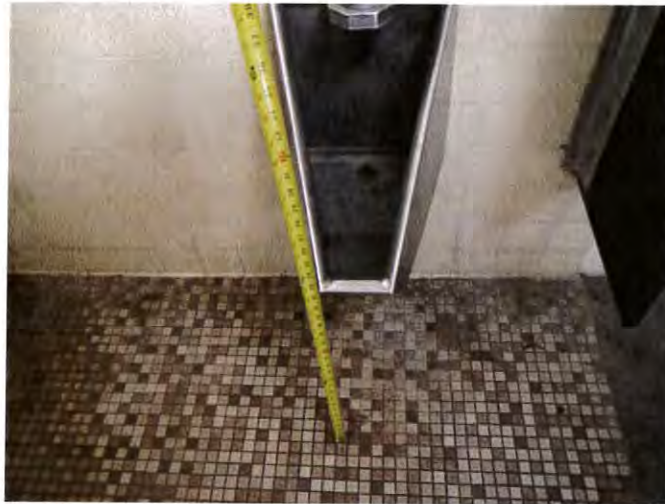
- 5) Urinal rim is 22" in men's toilet room (2013 CBC 11B-605.2)

Provide urinal with rim at 17" maximum above finish floor. Urinal to be 13-1/2" deep minimum and flush valve is to be 44" maximum above finish floor.

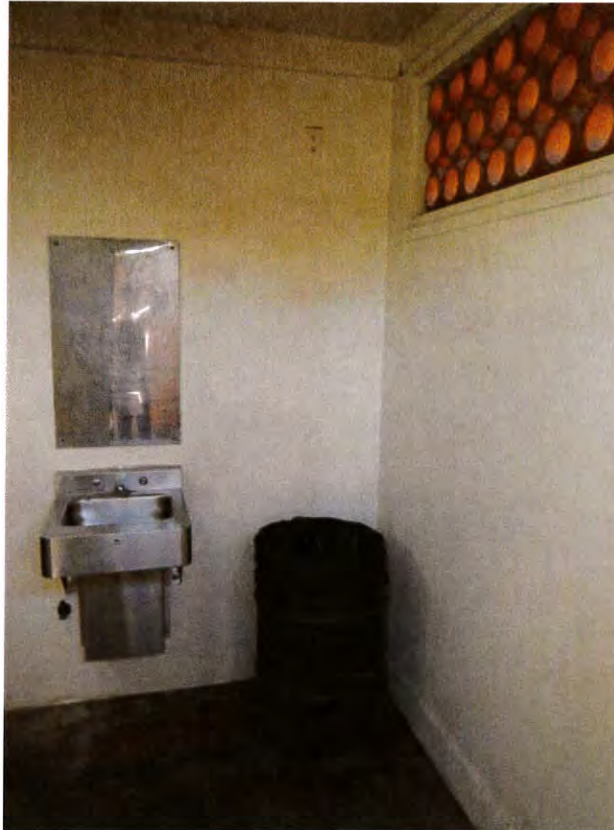
- 7) Sink facet does not allow for 10 seconds of metered water flow. (2013 CBC 11B-606.4)

Provide facet meter which will allow 10 seconds of water flow.

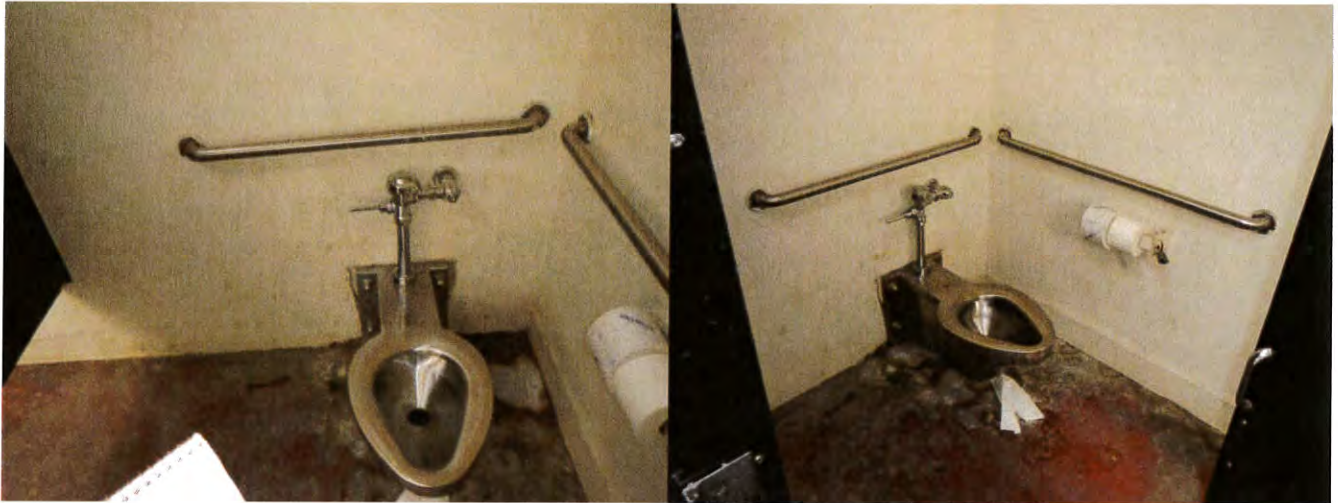
- 9) Water closet in women's toilet room is 19" from adjacent wall to center line of water closet. (2013 CBC 11B-604.2) The top of the seat is 14-1/2" from finish floor. (2013 CBC11B-604.4) Side wall grab bar is 18" past front of toilet (2013 CBC 11B-604.5.1)

- 12)** Toilet paper dispenser centerline is not 7" in front of the water closet in women's toilet room. Toilet paper dispenser limits continuous flow of paper. (2013 CBC 11B-604.7)

Provide water closet with 17-18" from adjacent wall to center line of water closet. Provide water closet with top of seat at 17-19" from finish floor. Seats shall be 2" high maximum. Provide side wall grab bar per 11B-604.5.1.

Relocate dispenser so the centerline is 7-9" in front of the toilet and 19" above finish floor to center line. Provide toilet paper holder which will not limit paper flow.
