Project Name		CASp Survey #	Date
Heller Park		532004	5/12/2014 5/14/2014
Address		Weather	Temperature
257 16 th Street Costa Mesa, CA		Sunny	79° F 95° F
CASp Inspector	Owner	Start Time	Finish Time
Steve Miller #532	City of Costa Mesa	9:00 am 8:00 am	11:30 am 1:30 pm

Introduction

Findings

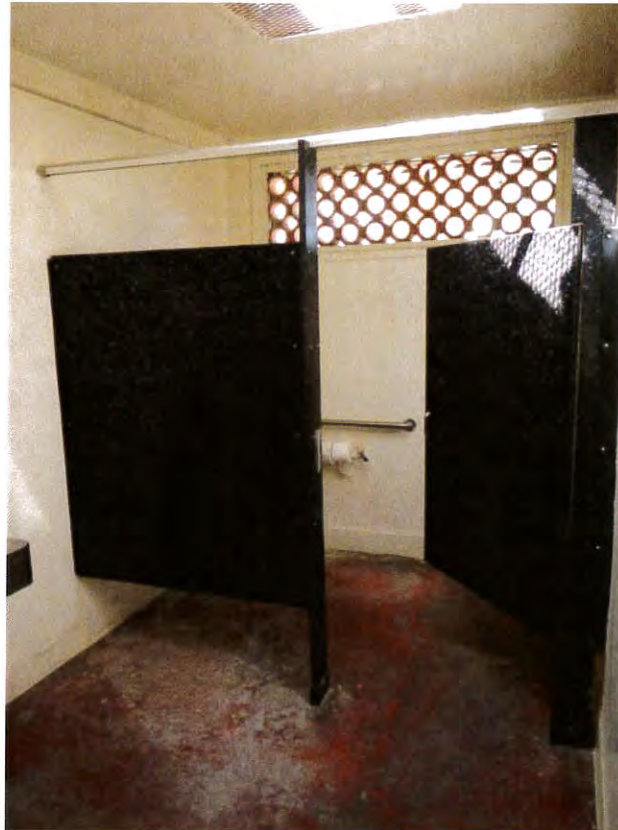
- 10) Door into women's water closet compartment conflicts with the water closet clear area. (2013 CBC 11B-604.8.1.2) Door does not close automatically. (2013 CBC 11B-604.8.1.2)**

Swing door out and provide self closing hinges.

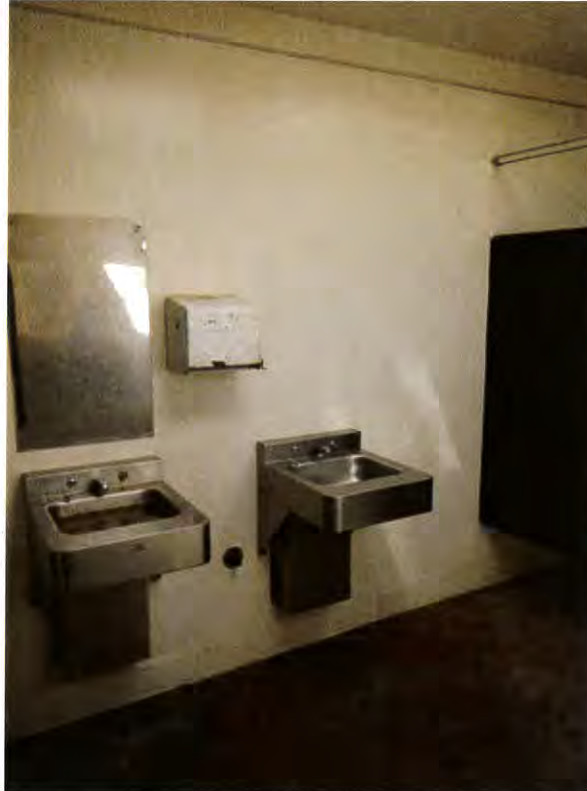
- 11)** Paper towel dispenser is 52" in women's toilet room (2013 CBC 11B-308.2.2) Dispenser requires pinching and twisting of wrist to operate. (2013 CBC 11B-309.4)

Provide paper towel dispenser with highest operable part at 48" maximum above finish floor. Dispenser to not require tight grasping, pinching, or twisting of wrist to operate.

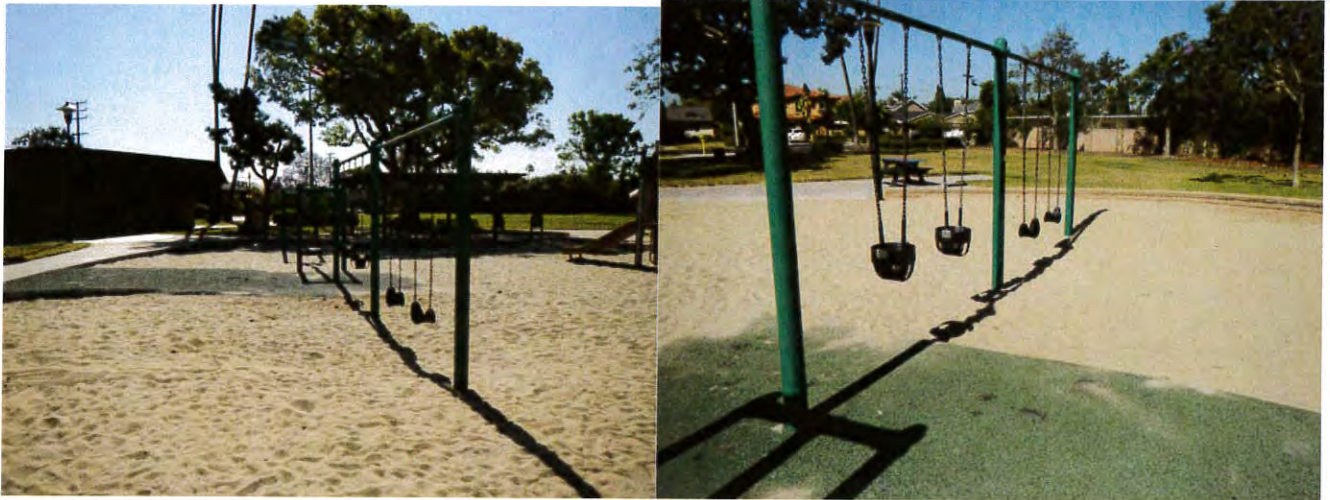
- 1) No accessible route to non-toddler swings (2013 CBC 11B-240.2.1.1)

Provide accessible route to non-toddler swings.

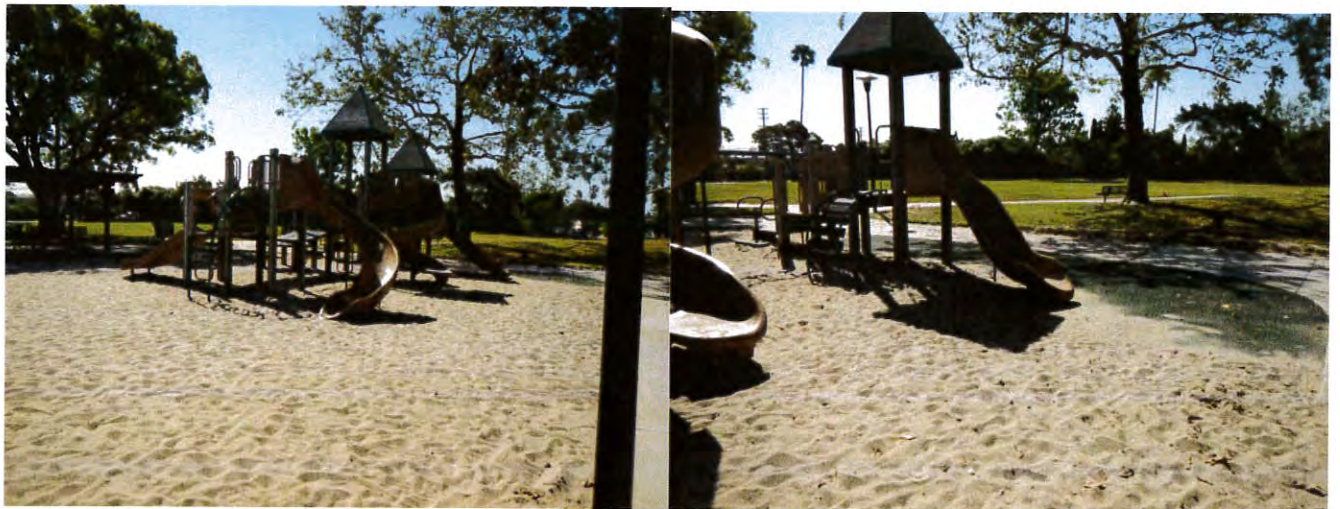
- 2) Less than 50% of elevated play components are on an accessible route. (2013 CBC 11B-240.2.2) Play equipment provides 14 elevated play components and 1 ground level component. (2013 CBC 11B-204.2.1.2)

Provide a minimum of 5 ground level play components (3 different types) on an accessible route.
