MESA VERDE BRANCH LIBRARY

2969 Mesa Verde Drive, Costa Mesa, California 92626

DISABLED ACCESS COMPLIANCE REPORT

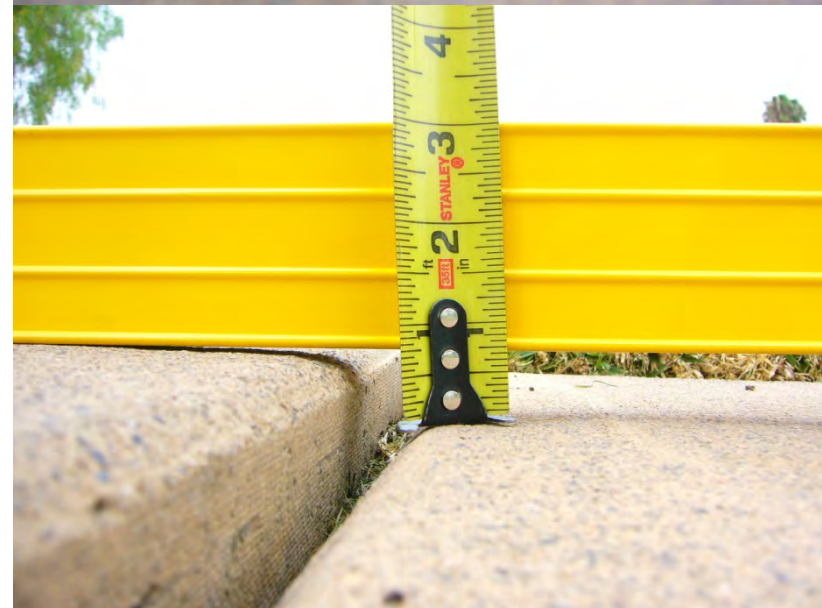
05

3	2015.06.10	Site	Walkway in front of main entrance	Floor Or Ground Surfaces	3	5 6	Concrete joint is open about 1/2". Openings in floor or ground surfaces shall not allow passage of a sphere more than ½ inch diameter	302.3	11B-302.3	Grind				
4	2015.06.10	Site	Walkway in front of building to south lot	Floor Or Ground Surfaces	4	7	Concrete is risen 1/2" at joint. Changes in level between ¼ inch high minimum and ½ inch high maximum shall be beveled with a slope not steeper than 1:2.	303.3	11B-303.3	Grind				
5	2015.06.10	Site	Walkway north of building to East lot	Floor Or Ground Surfaces	5	8 9	Concrete cracked at 2 areas and risen in excess of 1/4". Changes in level between ¼ inch high minimum and ½ inch high maximum shall be beveled with a slope not steeper than 1:2.	303.3	11B-303.3	Repair				
6	2015.06.10	Site	Walkway north of building to East lot	Floor Or Ground Surfaces	6	10 11	Walkway is adjacent to an elevation drop exceeding 4" of height, between the seating area and stairs. Abrupt changes in level exceeding 4 inches in a vertical dimension between walks, sidewalks or other pedestrian ways and adjacent surfaces or features shall be identified by warning curbs at least 6 inches in height above the walk or sidewalk surface.		11B-303.5	Fill with dirt, or add railing

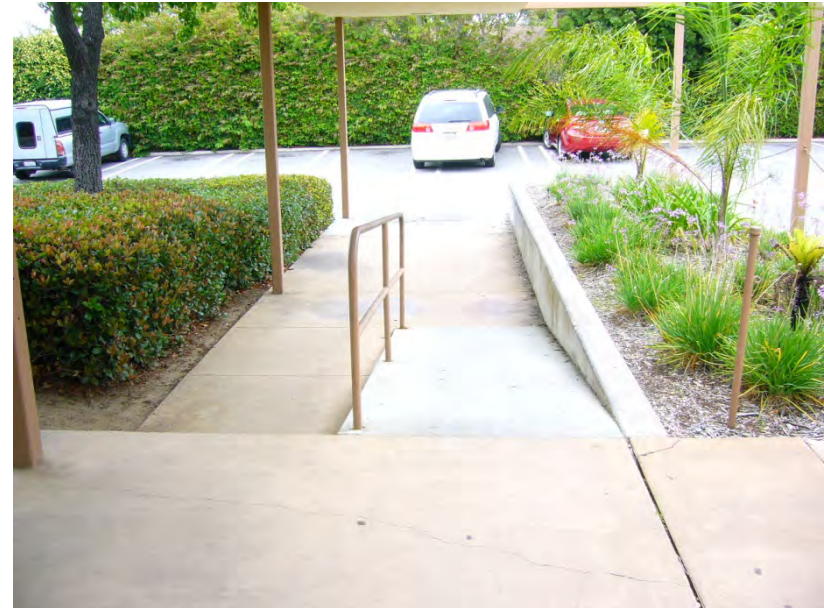
31	2015.06.10	Site	Ramp at north walkway to east lot	Ramps	6	11	Existing handrail posts on the surface of the ramp do not have guide rail. A curb, 2 inches high minimum, or uninterrupted rail barrier shall be provided that prevents the passage of a 4 inch diameter sphere, where any portion of the sphere is within 4 inches of the finish floor.	405.9.2	11B-405.9.2	Remove existing ramp and adjacent non-compliant stair , and replace with one wider compliant ramp for the entire width of the walk, including compliant handrails.				
32	2015.06.10	Site	Ramp in front of the main building entrance	Ramps	9	19	Running slope 14.9%. Ramp runs shall have a running slope not steeper than 1:12.	405.2	11B-405.2	Remove existing ramp and replace with a new compliant ramp along and parallel to existing west patio wall.

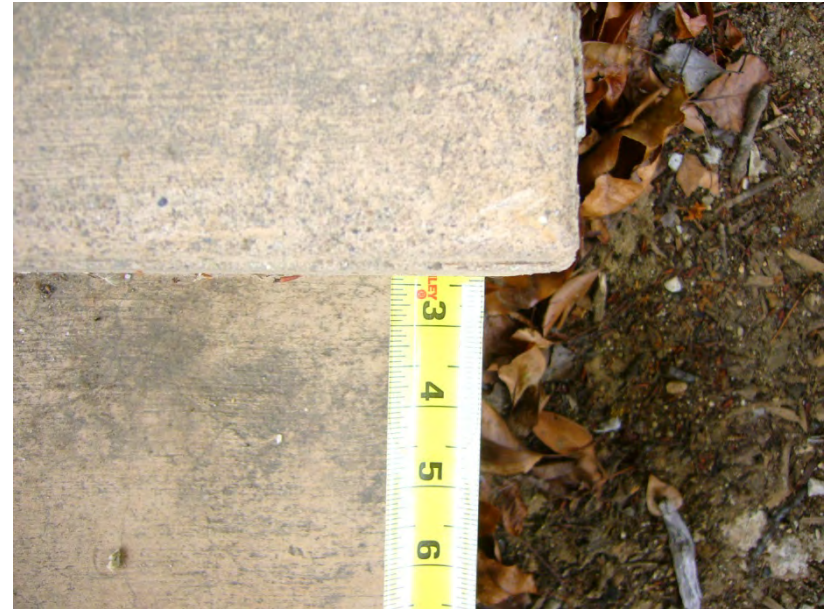
28	2015.06.10	Site	Ramp at north walkway to east lot	Ramps	6	15	Walkway terminates at a steep ramp with running slope of 14.4%. Ramp runs shall have a running slope not steeper than 1:12.	405.2	11B-405.2	Remove existing ramp and adjacent non-compliant stair , and replace with one wider compliant ramp for the entire width of the walk, including compliant handrails.				
29	2015.06.10	Site	Ramp at north walkway to east lot	Ramps	6	10 11	Hand rail is provided on one side only. Ramp runs shall have handrails on both sides.	405.8	11B-405.8	Remove existing ramp and adjacent non-compliant stair , and replace with one wider compliant ramp for the entire width of the walk, including compliant handrails.				
30	2015.06.10	Site	Ramp at north walkway to east lot	Ramps	6	11	Existing handrail does not have any extensions at top or the bottom of the ramp. Ramp handrails shall extend horizontally above the landing for 12 inches minimum beyond the top and bottom of ramp runs. Extensions shall return to the landing surface.	505.10.1	11B-505.10.1	Remove existing ramp and adjacent non-compliant stair , and replace with one wider compliant ramp for the entire width of the walk, including compliant handrails.

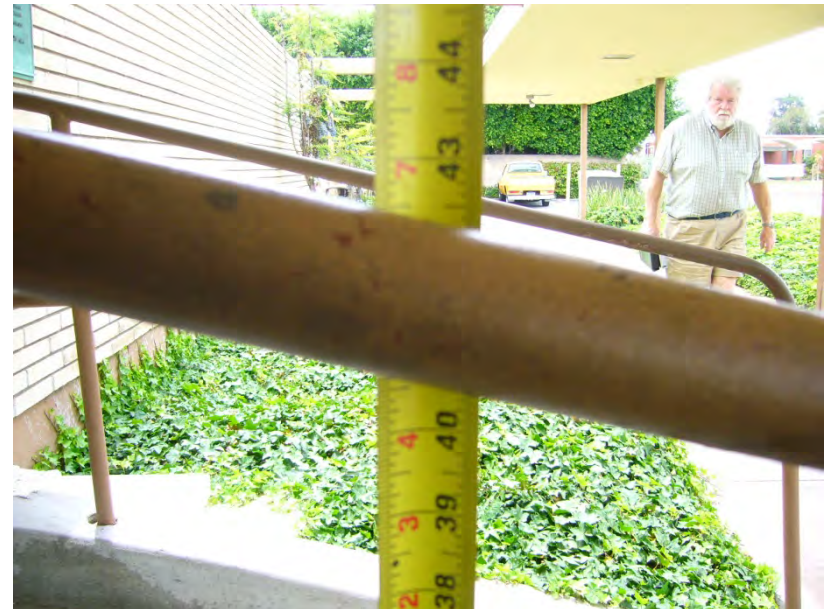
15	2015.06.10	Site	Stair at main building entrance on the west side	Stairs	9	21 22	Stair visual striping is not contrasting. Exterior stairs shall have the upper approach and all treads marked by a stripe providing clear visual contrast.		11B-504.4.1	Add striping. See below for additional information.				
16	2015.06.10	Site	Stair at main building entrance on the west side	Stairs		23 24	Stair nosing projects over riser 3 3/4". Nosings that project beyond risers shall have the underside of the leading edge curved or beveled. The permitted projection of the nosing shall extend 1 1/4 inches maximum over the tread below.	504.5	11B-504.5	Replace the stair with new compliant stair and handrails.				
17	2015.06.10	Site	Stair at main building entrance on the west side	Stairs		21 22	Stair has a handrail on one side. Stairs shall have handrails on both sides.	504.6	11B-504.6	Replace the stair with new compliant stair and handrails.

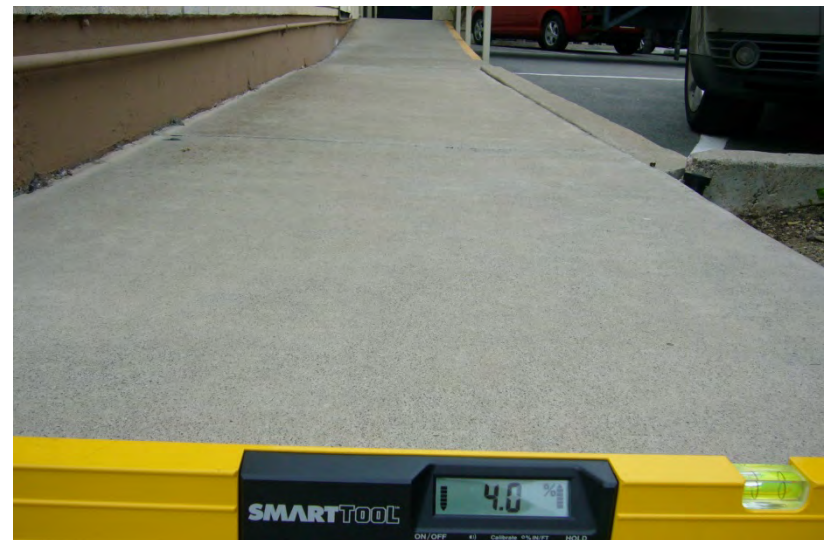
39	2015.06.10	Site	Ramp at back entrance to staff work room	Ramps	13	33 34	Existing handrail posts on the vertical side do not provide guide rail. A curb, 2 inches high minimum, or uninterrupted rail barrier shall be provided that prevents the passage of a 4 inch diameter sphere, where any portion of the sphere is within 4 inches of the finish floor.	405.9.2	11B-405.9.2	Remove existing ramp and replace with a new compliant ramp, and handrails.				
40	2015.06.10	Site	Ramp at back entrance to staff work room	Floor or Ground Surfaces	13	33 34	Existing handrail posts on the vertical side do not protect the vertical drop that exceeds 4" at upper end of the ramp and landing. Abrupt changes in level exceeding 4 inches in a vertical dimension between walks, sidewalks or other pedestrian ways and adjacent surfaces or features shall be identified by warning curbs at least 6 inches in height above the walk or sidewalk surface.		11B-303.5	Remove existing ramp and replace with a new compliant ramp, and handrails.

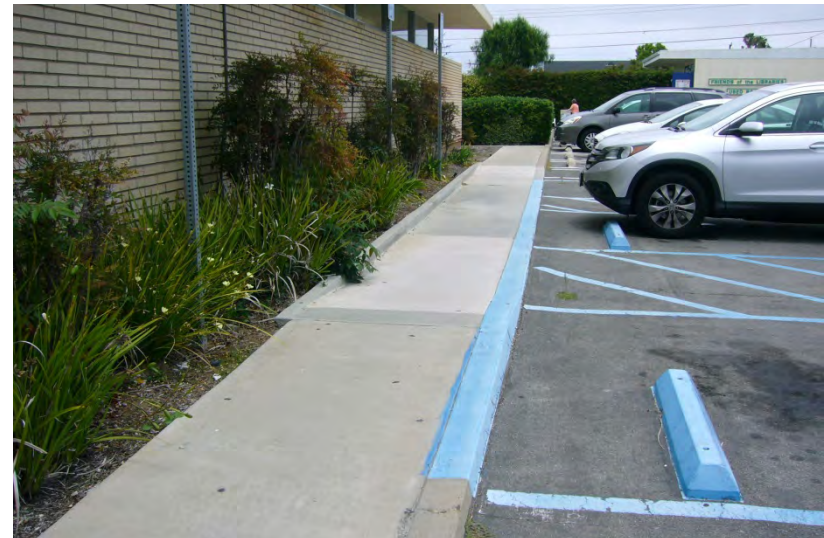
52	2015.06.10	Site	Accessible parking area	Parking	15	37 38	2 of the stalls and one access aisle are sloped 2.3% to 2.8%. Slopes in excess of 1:48 are not allowed at accessible parking stalls and their access aisles	502.4	11B-502.4	Rework asphalt				
53	2015.06.10	Site	Accessible parking area	Parking	15	39	ISA pavement marking are on a 30" by 30" blue background. The parking space shall be marked with an International Symbol of Accessibility in white on a blue background a minimum 36 inches wide by 36 inches high.		11B-502.6.4.1	Repaint				
54	2015.06.10	Site	Accessible parking area	Parking	15	40 41	Post mounted signs do not have the required Fine language. Additional language or an additional sign below the International Symbol of Accessibility shall state "Minimum Fine \$250."		11B-502.6.2	Replace signs				
55	2015.06.10	Site	Entrance form street	Signage	16	1	Tow-away text at contact information is not legible. Visual characters shall be conventional in form. Characters shall not be italic, oblique, script, highly decorative, or of other unusual forms.	703.5.3	11B-703.5.3	Replace.

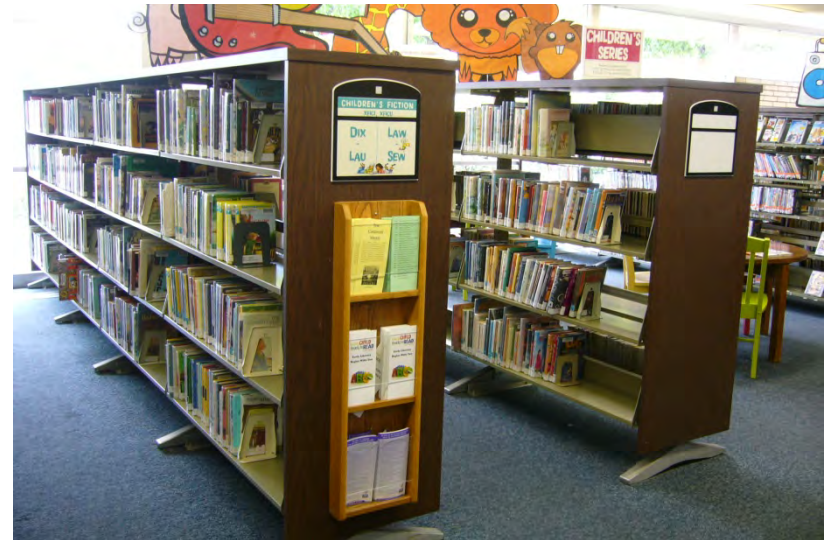
67	2015.06.10	Main Building	Children's Area Stacks	Accessible Route		50 51	Stack aisles are 34" next to glass, 36 1/2" to 37" in other aisle. The clear width for aisles shall be 36 inches minimum if serving elements on only one side, and 44 inches minimum if serving elements on both sides.		11B-403.5.1 Exception 4	Adjust spacing				
68	2015.06.10	Main Building	Adults Area main level	Protrusions		52 53	Lower counter projects 8 3/4" over circulation path with its bottom at 28 1/2" above floor. Objects with leading edges more than 27 inches and not more than 80 inches above the finish floor or ground shall protrude 4 inches maximum horizontally into the circulation path.	307.2	11B-307.2	Retrofit				
69	2015.06.10	Main Building	Adults Area main level	Built-in Elements		54	None of the study carrels are accessible. All have 26 1/2" vertical clearance at knee space. where work surfaces are provided for use by other than employees, at least 5 percent shall comply. Minimum 27" vertical clearance id required for compliance.	226.1 902.2	11B-226.1 11B-902.2	Retrofit the apron at 5% of the carrels

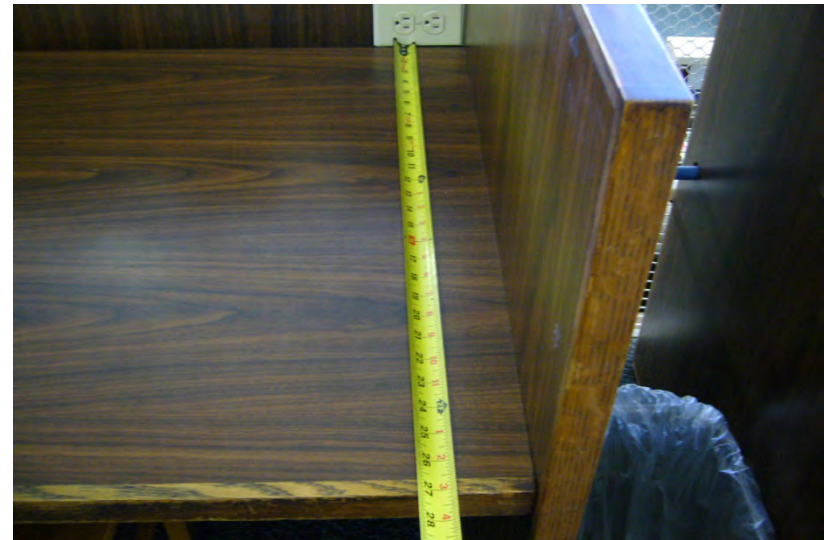
78	2015.06.10	Main Building	Periodicals Mezzanine Level	Built-in Elements		63	Power outlets at the back panel of the carrels are 27" from front edge of the work top. Maximum reach depth for front approach is 25".	308.2.2	11B-308.2.2	Reposition outlet in one of the carrels to within range				
79	2015.06.10	Main Building	Stair to basement and mezzanine	Stairs		62 64	Risers are open. Open risers are not permitted	504.3	11B-504.3	Close the risers				
80	2015.06.10	Main Building	Stair to basement and mezzanine	Stairs		65	Top of grip at handrails is 29" above ramp surface. Top of gripping surfaces of handrails shall be 34 inches minimum and 38 inches maximum vertically above ramp surfaces, and at consistent height.	505.4	11B-505.4	Replace with new compliant handrails.

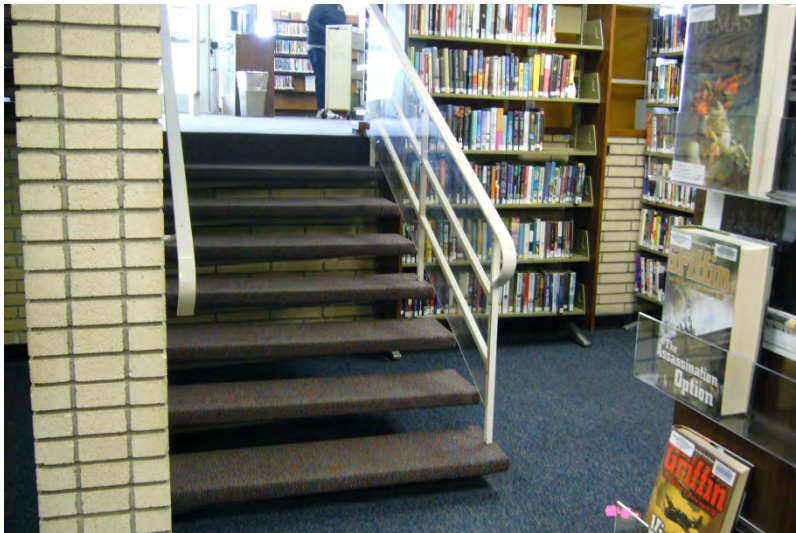
82	2015.06.10	Main Building	Stair to basement and mezzanine	Stairs		66 67 68	Stair visual striping is not provided. Interior stairs shall have the upper approach and lower tread marked by a stripe providing clear visual contrast.		11B-504.4.1	Provide				
83	2015.06.10	Main Building	Stair to basement and mezzanine	Protrusions		69	Handrail at switch back projects 4 1/2" over main level circulation path. Objects with leading edges more than 27 inches and not more than 80 inches above the finish floor or ground shall protrude 4 inches maximum horizontally into the circulation path.	307.2	11B-307.2	Replace with new compliant handrails.				
84	2015.06.10	Main Building	Public Women's Multi-user Restroom	Doors		70	Entry door is 29 1/2" wide. Door openings shall provide a clear width of 32 inches minimum, when 90 degrees open.	404.2.3	11B-404.2.3	Reconfigure				
85	2015.06.10	Main Building	Public Women's Multi-user Restroom	Doors		70	Entry door has both latch and closer and is accessed through a 42" wide hallway. Minimum 48" clearance perpendicular to door is required for hinge approach on push side.	404.2.4.1	11B-404.2.4.1	Reconfigure

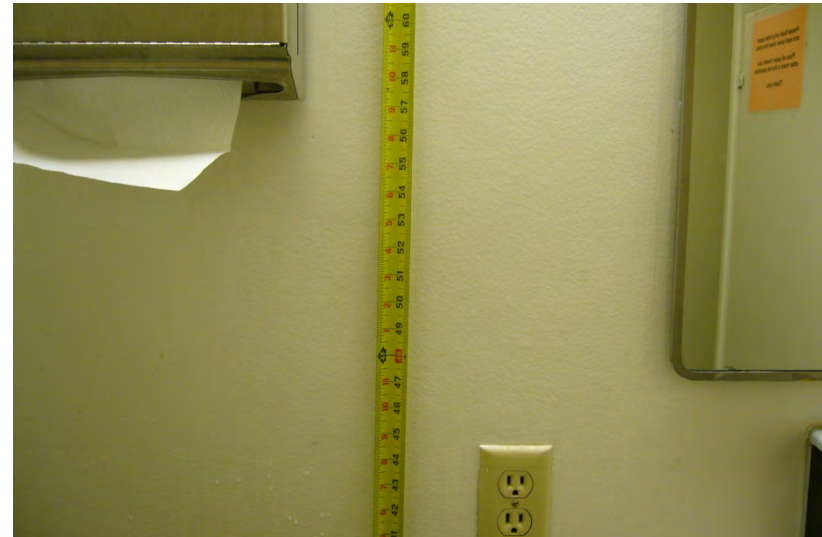
92	2015.06.10	Main Building	Public Women's Multi-user Restroom	Reach Ranges		72 73	Surface mounted paper towel dispenser opening is at 58" above floor. 48" high is maximum for un-obstructed reach	308	11B-308	Reconfigure				
93	2015.06.10	Main Building	Public Men's Multi-user Restroom	Doors		80	Entry door is 30" wide. Door openings shall provide a clear width of 32 inches minimum, when 90 degrees open.	404.2.3	11B-404.2.3	Reconfigure				
94	2015.06.10	Main Building	Public Men's Multi-user Restroom	Doors		80	Entry door has both latch and closer and is accessed through a 40" wide hallway. Minimum 48" clearance perpendicular to door is required for latch approach on push side.	404.2.4.1	11B-404.2.4.1	Reconfigure				
95	2015.06.10	Main Building	Public Men's Multi-user Restroom	Doors			On swing side of entry door only 2 1/2" exist at strike jamb. Minimum 18" of clear floor space past the strike jamb is required.	404.2.4.1	11B-404.2.4.1	Reconfigure

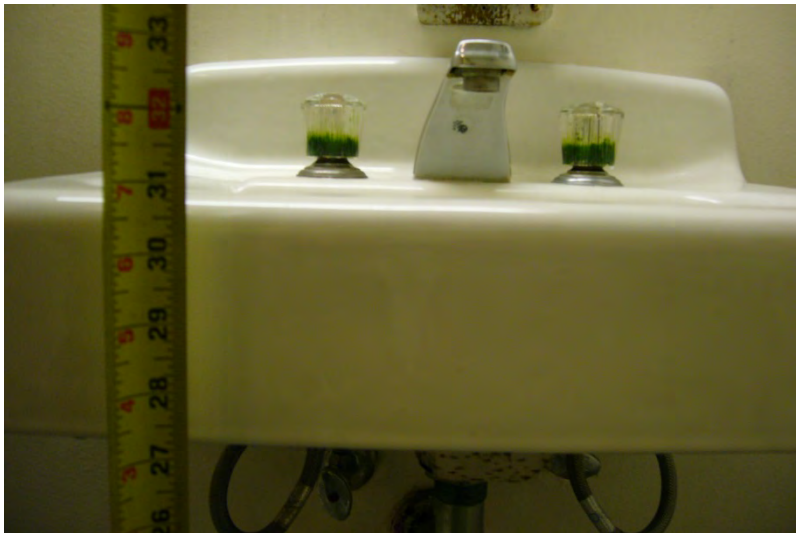
79

100	2015.06.10	Main Building	Public Men's Multi-user Restroom	Toilets		78	27 1/4" of vertical clearance exist below apron at sink. Minimum 29" is required.		11B-306.3.3 Exception	Reconfigure

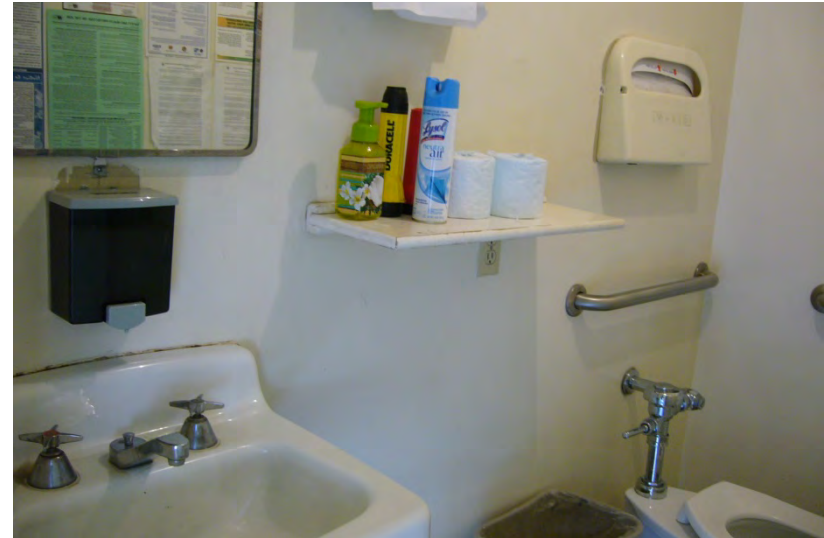
84

111	2015.06.10	Main Building	Staff Single-user Restroom	Toilets		83	Surface mounted paper towel dispenser opening is at 57" above floor. 48" high is maximum for un-obstructed reach	308	11B-308	Reconfigure				
112	2015.06.10	Main Building	Staff Single-user Restroom	Toilets		83	Opening at wall mounted seat cover dispenser is 54" above floor on the wall behind seat. Dispensers shall be on accessible route and not higher than 40" above floor.		11B-603.5	Reconfigure				
113	2015.06.10	Main Building	Staff Single-user Restroom	Toilets		82	Top of seat is 16" above floor. The seat height of a water closet above the finish floor shall be 17 inches minimum and 19 inches maximum measured to the top of the seat.	604.4	11B-604.4	Reconfigure				
114	2015.06.10	Main Building	Staff Single-user Restroom	Toilets		83	Back grab bar is 25" long. The rear wall grab bar shall be 36 inches long minimum and extend from the centerline of the water closet 12 inches minimum on one side and 24 inches minimum on the other side.	604.5.2	11B-604.5.2	Reconfigure

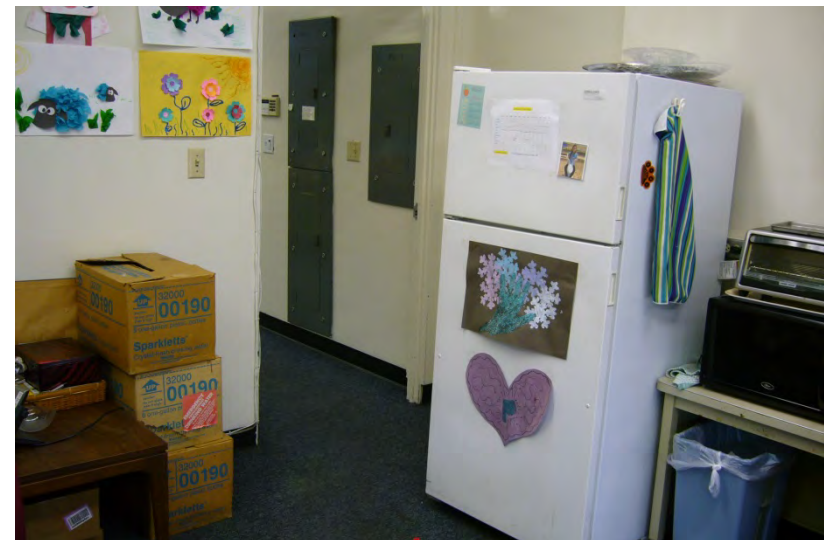
92

119	2015.06.10	Main Building	Staff Break Room	Doors		80 89	Interior door to staff Break room from Library hallway is permanently locked, and blocked by refrigerator on the inside. Access is gained through Work room interconnecting door. The locked door has knob, and lacks the required maneuvering space.	404.2.7 404.2.4.1	11B-404.2.7 11B-404.2.4.1	Reconfigure if this door is to become operations. Otherwise see remarks below for staff area doors.				
120	2015.06.10	Main Building	Staff Break Room	Doors			Door from Work Room has a knob handle. Operable parts shall be operable with one hand and shall not require tight grasping, pinching, or twisting of the wrist.	404.2.7	11B-404.2.7	Replace with lever type				
121	2015.06.10	Main Building	Staff Break Room	Doors		88	On swing side of door between Work and to Break area only 3" exist at strike jamb. Minimum 18" of clear floor space past the strike jamb is required.	404.2.4.1	11B-404.2.4.1	Reconfigure, or remove the door. This door appear to have been tied with cord to always remain open.

122	2015.06.10	Main Building	Staff Break Room	Doors		88 89	On push side of door between Work and to Break area refrigerator is blocking the maneuvering clearances. Minimum 44" is required for side approach to a door without closer.	404.2.4.1	11B-404.2.4.1	Reposition refrigerator, or remove the door. This door appear to have been tied with cord to always remain open.				
123	2015.06.10	Main Building	Staff Work Room	Built-in Elements		90 91	Counter with sink is 36" high to top of counter. The tops of work surfaces shall be 28 inches minimum and 34 inches maximum above the finish floor or ground.	902.3	11B-902.3	Replace the counter with a lower compliant one.				
124	2015.06.10	Main Building	Staff Work Room	Sinks		90 91	Counter with sink is 36" high to top of counter. Sinks shall be installed with the front of the higher of the rim or counter surface 34 inches maximum above the finish floor or ground.	606.3	11B-606.3	Replace the counter with a lower compliant one. Sink does not appear to be used. Remove sink.

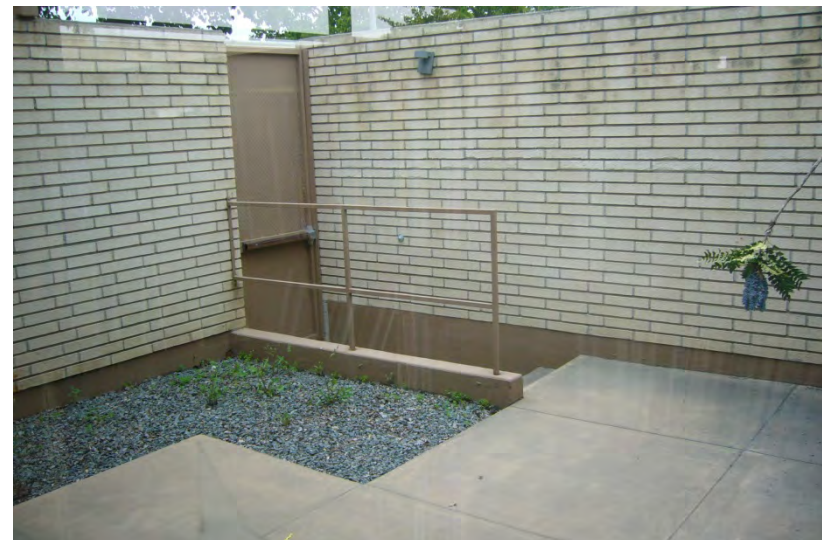
98

129	2015.06.10	Main Building	Children's Area	Accessible Means of Egress		96 97	It appears the only other exit from the public area of the library is through the Children's area exterior exit door. This narrow stile non compliant door leads to top of a raised curb and path continues through a non compliant stair , and a narrow exit door to walkway on the north side of the building. Where more than one means of egress are required by Section 1015.1 or 1021.1 from any accessible space, each accessible portion of the space shall be served by accessible means of egress in at least the same number as required by Section 1015.1 or 1021.1.		1007.1	Accessible means of egress are not required in alterations to existing buildings.				
130	2015.06.10	Friends Building	Entry door on top of the ramp	Doors			Door has surface stop on push side. Swinging door surfaces within 10 inches of the finish floor measured vertically shall have a smooth surface on the push side extending the full width of the door.	404.2.10	11B-404.2.10	Remove

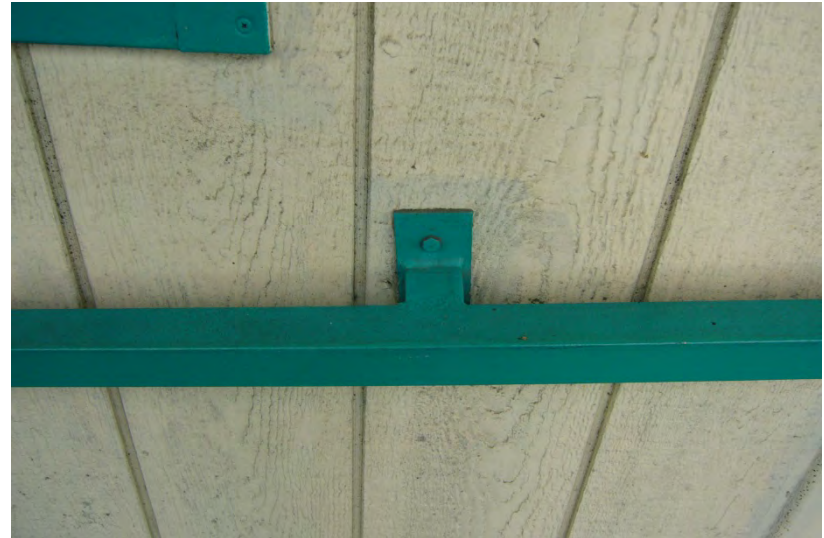
47	2015.06.10	Site	Ramp to "Friends" Building in Parking lot	Ramps	14	102	Hand grip at upper run has a square profile. Hand grip at lower run is circular. The transition from circular to square is not smooth. Handrail gripping surfaces and any surfaces adjacent to them shall be free of sharp or abrasive elements and shall have rounded edges.	505.8	11B-505.8	Replace with a compliant ramp and handrails				
48	2015.06.10	Site	Ramp to "Friends" Building in Parking lot	Ramps	14	104	Hand rail has no extension on top landing on wall side and only 8" extension on the other side. Minimum 12" extension beyond the top is required.	505.10.1	11B-505.10.1	Replace with a compliant ramp and handrails				
49	2015.06.10	Site	Ramp to "Friends" Building in Parking lot	Ramps	14	103	Rail wall brackets block the grip. Handrail gripping surfaces shall be continuous along their length and shall not be obstructed along their tops or sides.	505.6	11B-505.6	Replace with a compliant ramp and handrails
