**ACCESSIBILITY
SURVEY & REPORT**
for

COSTA MESA CIVIC CENTER

77 - 99 Fair Drive
Costa Mesa, California

ITEM: Accessibility Survey and Report

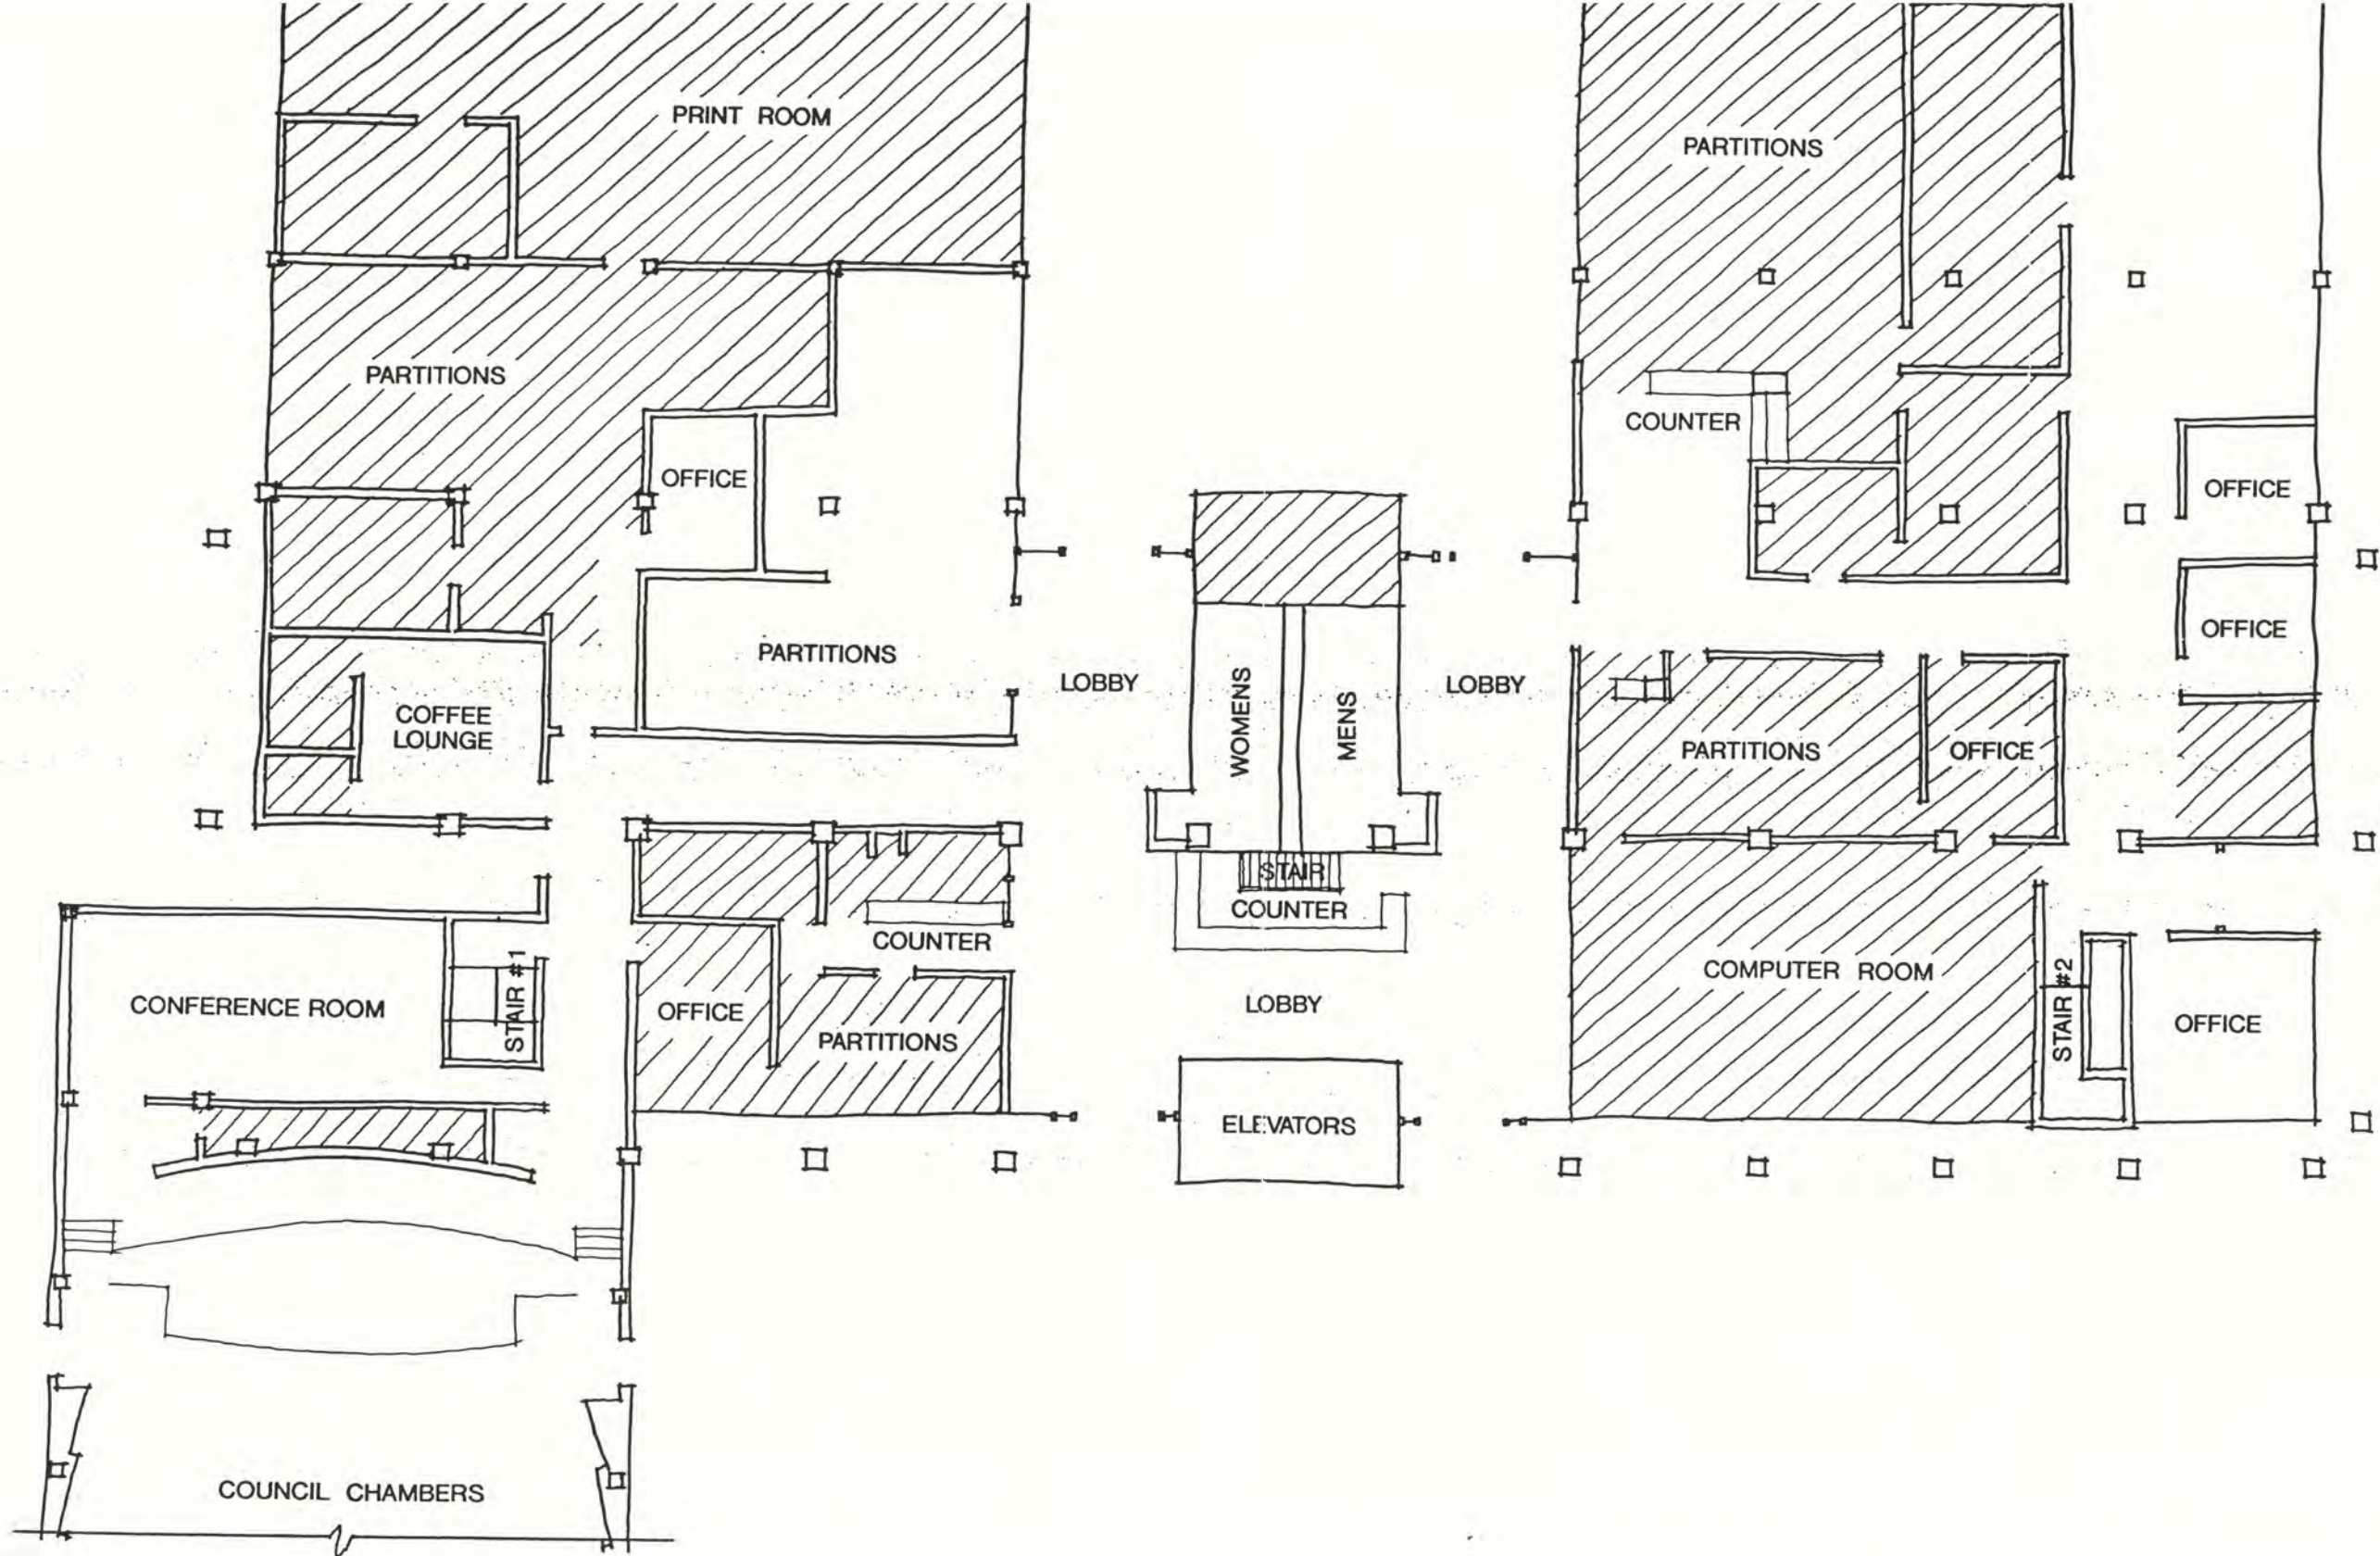
Item Location/ Plan No.	ADA Deficiency Description	ADA Code Reference	ADA Priority	Correction Description	Corr. Cost Est	Readily Ach'vble? <high-----low->	Corr. Priority
2	CC-2 Insufficient "passing space" provided in front of City Clerk's office, measuring 57" clear.	4.3.4	2	Passing space required in front of City Clerk's counter to be 60" clear. Move counter back, or modify counter, in order to provide clearances required.	\$640	<.1..2..3..4..5.>	
3	CC-2 No access to Council Chambers auditorium from inside City Hall Building, due to interior stairs. Note that the ADA stipulates stairs shall not be a part of an accessible route. An accessible route to restroom facilities, equivalent to the route for the general public, is not provided.	4.1.3(1) 4.3.8 4.5.2 4.1.6(1)(f)	2	Provide wheelchair or platform lift as a means of accessible vertical access. (Note: Means of access (accessible route) via exterior route is only feasible if such route is designated route for the general public. The current route is the interior corridor.)	\$12,000	<.1..2..3..4..5.>

4	CC-2 Terrazzo flooring in main entrance lobby areas is slippery when wet.	4.3.6 4.5	2	Provide abrasive flooring surface in lobby and other areas which are subject to moisture accumulation.	\$5,500	<.1..2..3..4..5.>	
5	CC-2 Excessively protruding objects, projecting into accessible route, walks, and corridors, deficient as follows: <ul style="list-style-type: none"> In Council Chambers, counter at back of room projects 12". In Council Chambers, bracket for display board projects 5". In Council Chambers, podium extension project 12". 	4.1.2(3) 4.4.1	2	The ADA stipulates that objects shall not project greater than 4" into walks or corridors, which are above 27" from finish floor. Remove deficient protruding objects, and/or modify to comply with ADA criteria. There are essentially two means of correcting these deficiencies: 1) Remove or modify the object to project no more than 4" or 2) Construct a furring below the object which is below 27" from finish floor. (In this way, a person with a sight disability using a cane may encounter the object prior to physically contacting it).	\$1,710	<.1..2..3..4..5.>

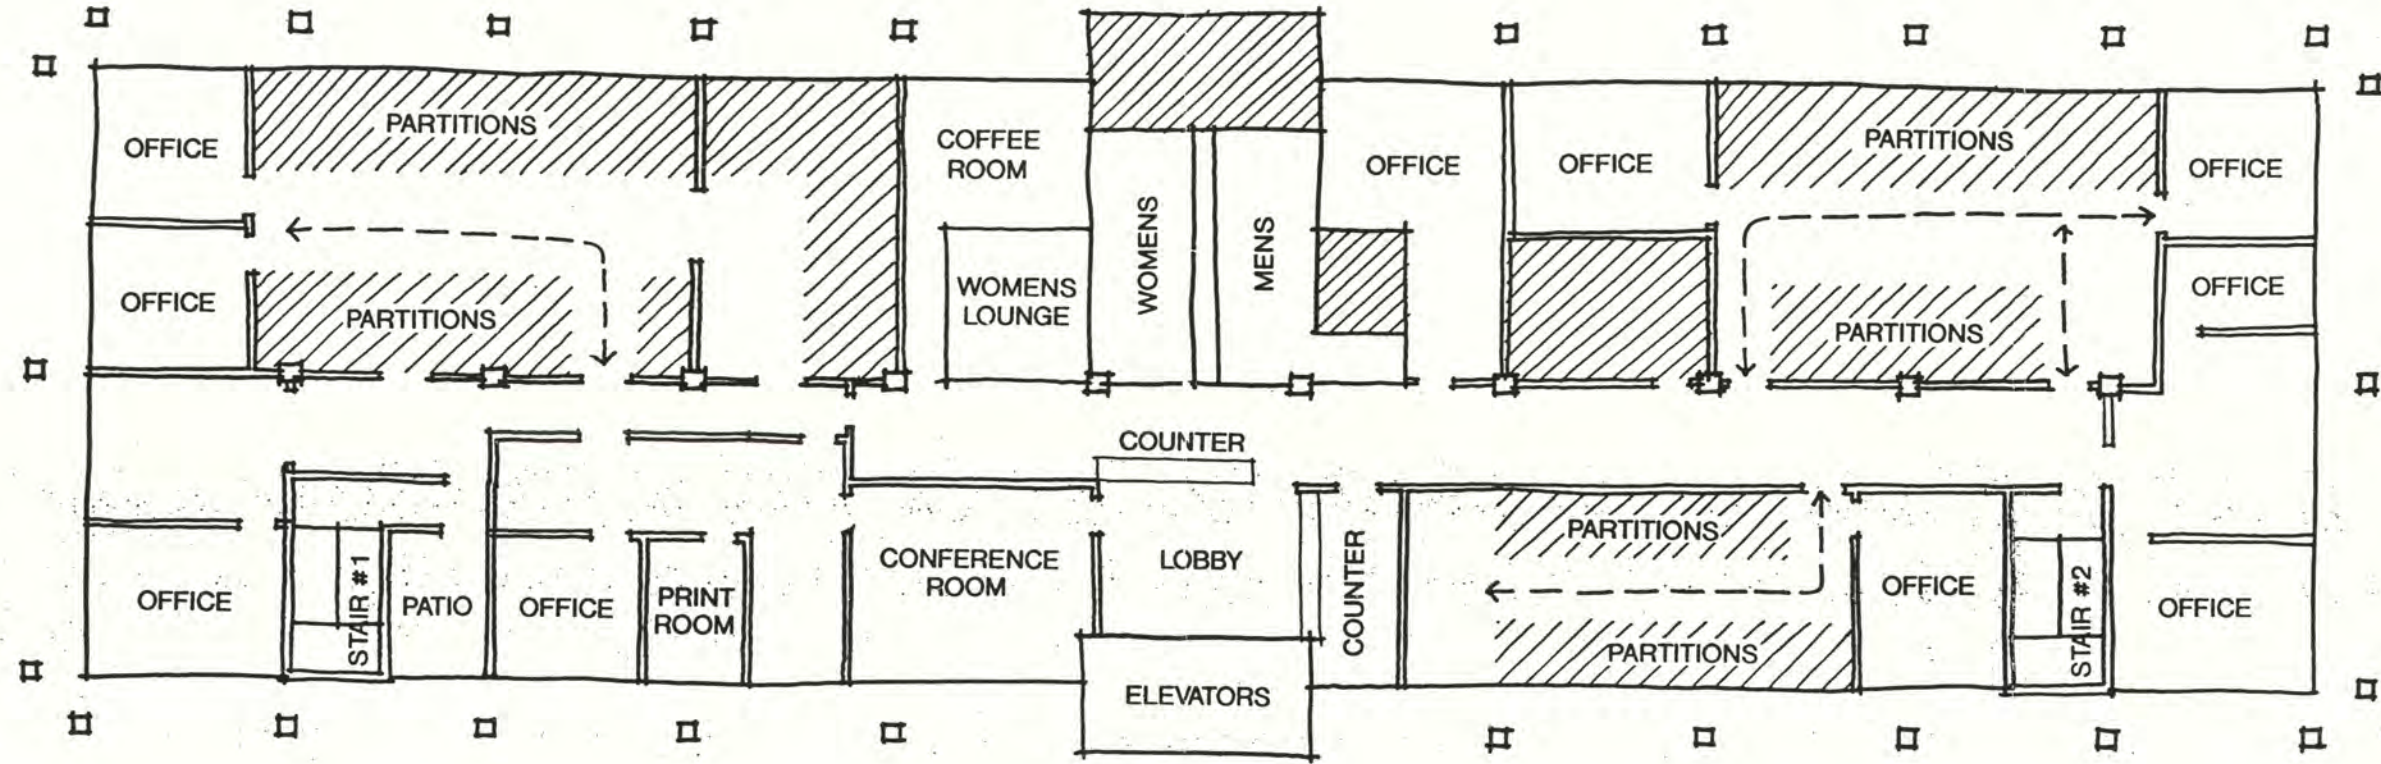
Item Location/ Plan No.	ADA Deficiency Description	ADA Code Reference	ADA Priority	Correction Description	Corr. Cost Est	Readily Ach'vble? <-high-----low->	Corr. Priority
CITY HALL FOURTH FLOOR							
14	CC-5 Insufficient minimum clear width provided at the following locations: <ul style="list-style-type: none"> In Transportation Services area, "hallway" crated by moveable partitions measures 33-1/2" clear. In Project Administration area, a clearance of 33-1/2" exists into back offices between furniture and moveable partitions. In Engineering Department, access to Assistant City Engineer's office measures 28-1/2" due to file cabinets in Reception area. 	4.3.3	2	Rearrange furniture and moveable partitions to provide the minimum clear width of 36".	\$150	<.1..2..3..4..5.>	
15	CC-5 Insufficient minimum clear headroom, provided at the following locations: <ul style="list-style-type: none"> Cross brace above doorway in partition to Mike Waters' office, measured at 77" high. Suspended VCR/TV in conference room from ceiling, measured at 36". 	4.3.5 4.4.2	2	The ADA stipulates a minimum clear headroom of 80". Modify cross bracing above doorway into Waters' office accordingly. Construct cabinet below TV/VCR to provide adequate protection.	\$1,000	<.1..2..3..4..5.>

16	CC-5 In several areas in the main corridor, carpeting is in disrepair, with pleats or "bagged" portions being potentially hazardous.	4.5.3	2	Replace carpeting in excessively worn areas.	\$1,400	<.1..2..3..4..5.>
