Appendix H Asbestos Survey

September 9, 2013

SUBJECT: Asbestos Survey for One Building Located at 1683 Sunflower Avenue, Costa Mesa, California

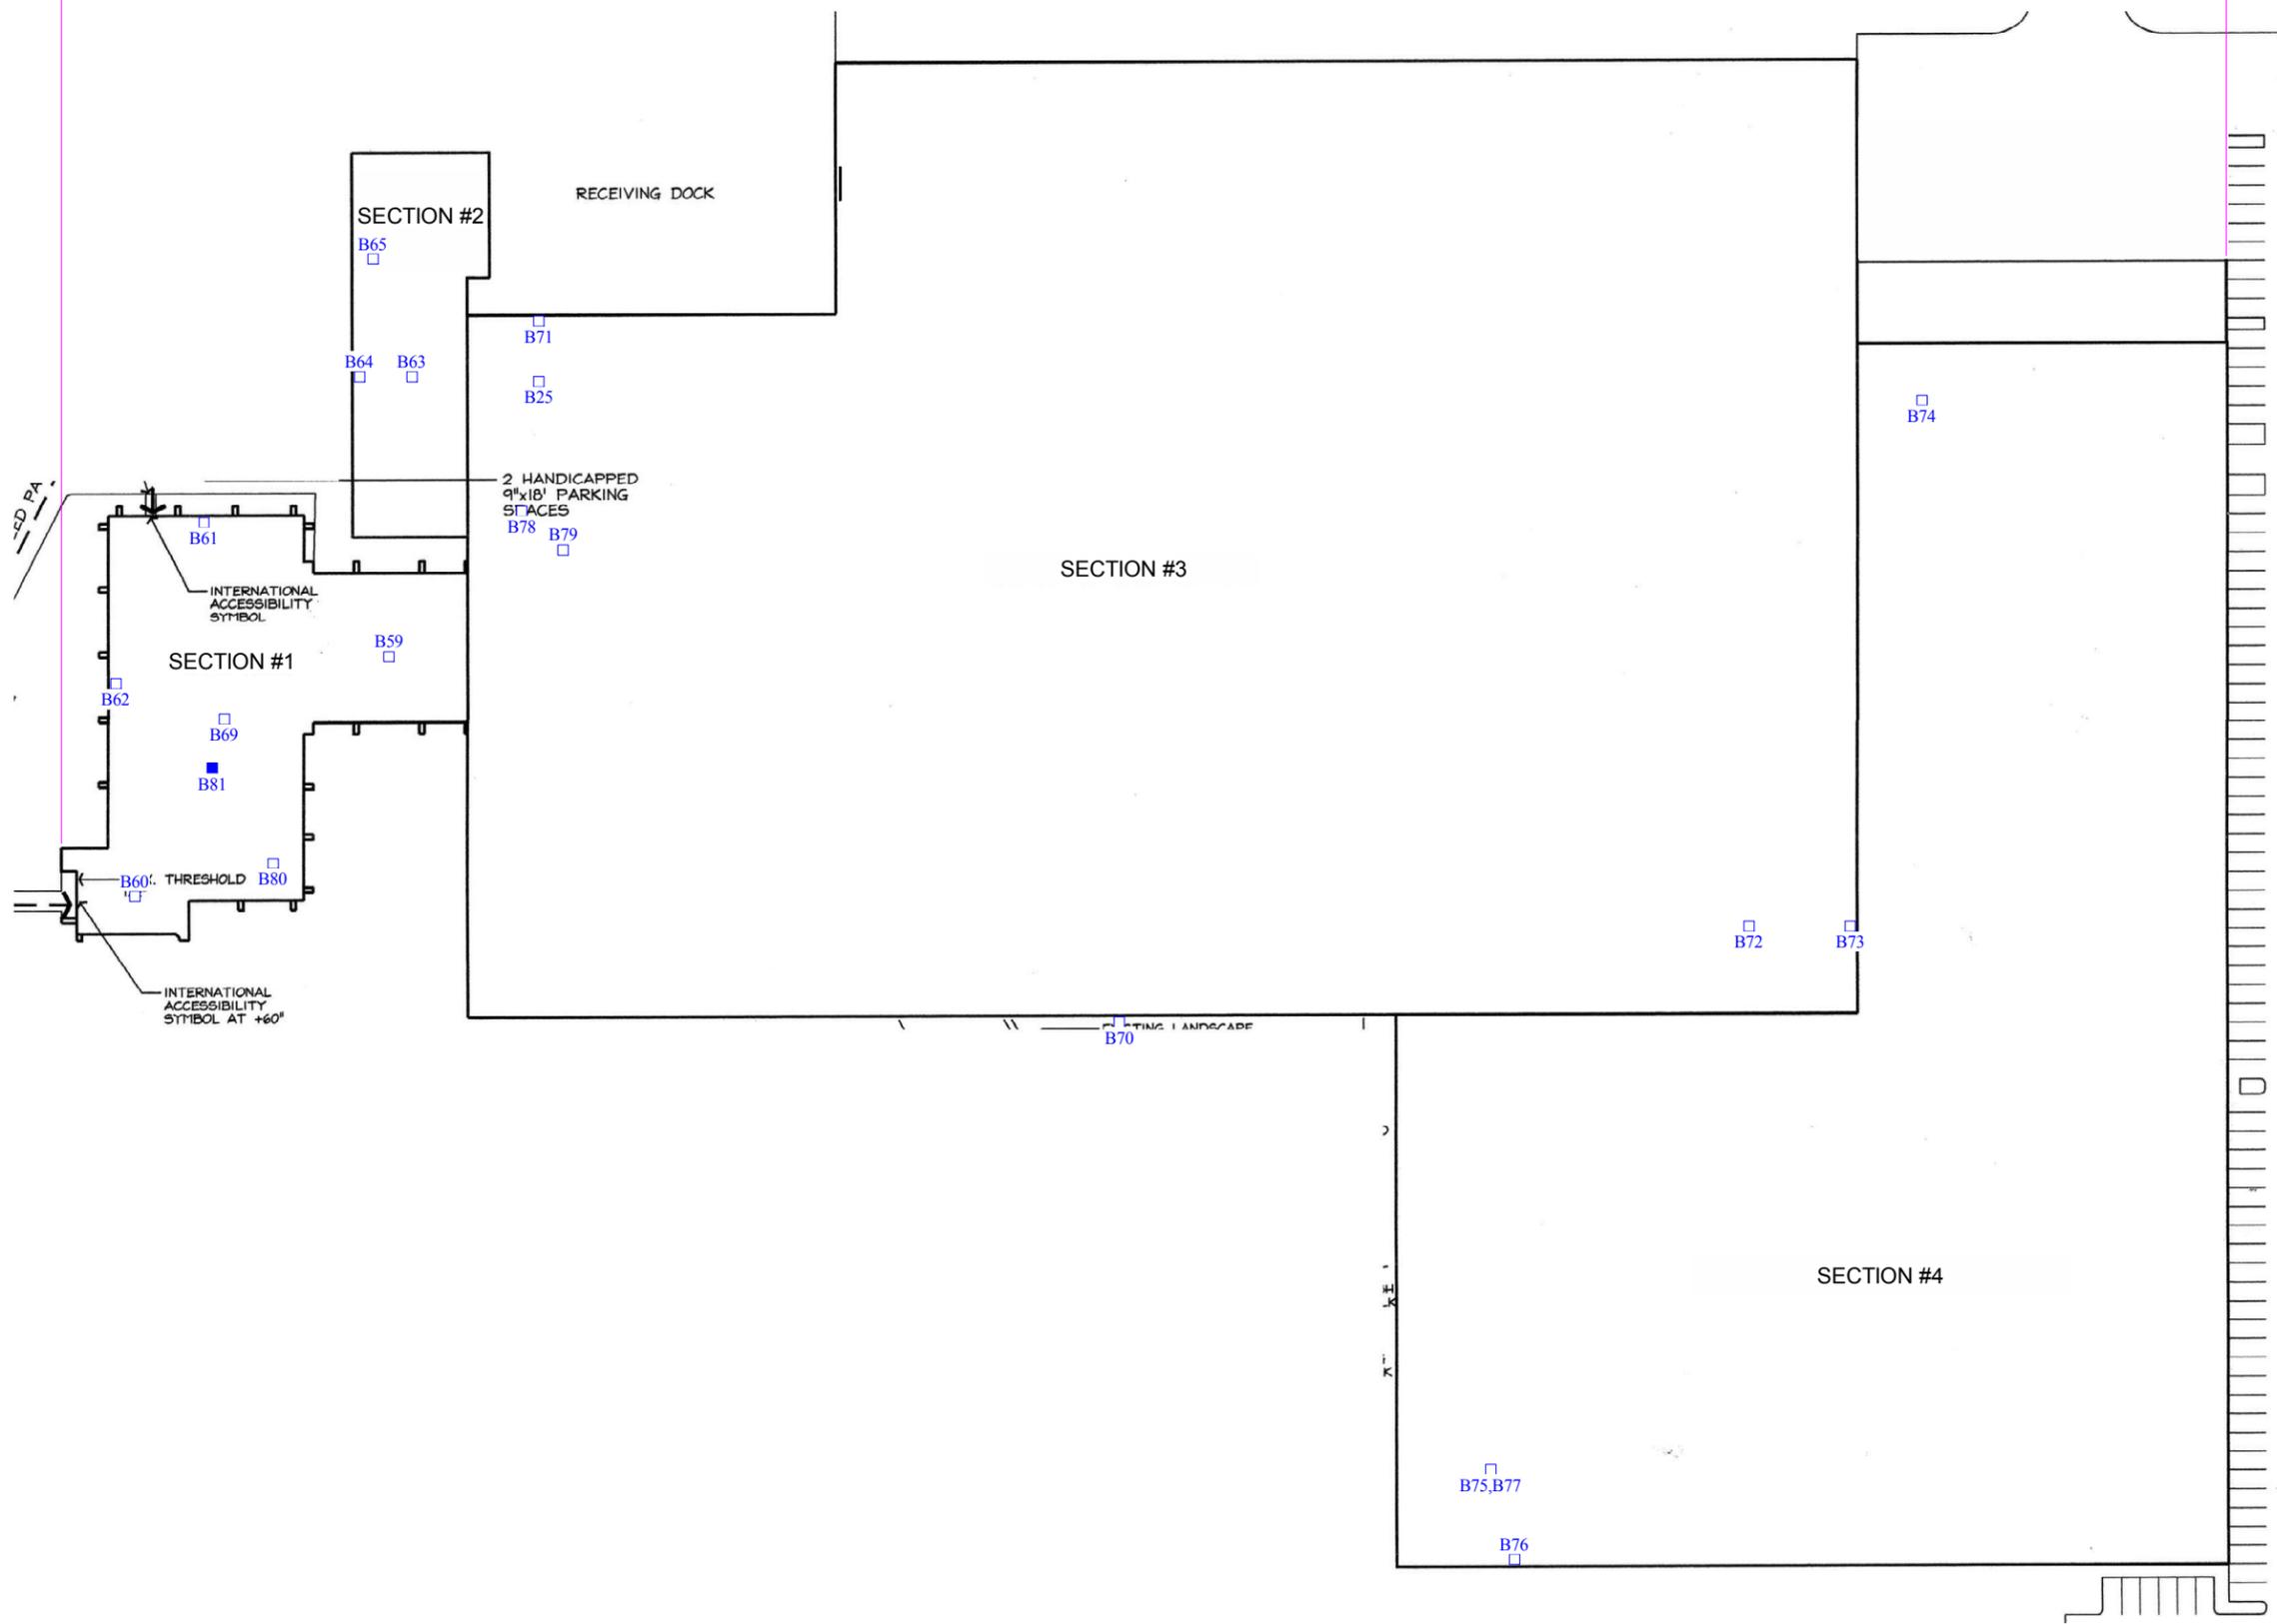
BULK SAMPLE LOCATIONS
 ROOF AND EXTERIOR PLAN
 1683 SUNFLOWER AVENUE
 COSTA MESA, CALIFORNIA

Plastic roof cement (roof mastic) observed on penetrations, seals, and components on the roofs of this building contains >1% asbestos. Assumed <2,000 SF of this material was present.

- Floor tile and black mastic;
 - Black mastic on non-ACM flooring materials;
 - Joint compound; and
 - Plastic roof cement (roof mastic).
- ACMs should be removed by an asbestos-licensed contractor prior to the renovation or demolition of the building. DOSH Class I, II, III, or IV asbestos work procedures should be followed for all asbestos abatement.
