### **ZONING VERIFICATION LETTER – MASTER PLAN PROJECT L 55 FAIR DRIVE, COSTA MESA**

# Streetscape Tree Evaluation Study

Vanguard University, Fair Drive & Newport Blvd., Costa Mesa, CA

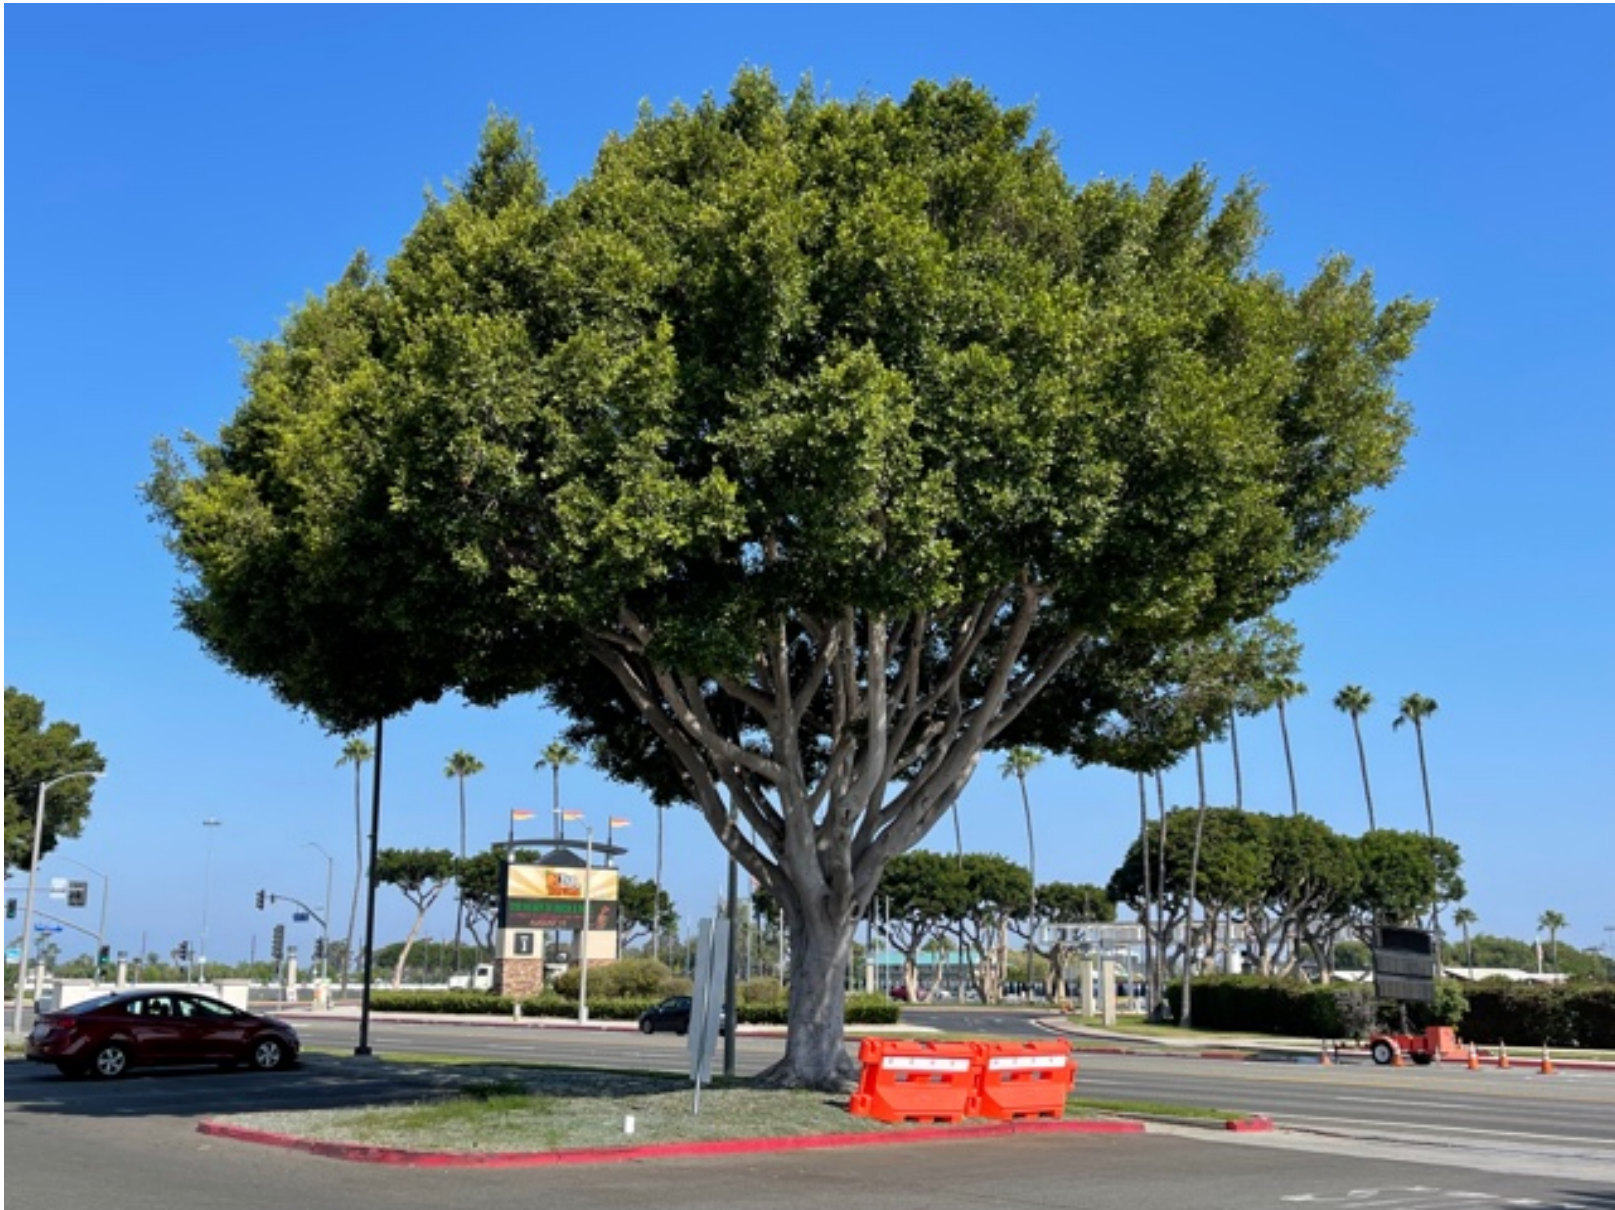
#2 Indian laurel by driveway.

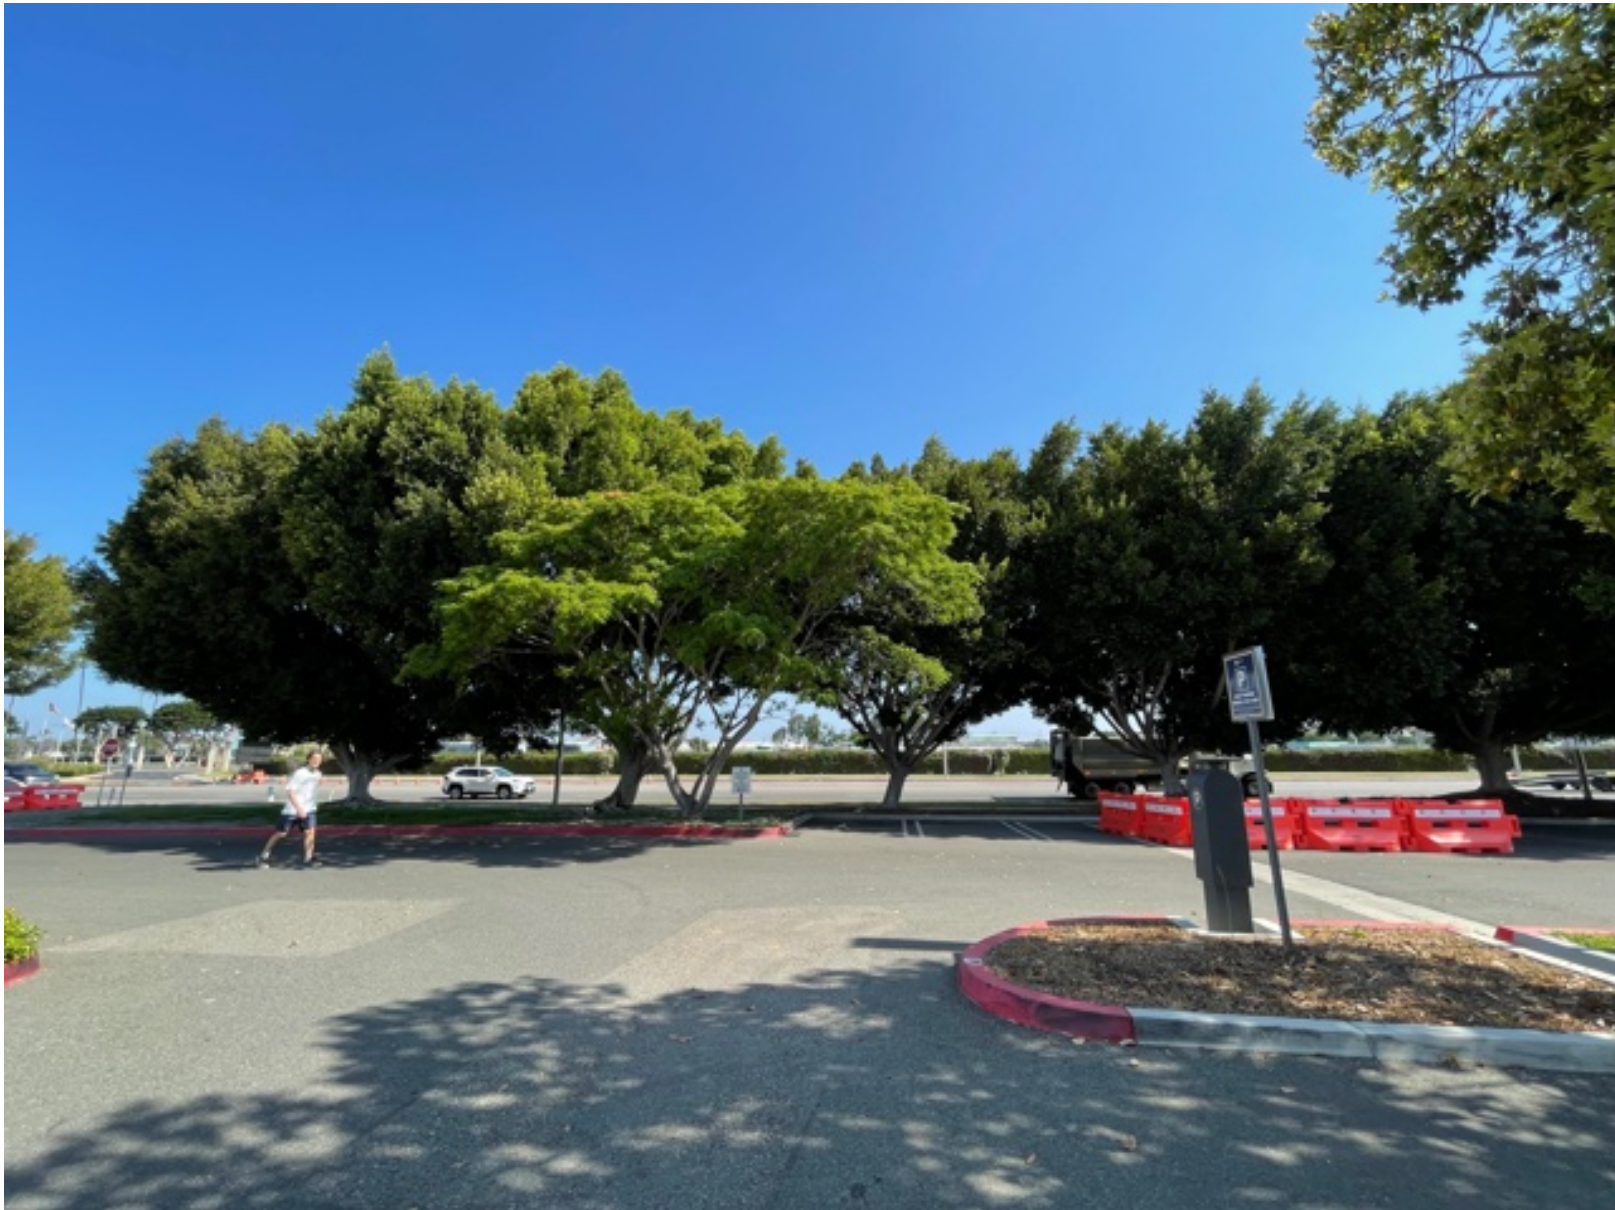
Mimosa #62 in foreground. Indian laurels #3 to 7 behind

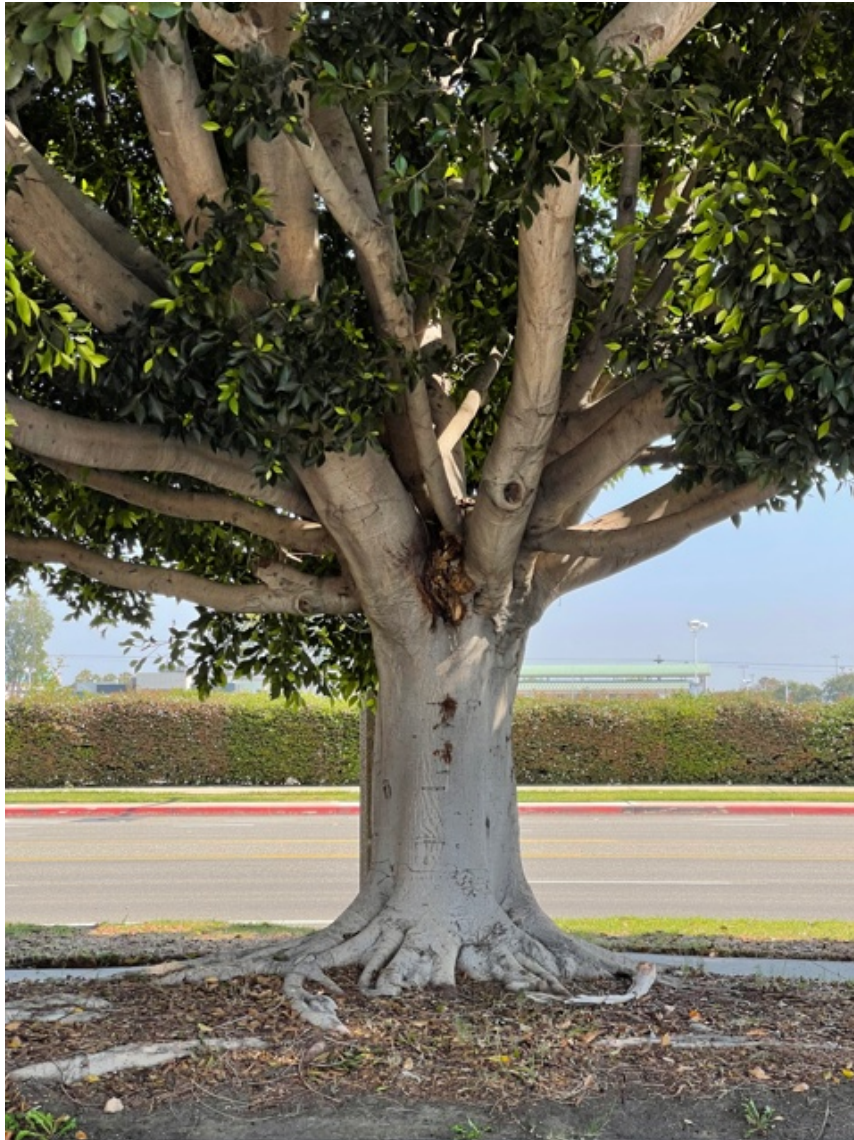
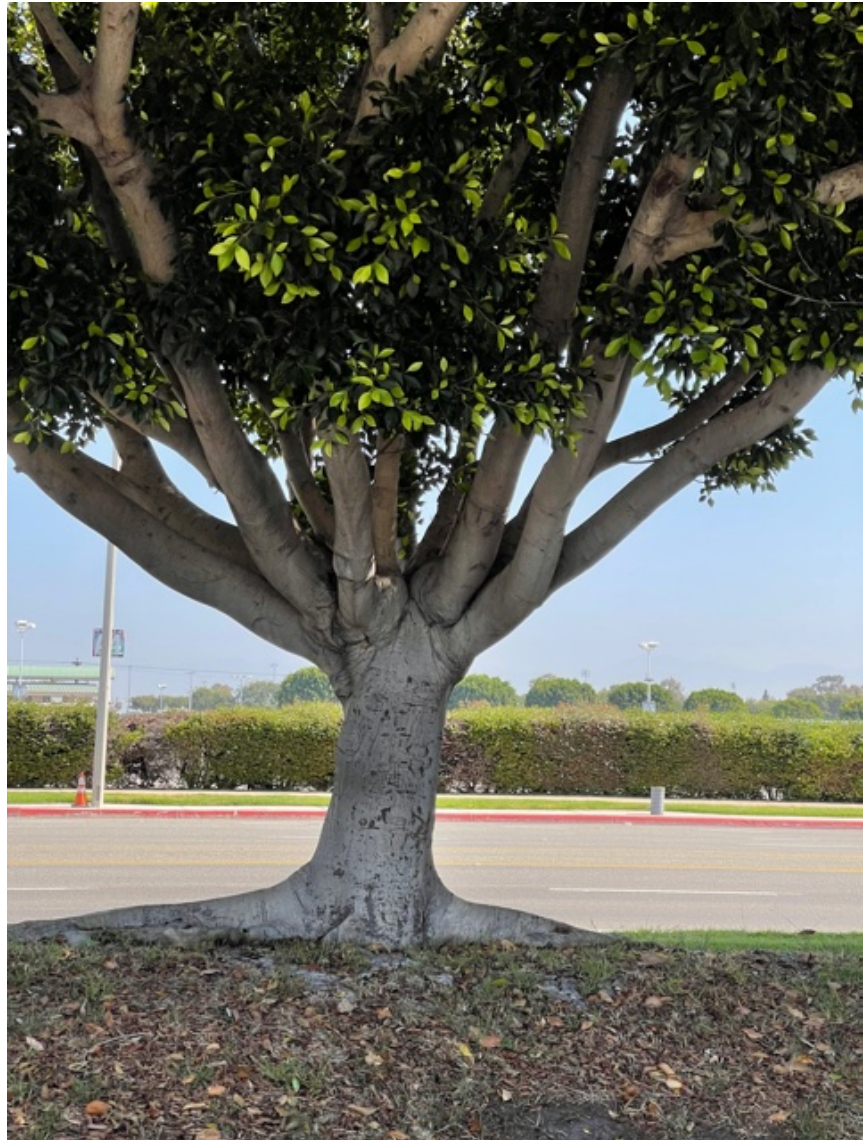
Note where one limb has been pinched out due to the common crowding of scaffold limbs at the same elevation

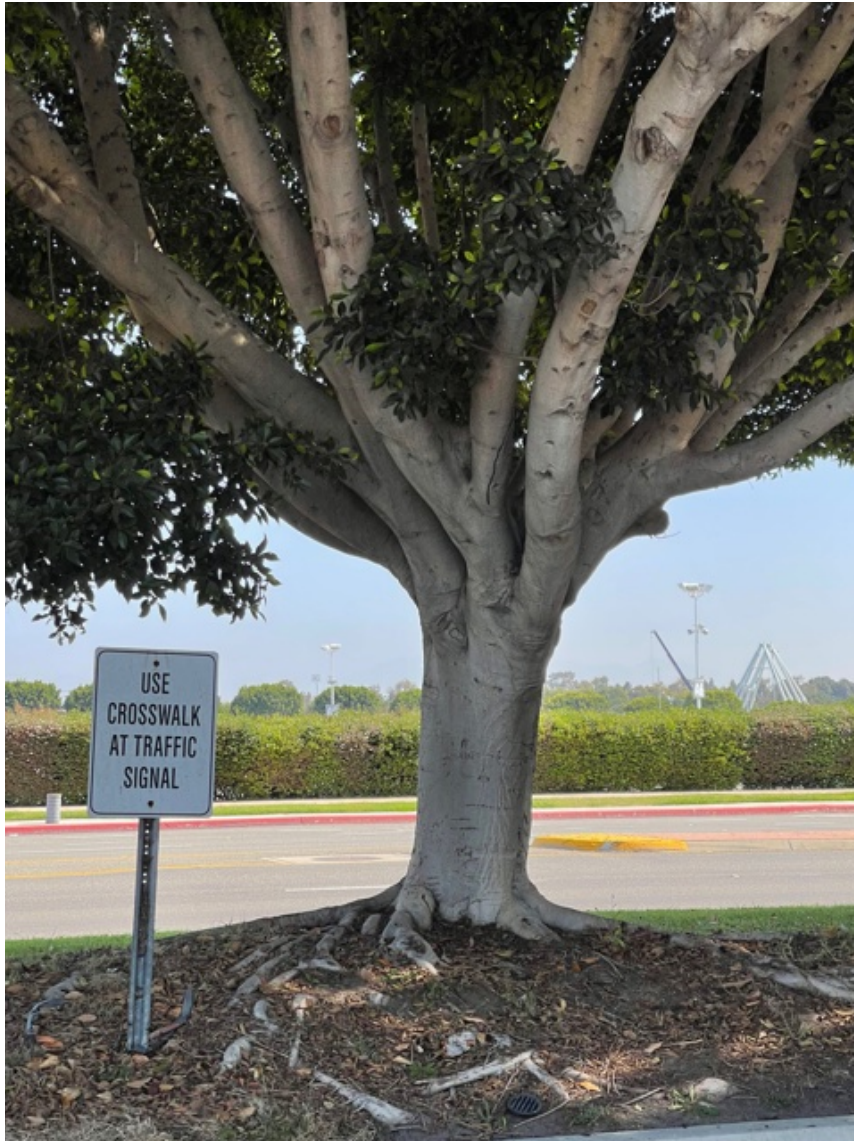
Early topping led to crowding of scaffold limbs at the same elevation.

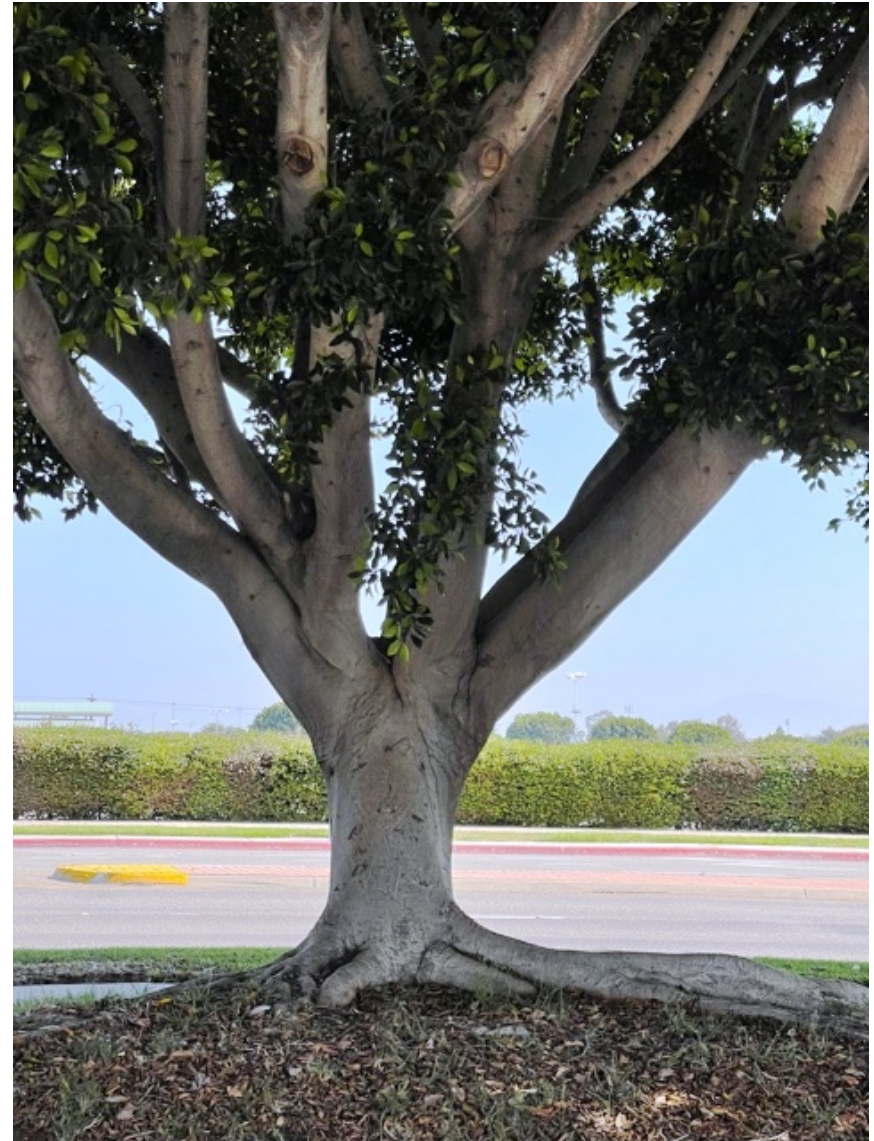
Note multiple points of included bark.

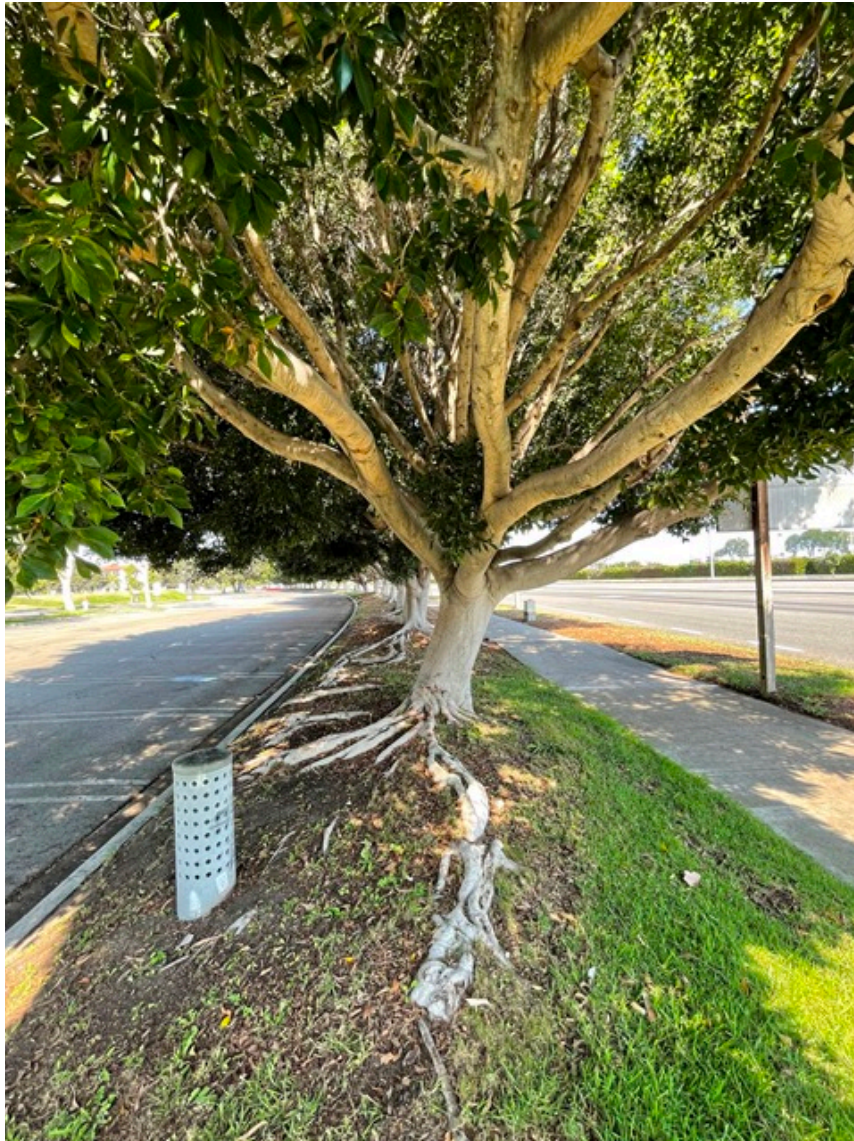
Shallow rooting and lion-tailing makes them less safe.

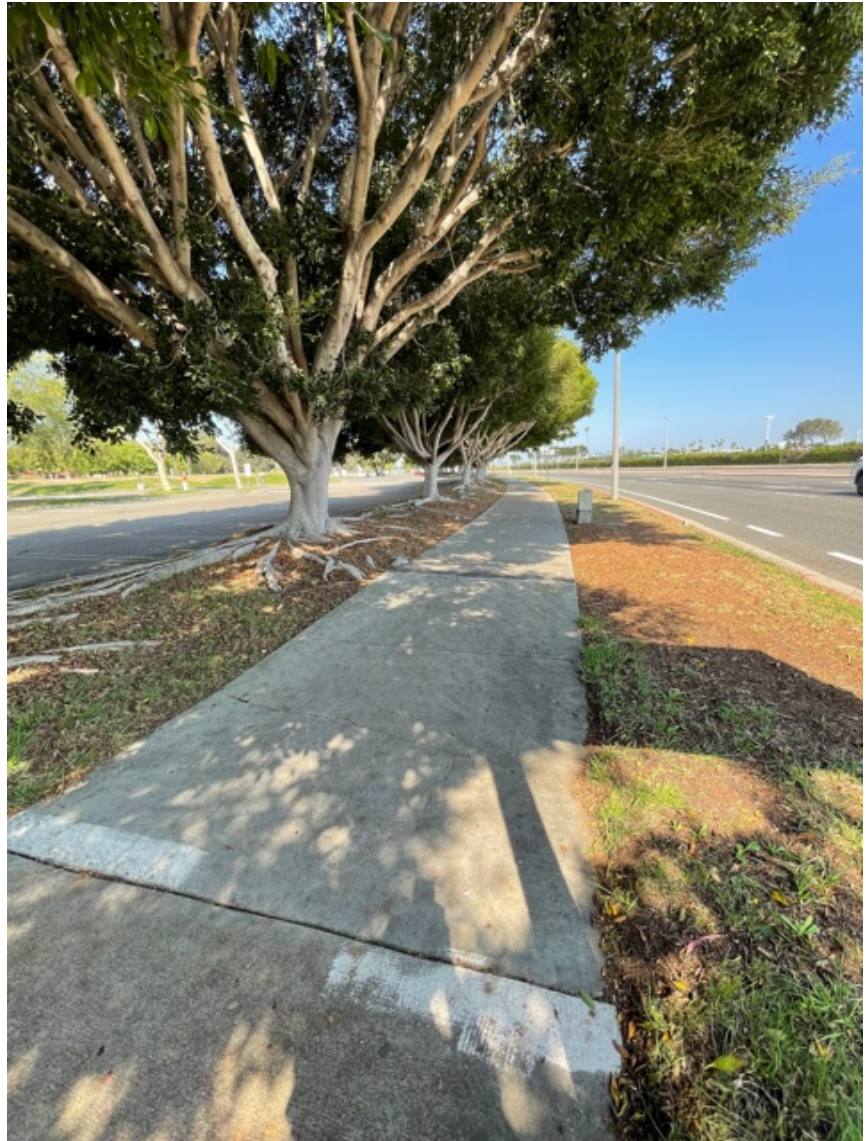
The rusty leaf figs, *Ficus rubiginosa*, and other ficus are notorious for lifting paving and small buildings. Possibly two cultivars were planted, one (#45) is larger and more vigorous. The cultivars are typically larger trees. Keep in mind that these are still relatively young trees and will certainly cause more damage as they grow.

The aggressive Ficus roots cause lifted paving and trip and fall accidents.

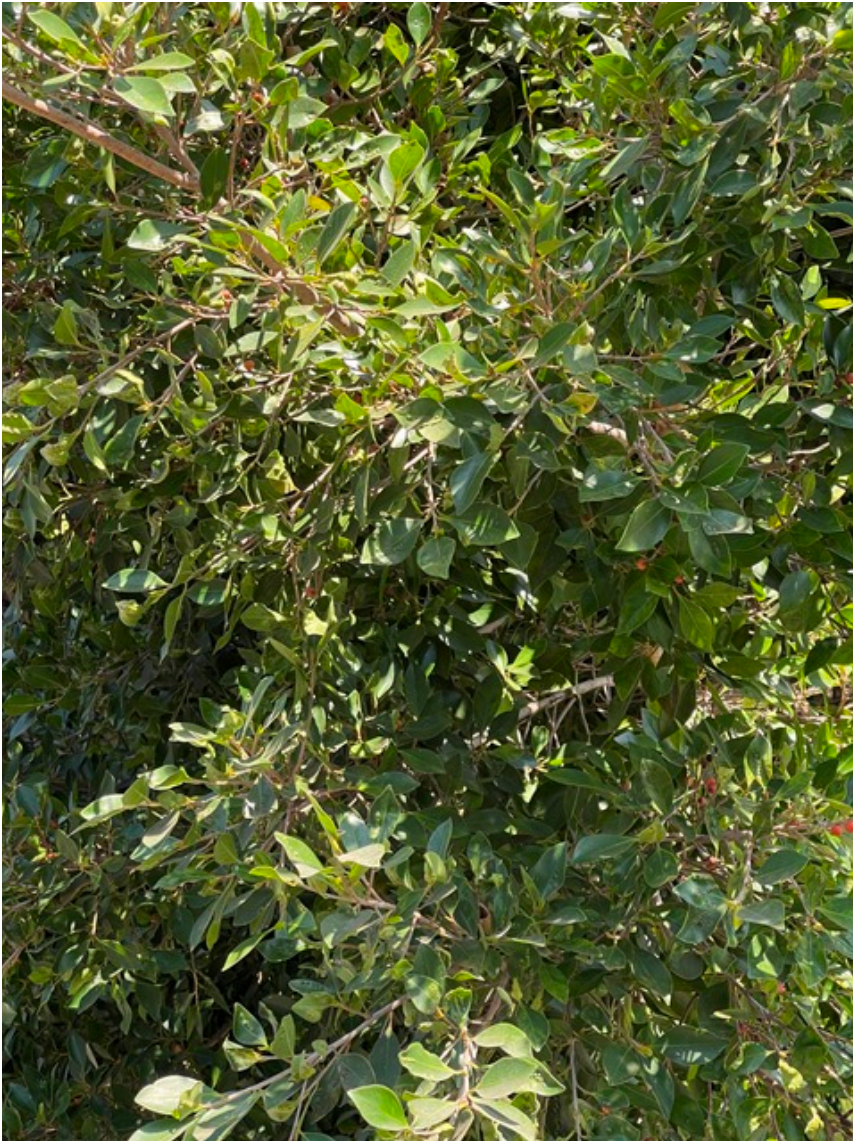
Note gall wasp and thrip damage.

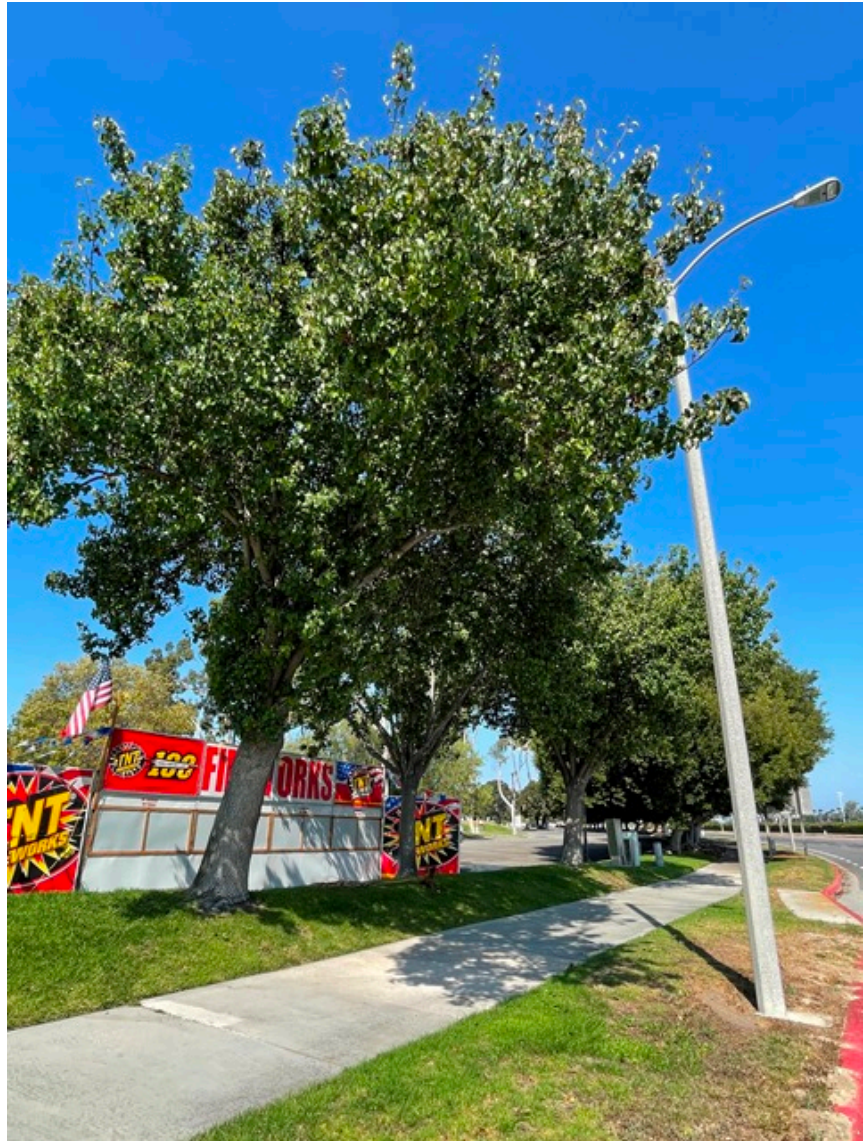
The Bradford pears have the same weak attachment problems as the Indian laurels and their limbs are arching out and sagging under the end weight and weak wood. Limb failure is likely in the near future. Their shallow roots have been damaged by lawn mowers.

Bradford pears #24 to 26 – note crowded scaffold limbs.

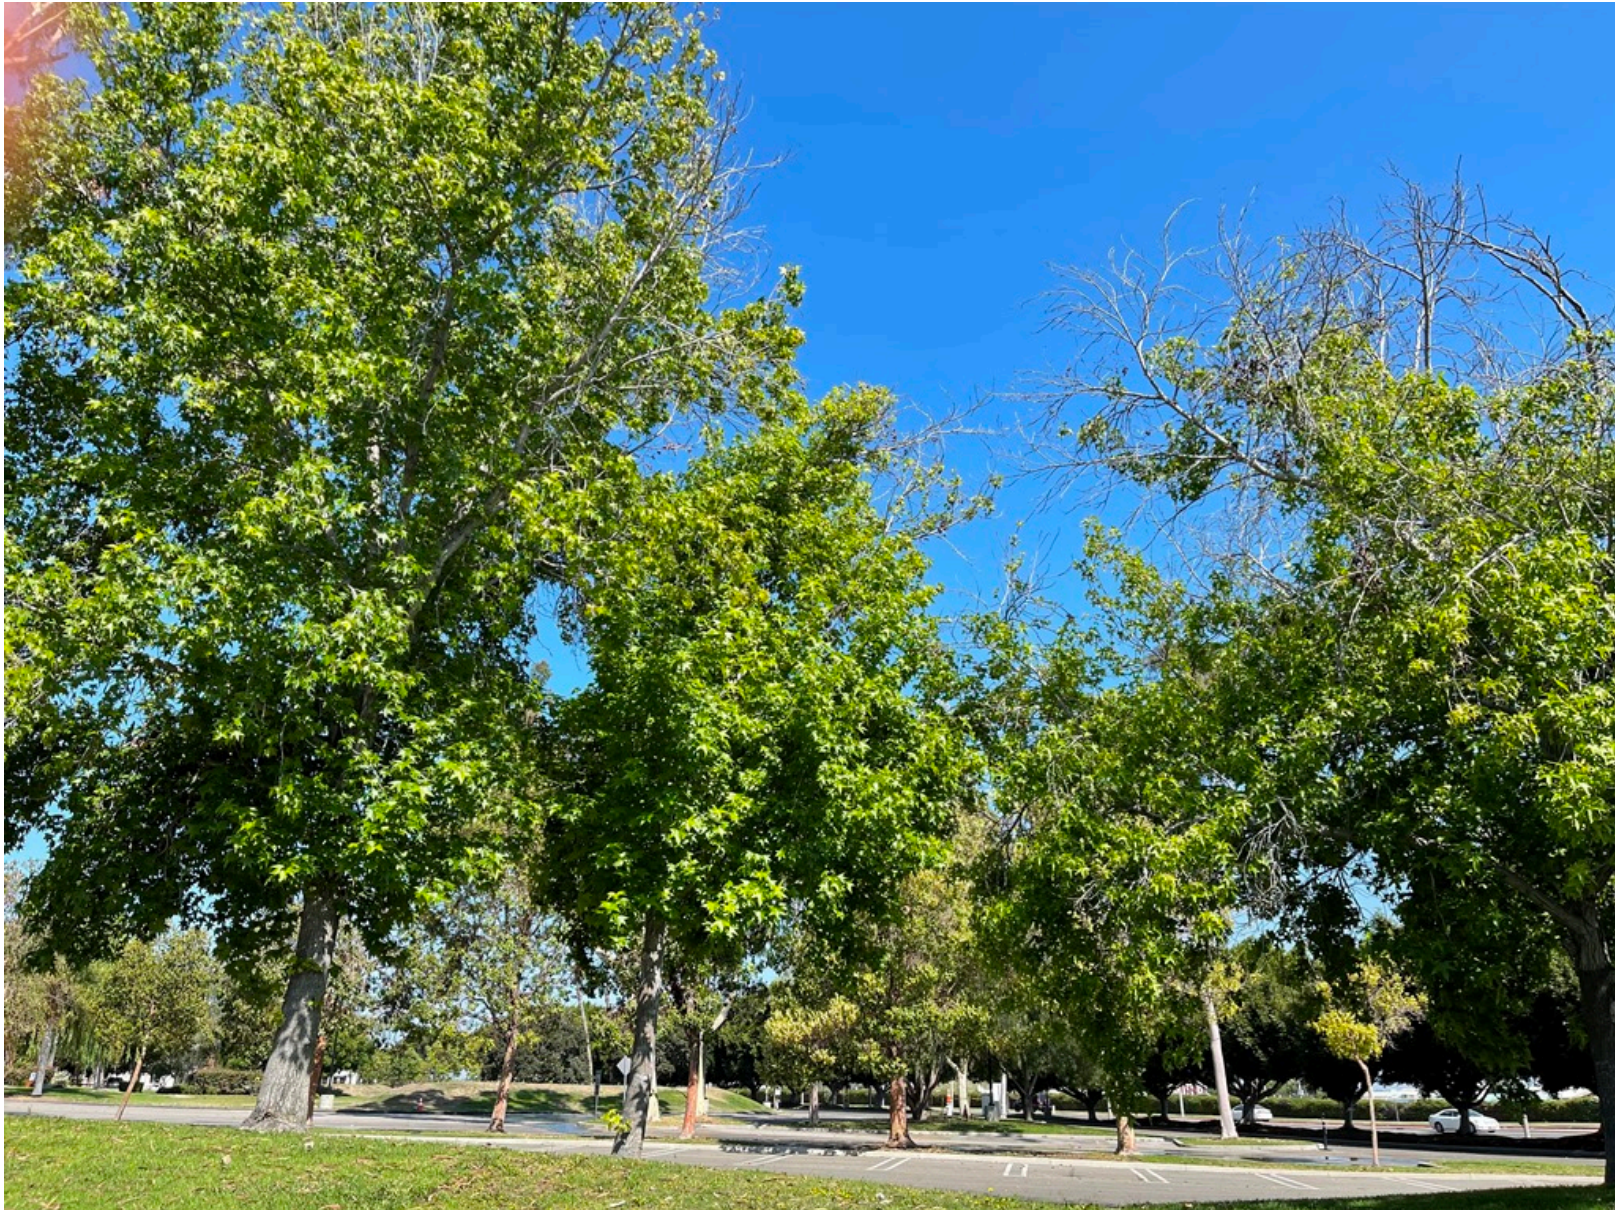
The sweet gums have dieback and dead tops. They appear to be dying from Xylella. Their shallow roots have been damaged by lawn mowers.

Sweet gums #32 to 34 – note dieback

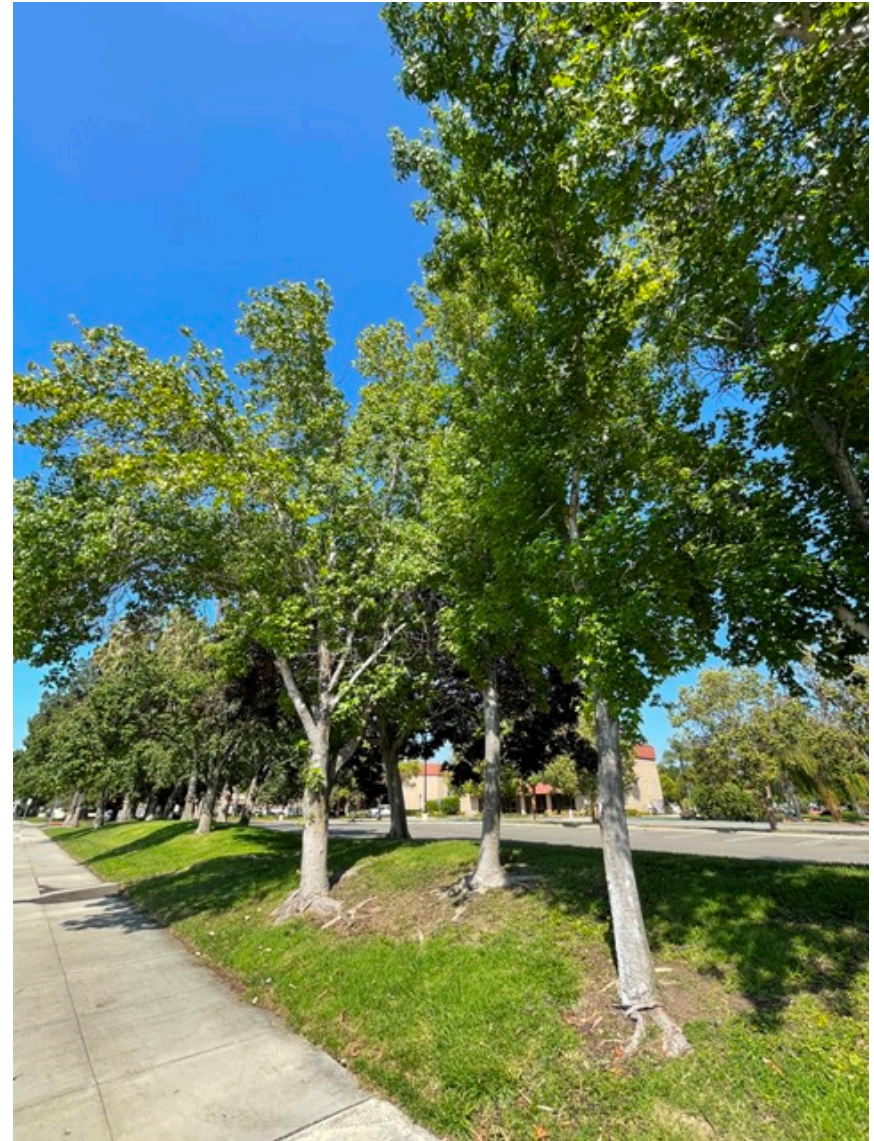
Sweet gum, *Liquidambar styraciflua*, can tolerate turf conditions, but will have shallow roots. The shallow roots are then damaged by lawn mowers unless the exposed roots are kept covered in a mulch bed. They have never been an approved street

Sweet gums #40 to 44 – note shallow roots.

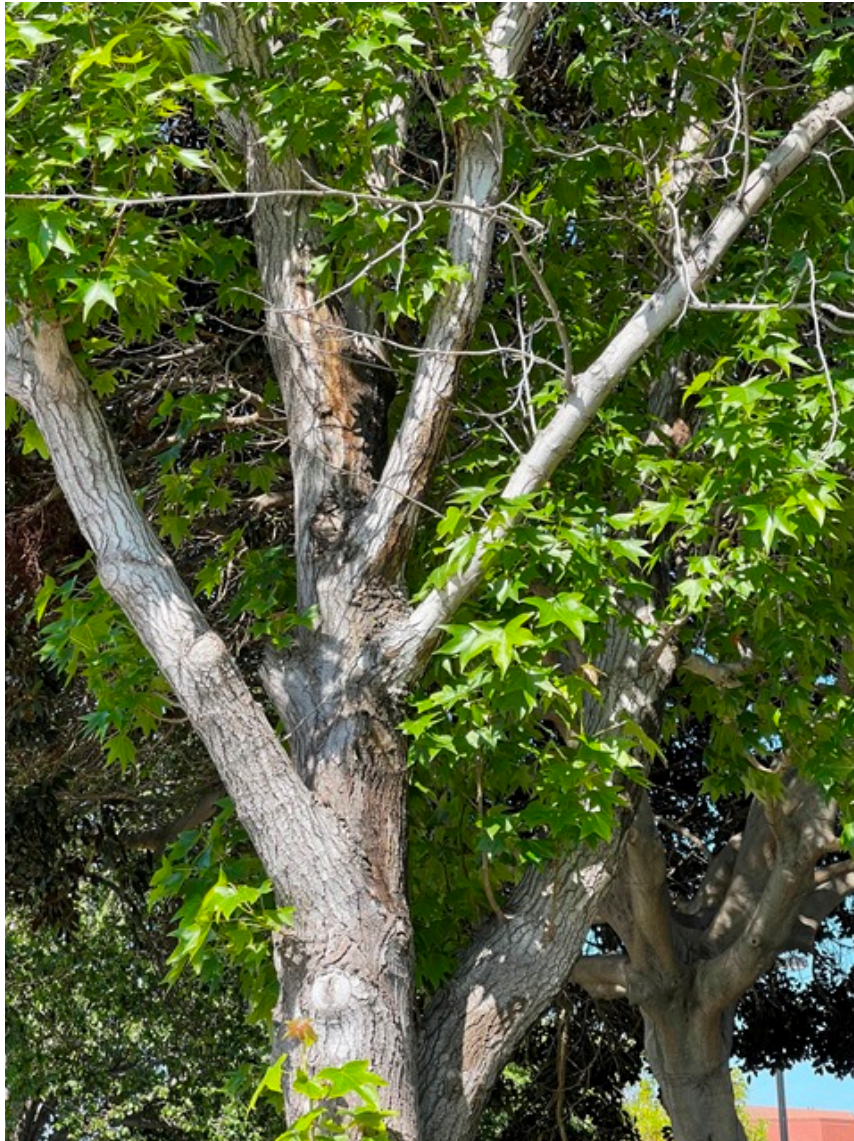
Sweet gum #44 – note bleeding likely caused by Xylella infection.

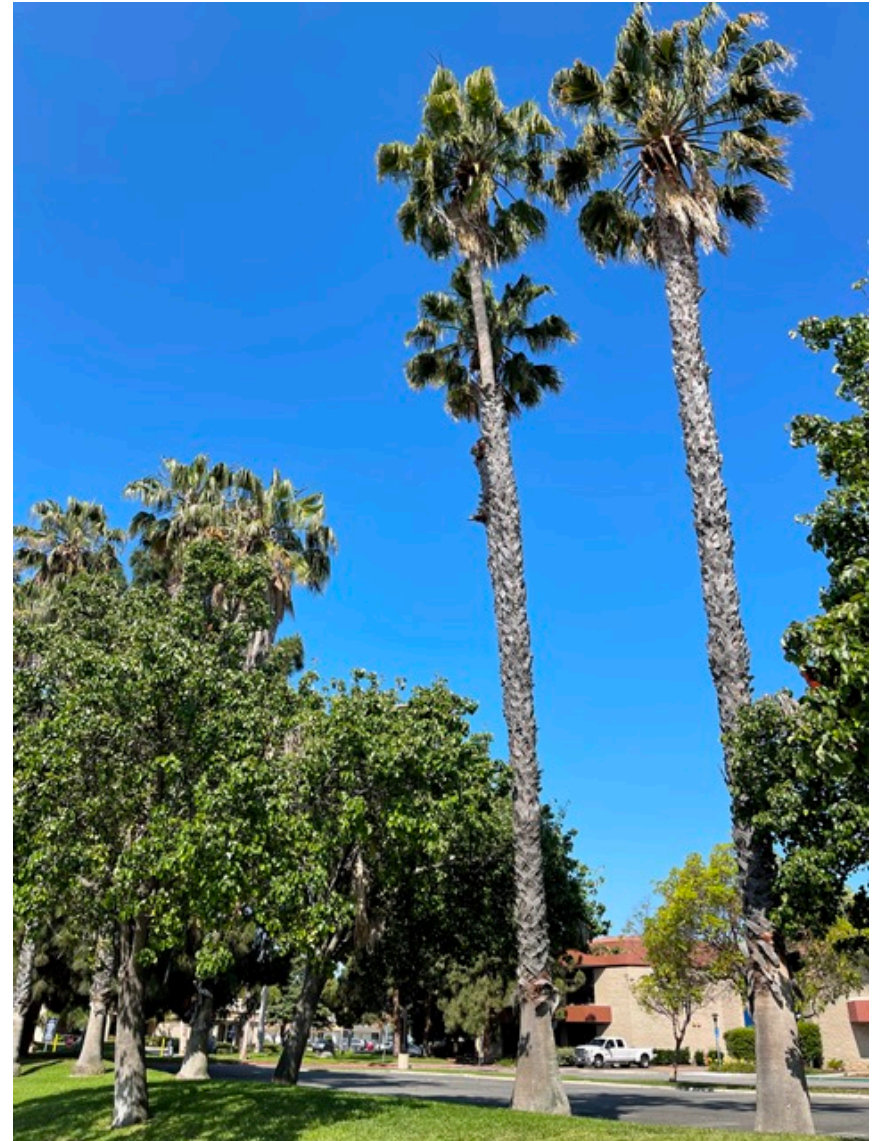
The Mexican fan palms, *Washingtonia robusta*, are currently healthy, but so tall they provide little more aesthetic benefits than telephone poles. They have started naturally shedding fronds and old leaf bases. As a result there may be less trimming needed, but two still have longer skirts of dead fronds. The fronds that are shed now end up stuck in the canopies of the surrounding trees. The cost of transplanting them is more than their value and more than the cost to replace them with shorter palms of the same species. The new fatal disease (*Fusarium oxysporium* forma sp. *Palmarum*) has started in the San Diego area, and it is probably spread by pruning tools. Only removing old dead fronds is the best way to avoid spreading the disease. Removal of old fronds, especially on specimens with significant skirts of dead fronds, is a dangerous and sometimes lethal activity. Skirts have been known to suddenly slough off and onto climbers suffocating them to death

Mexican fan palms #48 to 50 – note leaf bases being shed

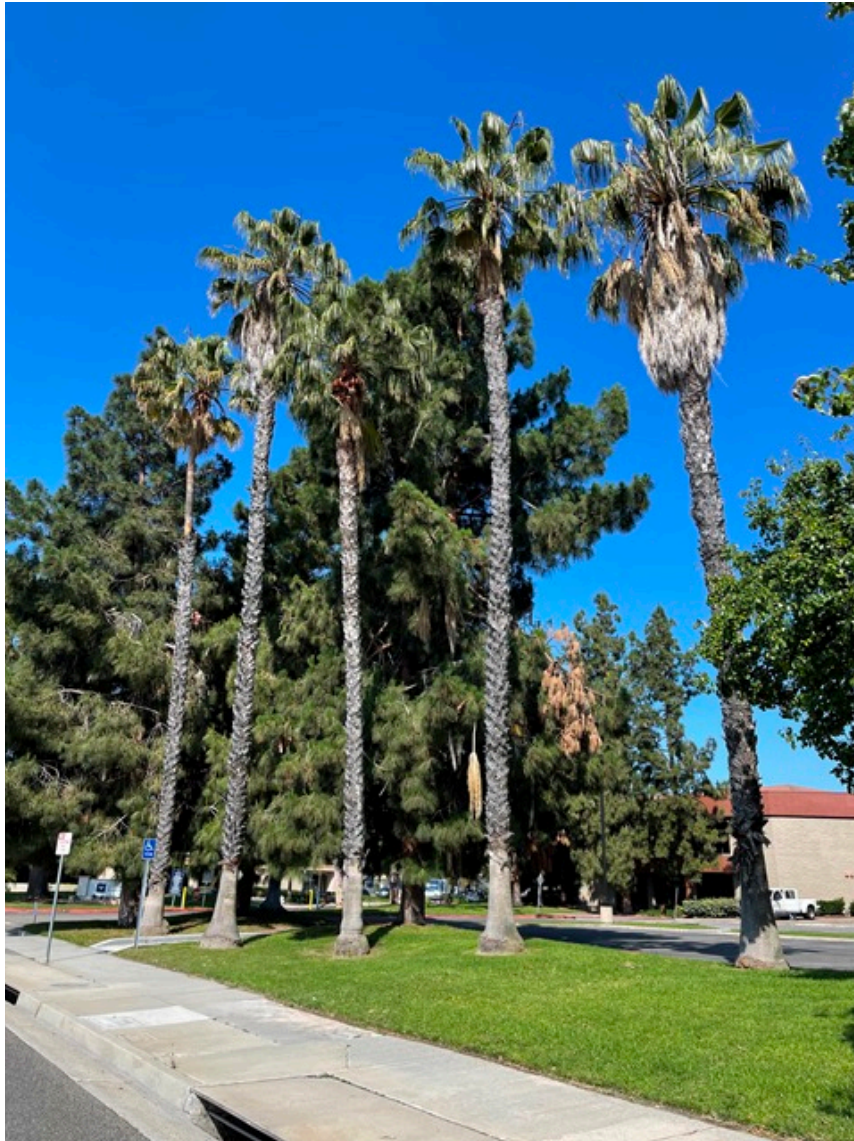
Mexican fan palms #53 to 57 – some leaf bases and fronds being shed.

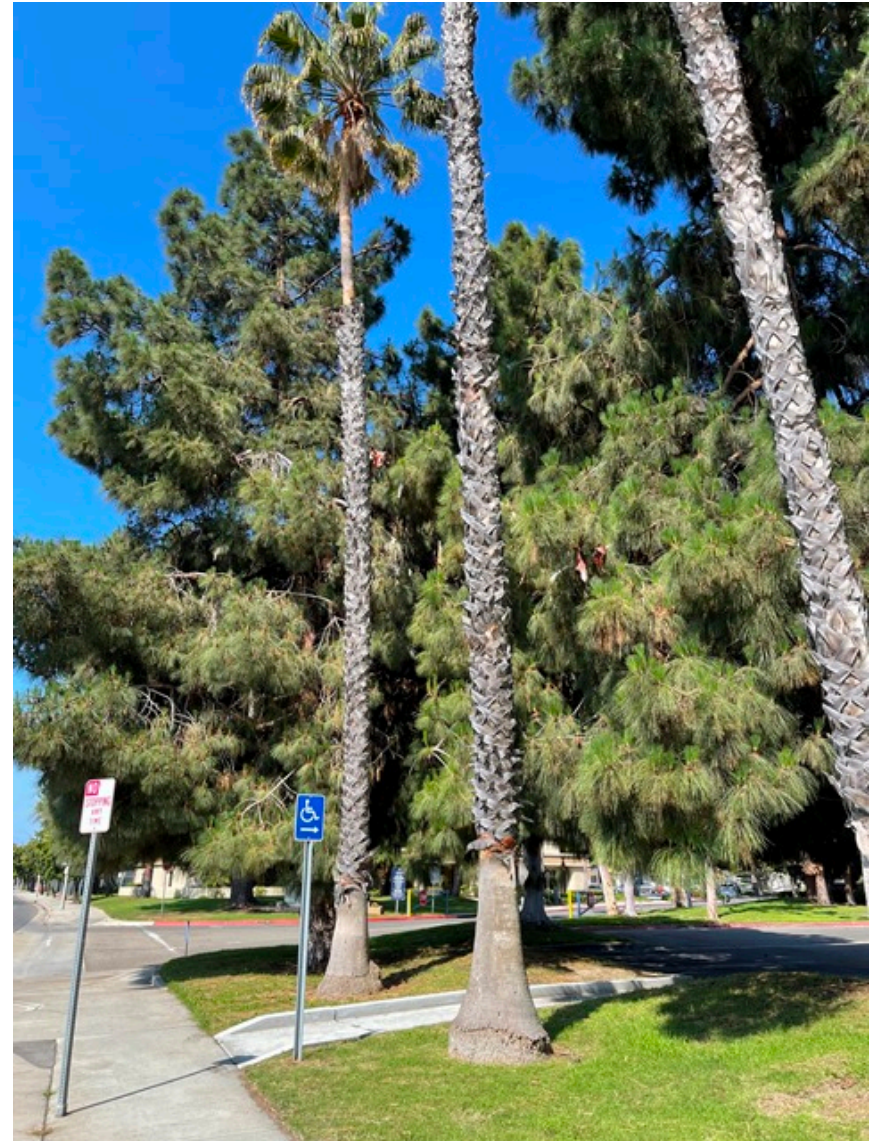
Canary Island pines 58 & 59

The Canary Island pines have overly long, heavy limbs and weak wood due to turf grass conditions, and they are crowding out the adjoining floss silk tree.

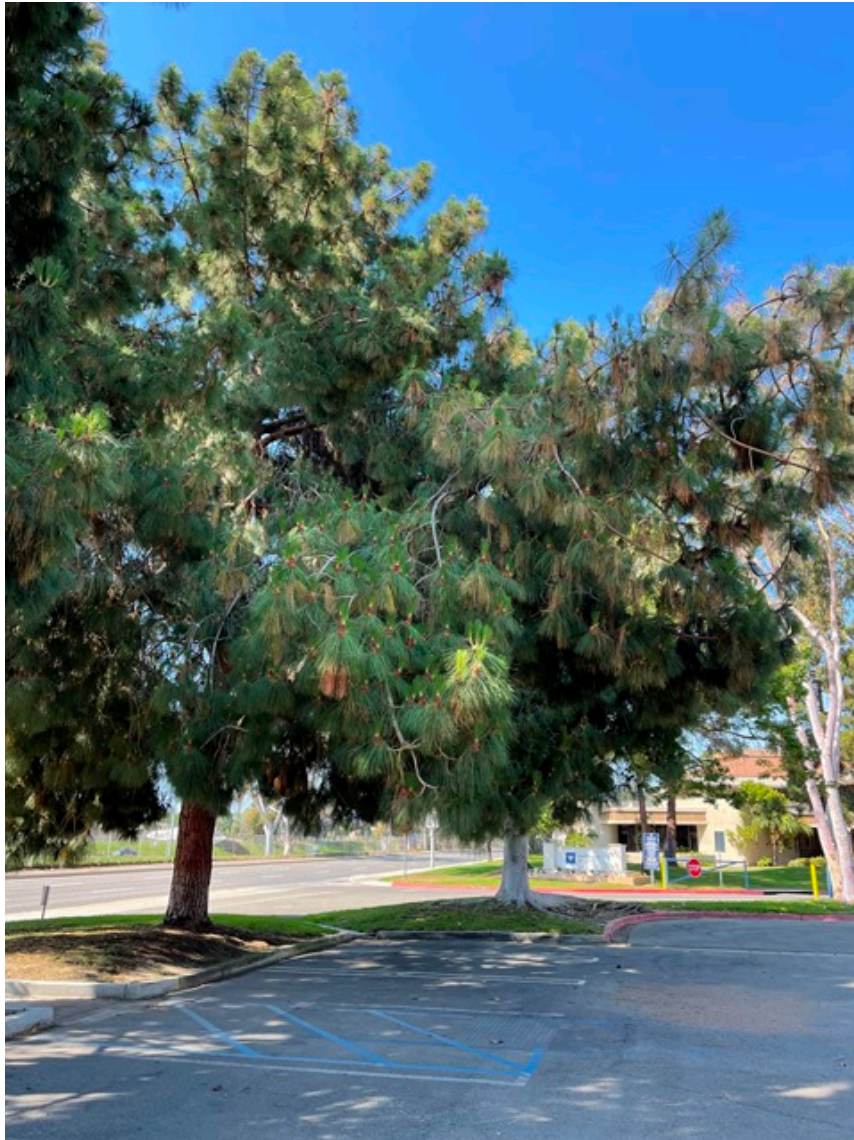
Canary Island pine #60 – note overly long limbs and lack of a leader.

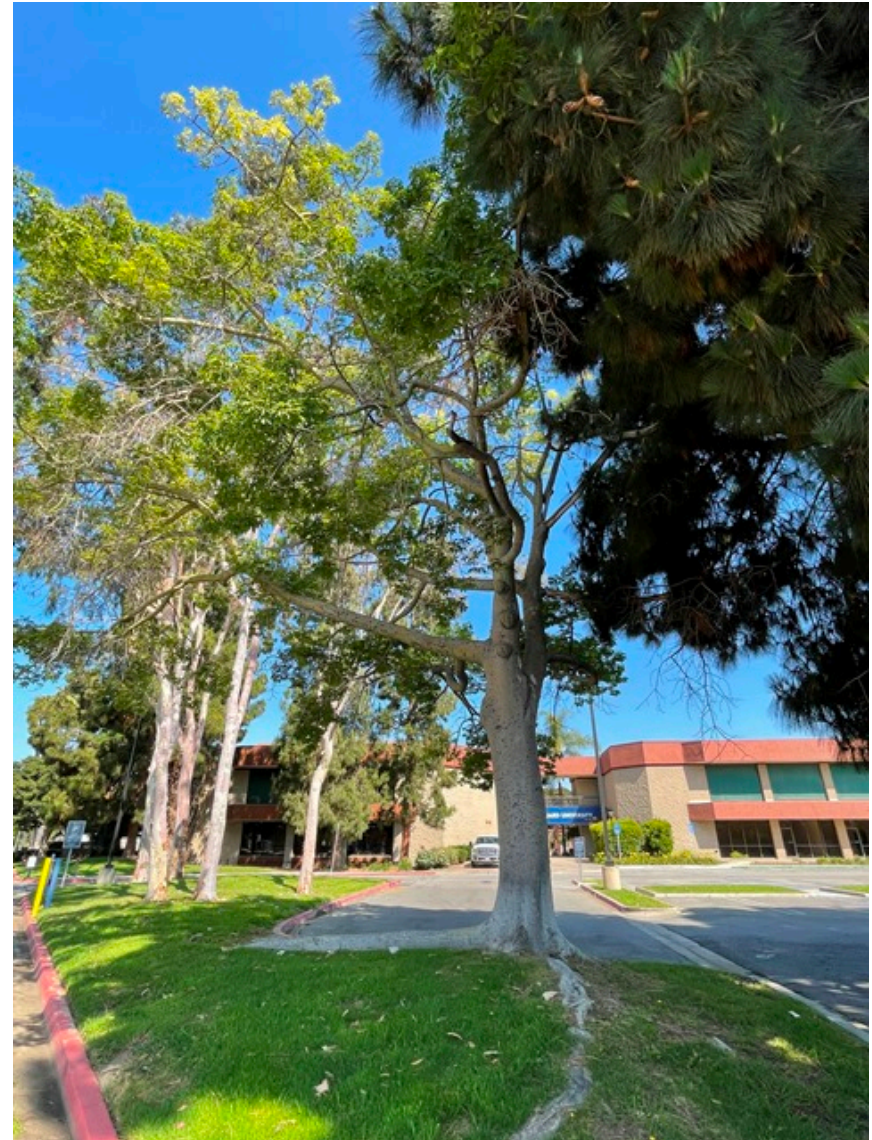
#61 Floss silk tree – note shallow roots and mower blight
