MESA VERDE BRANCH LIBRARY

2969 Mesa Verde Drive, Costa Mesa, California 92626

DISABLED ACCESS COMPLIANCE REPORT

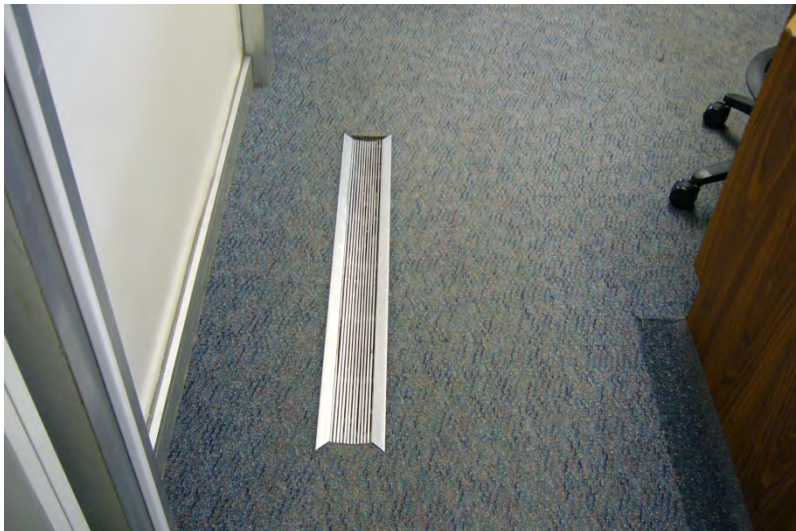
64	2015.06.10	Main Building	Book Return and Check-out counter staff area	Floor or Ground Surfaces		47	Floor air grille end trims are missing, the opening 5/8" wide is exposed. The elongated openings in the direction of travel are bent and concave and can be a tripping hazard. Openings in floor surfaces shall not allow passage of a sphere more than 1/2 inch diameter. Elongated openings shall be placed so that the long dimension is perpendicular to the dominant direction of travel.	302.3	11B-302.3	Replace grille with a new one that can withstand the traffic load, and has small openings perpendicular to direction of traffic.

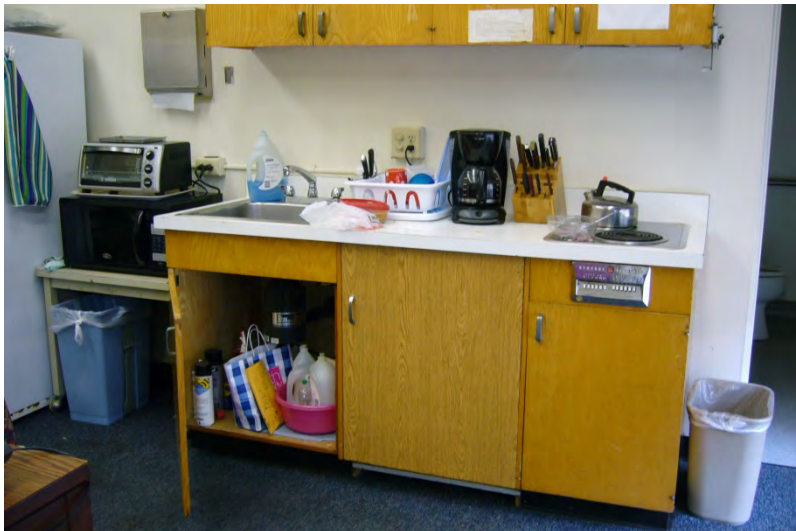
125	2015.06.10	Main Building	Staff Break Room	Sinks		92	No knee space at sink. This counter has a cook top. Knee space is required.	606.2	11B-606.2	Replace the counter with a lower compliant one.				
126	2015.06.10	Main Building	Staff Break Room	Sinks		92 93	Counter with sink is 36" high to top of counter. Sinks shall be installed with the front of the higher of the rim or counter surface 34 inches maximum above the finish floor or ground.	606.3	11B-606.3	Replace the counter with a lower compliant one.

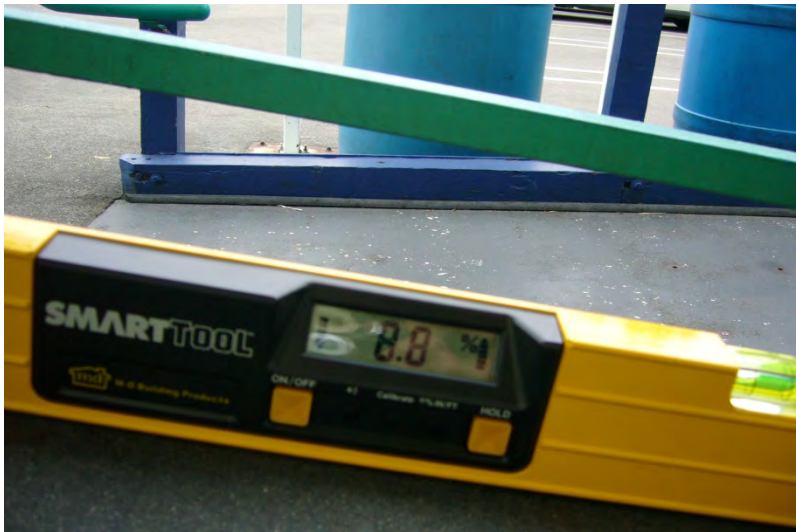
43	2015.06.10	Site	Ramp to "Friends" Building in Parking lot	Ramps	14	98	Slope increases to 8.8% at upper run. Slope at ramps shall not be more than 1:12.	405.2	11B-405.2	Replace with a compliant ramp and handrails				
44	2015.06.10	Site	Ramp to "Friends" Building in Parking lot	Ramps	14	99	Ramp is 40" wide. The clear width of a ramp run shall be 48 inches minimum.		11B-405.5	Replace with a compliant ramp and handrails				
45	2015.06.10	Site	Ramp to "Friends" Building in Parking lot	Ramps	14	100	Intermediate landing at change of direction is 5'-0" long in the direction of ramp. Ramps that change direction between runs at landings shall have a clear landing 60 inches minimum by 72 inches minimum in the direction of downward travel from the upper ramp run.		11B-405.7.4	Replace with a compliant ramp and handrails				
46	2015.06.10	Site	Ramp to "Friends" Building in Parking lot	Ramps	14	101	Wheel guide is not provided at upper run. Lower rail is welded behind the posts. To prevent wheel entrapment, the curb or barrier shall provide a continuous and uninterrupted barrier along the length of the ramp.		11B-405.9.2	Replace with a compliant ramp and handrails

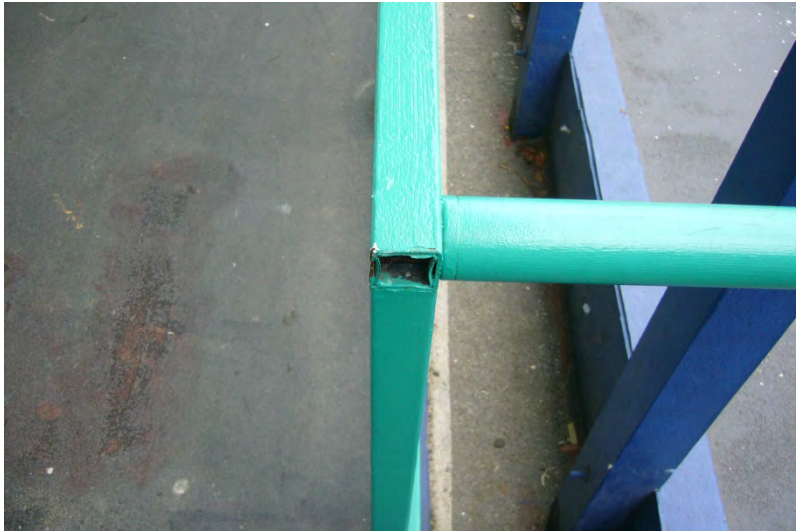
47	2015.06.10	Site	Ramp to "Friends" Building in Parking lot	Ramps	14	102	Hand grip at upper run has a square profile. Hand grip at lower run is circular. The transition from circular to square is not smooth. Handrail gripping surfaces and any surfaces adjacent to them shall be free of sharp or abrasive elements and shall have rounded edges.	505.8	11B-505.8	Replace with a compliant ramp and handrails				
48	2015.06.10	Site	Ramp to "Friends" Building in Parking lot	Ramps	14	104	Hand rail has no extension on top landing on wall side and only 8" extension on the other side. Minimum 12" extension beyond the top is required.	505.10.1	11B-505.10.1	Replace with a compliant ramp and handrails				
49	2015.06.10	Site	Ramp to "Friends" Building in Parking lot	Ramps	14	103	Rail wall brackets block the grip. Handrail gripping surfaces shall be continuous along their length and shall not be obstructed along their tops or sides.	505.6	11B-505.6	Replace with a compliant ramp and handrails
